MIDLAND UNITS 1 & 2
JOB NO. 7220

REVIEW OF U.S. TESTING
FIELD AND LABORATORY CONSTRUCTION
TEST DATA ON SOILS USED AS FILL

PREPARED BY
BECHTEL POWER CORPORATION
JUNE 12, 1979

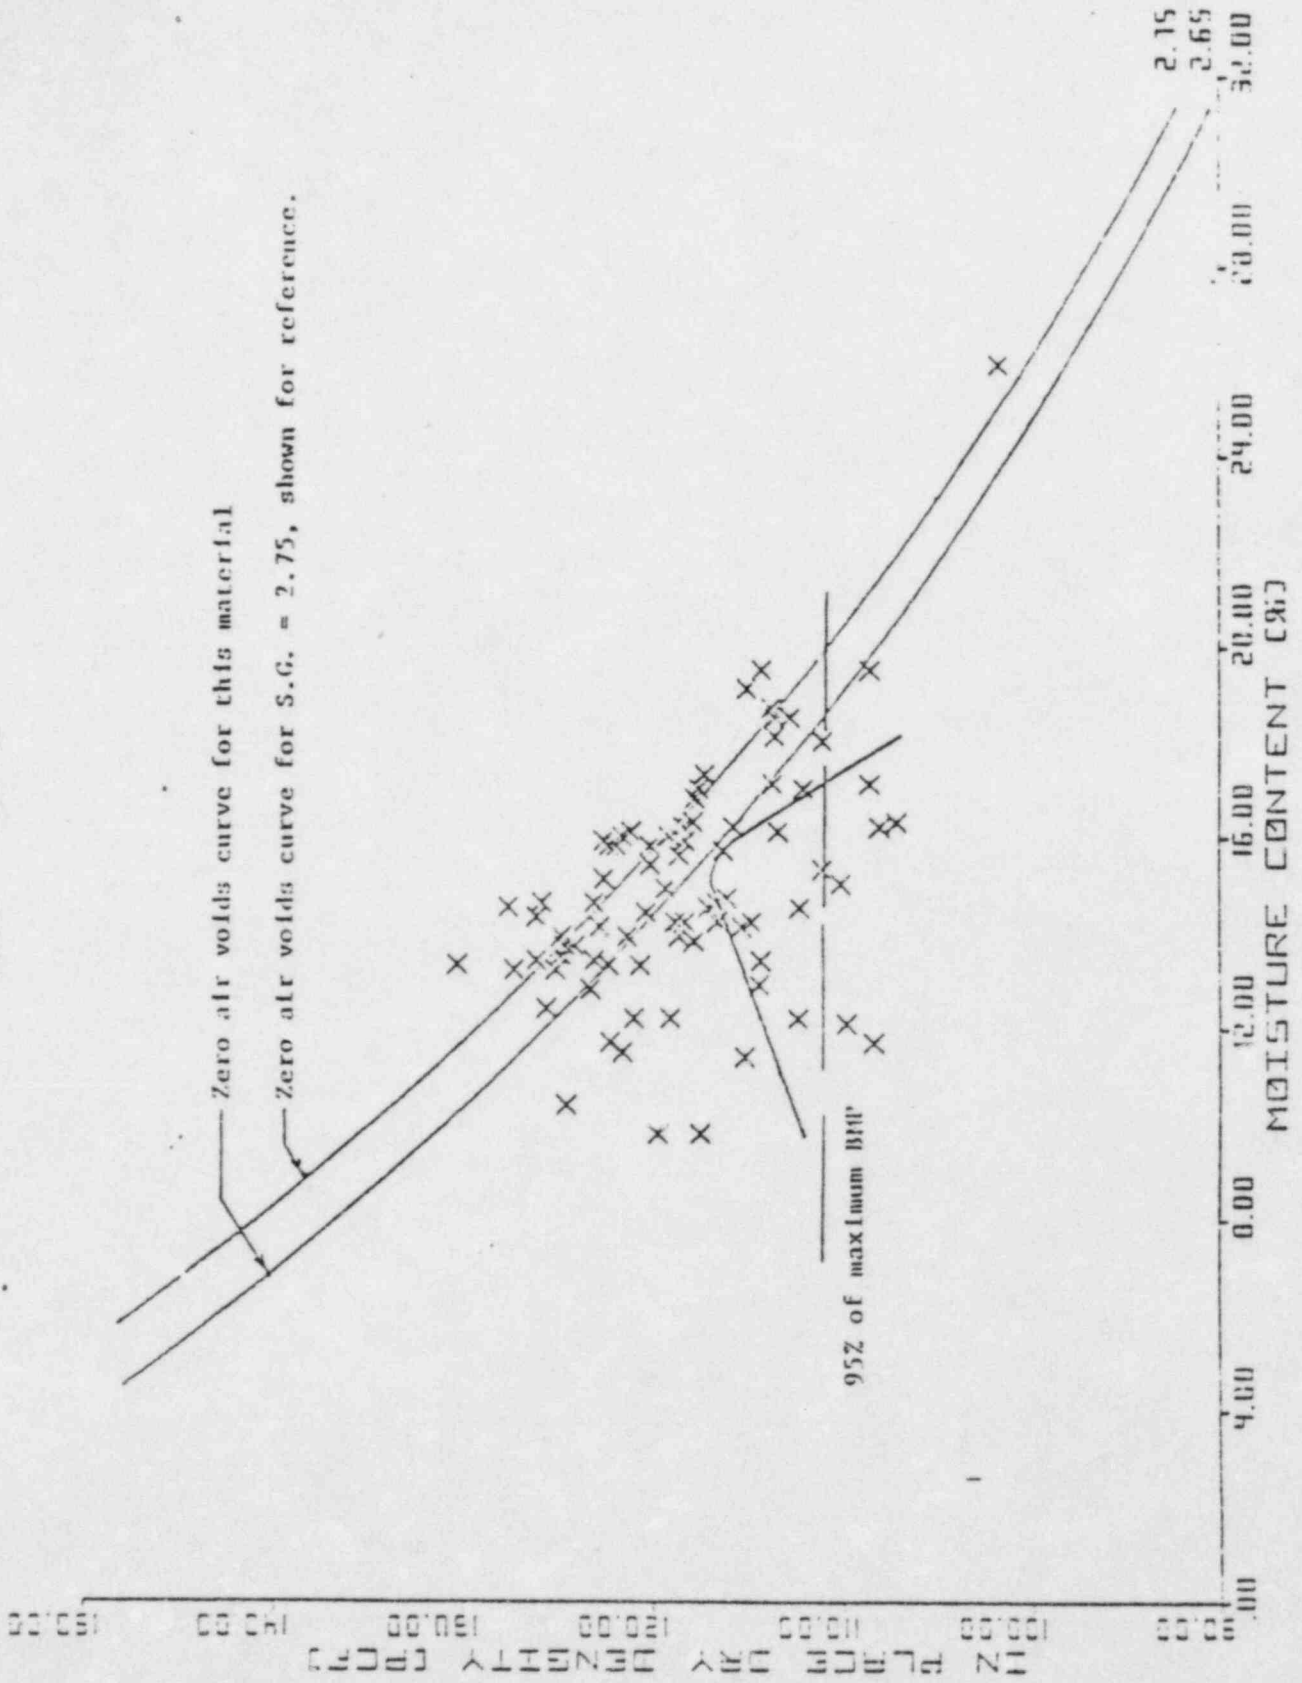
FIGURE 1

Soils cannot be more than 100 percent saturated; therefore, all field test data points, when plotted as dry density versus moisture content, must be below the zero air voids curve as defined by the specific gravity of the material. Specifications do not require examination of the zero air voids curve, but it is considered fundamental soil mechanics relative to compaction plots. There are numerous cases in the U. S. Testing Company data where points plot above the zero air voids curve. Figure 1 attached shows a typical laboratory compaction test curve with field test results plotted on it. Many of the field test results plot above the zero air voids curve. Provided the specific gravity is correct this is not possible so that all such points must represent erroneous data. The

MOISTURE DENSITY FIRM GMP 278
 SPECIFIC GRAVITY = 2.65
 ALL TESTS

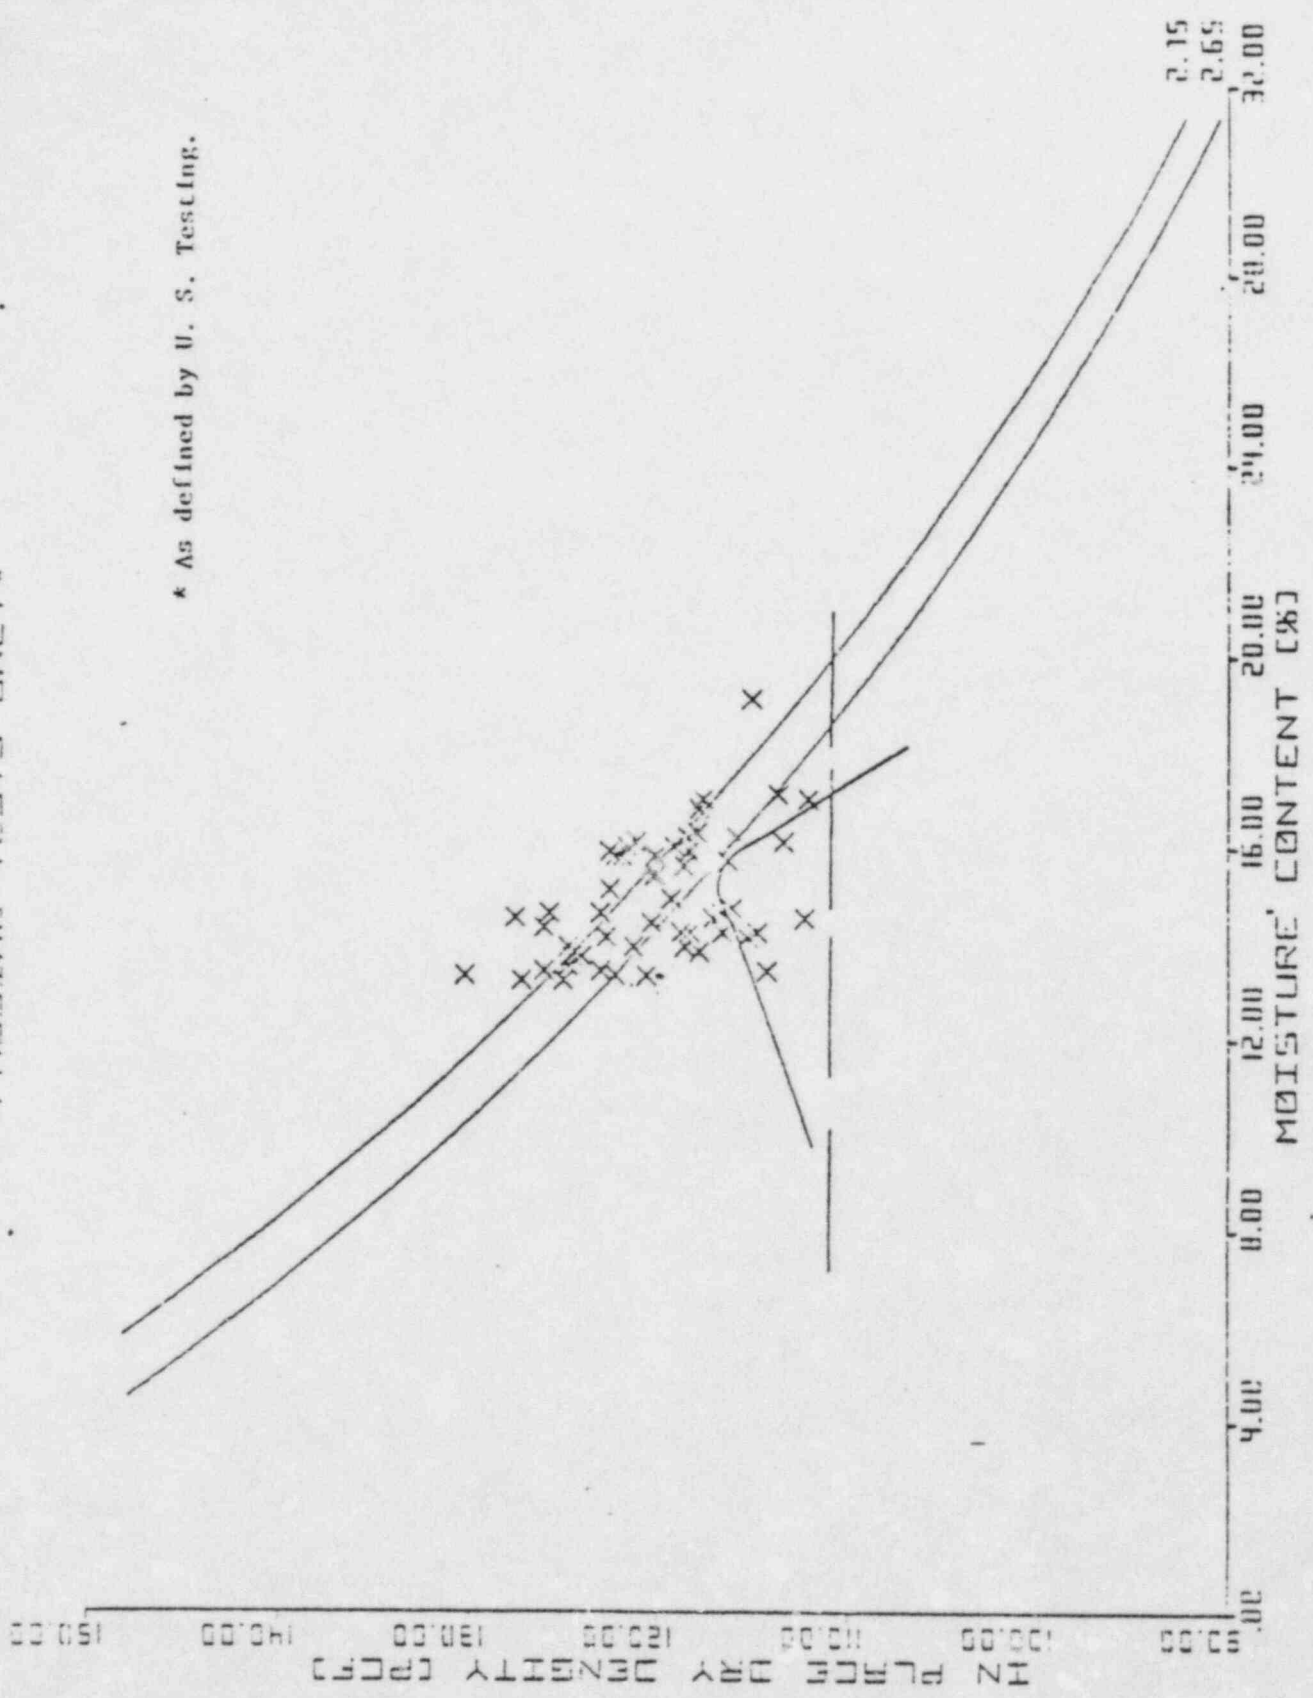
FIGURE 2

MOISTURE-DENSITY FOR GMP 278
 SPECIFIC GRAVITY = 2.65
 PASSING TESTS ONLY*

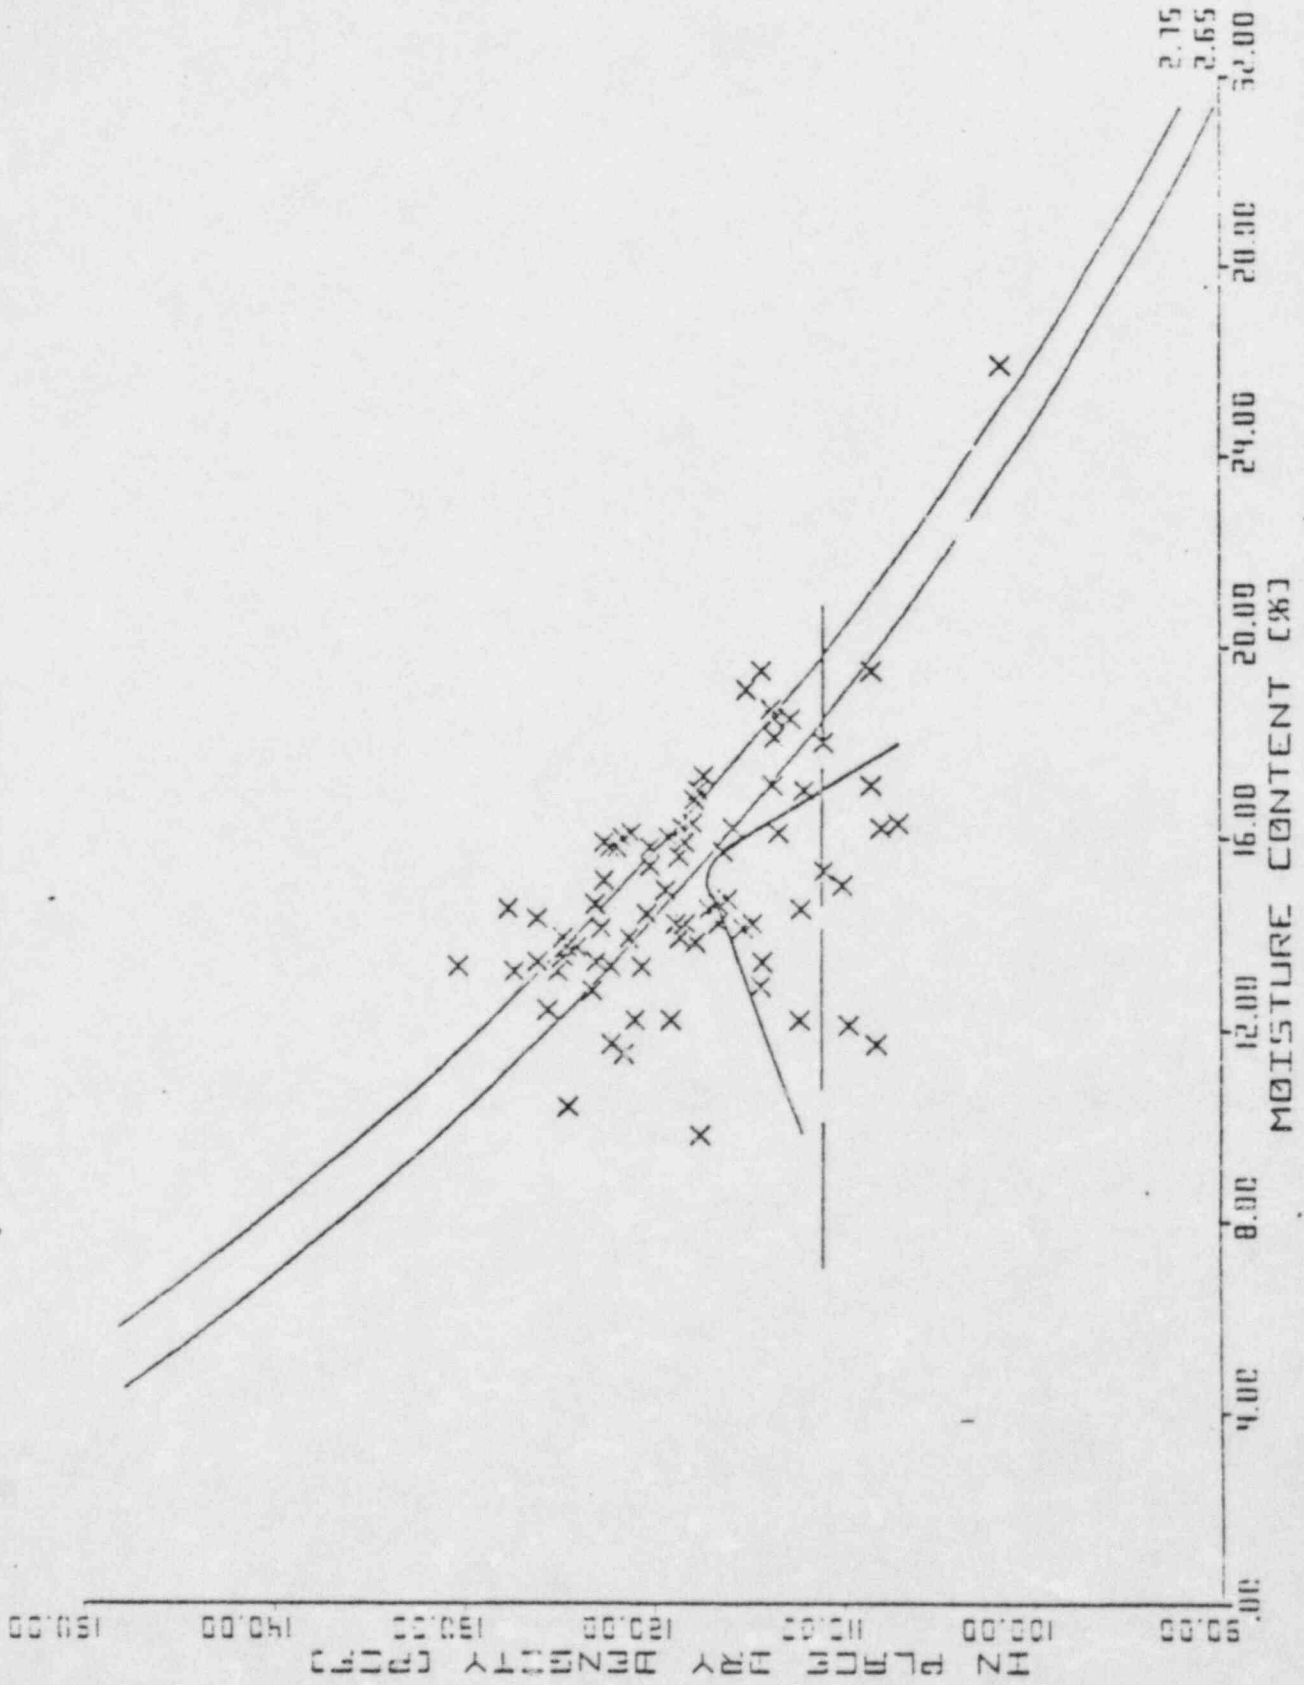
FIGURE 3

MOISTURE-DENSITY FOR BMP 273.
 SPECIFIC GRAVITY = 2.65
 NUCLEAR DENSOMETER TESTS

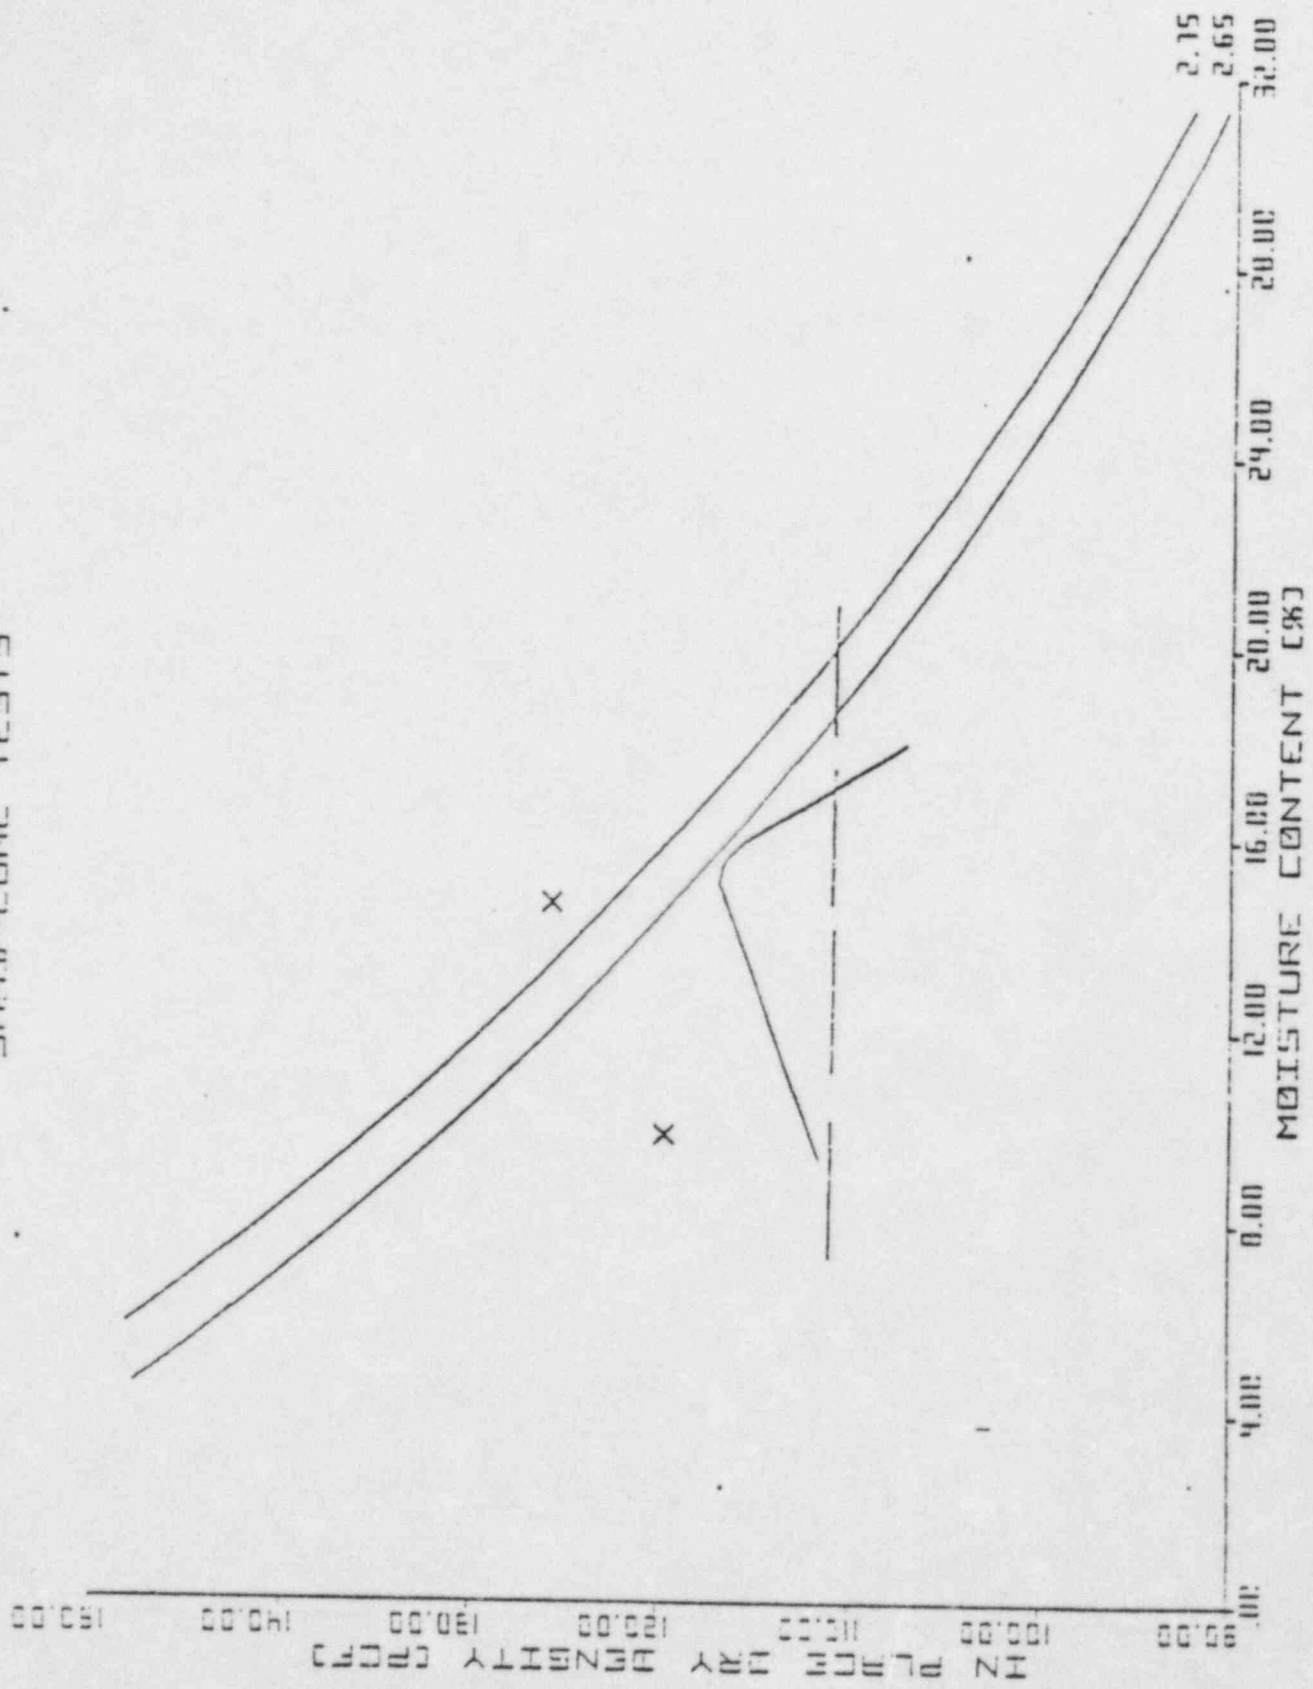
FIGURE 4

MOISTURE-DENSITY FOR BMP 273
 SPECIFIC GRAVITY = 2.65
 SAND-CONE TESTS

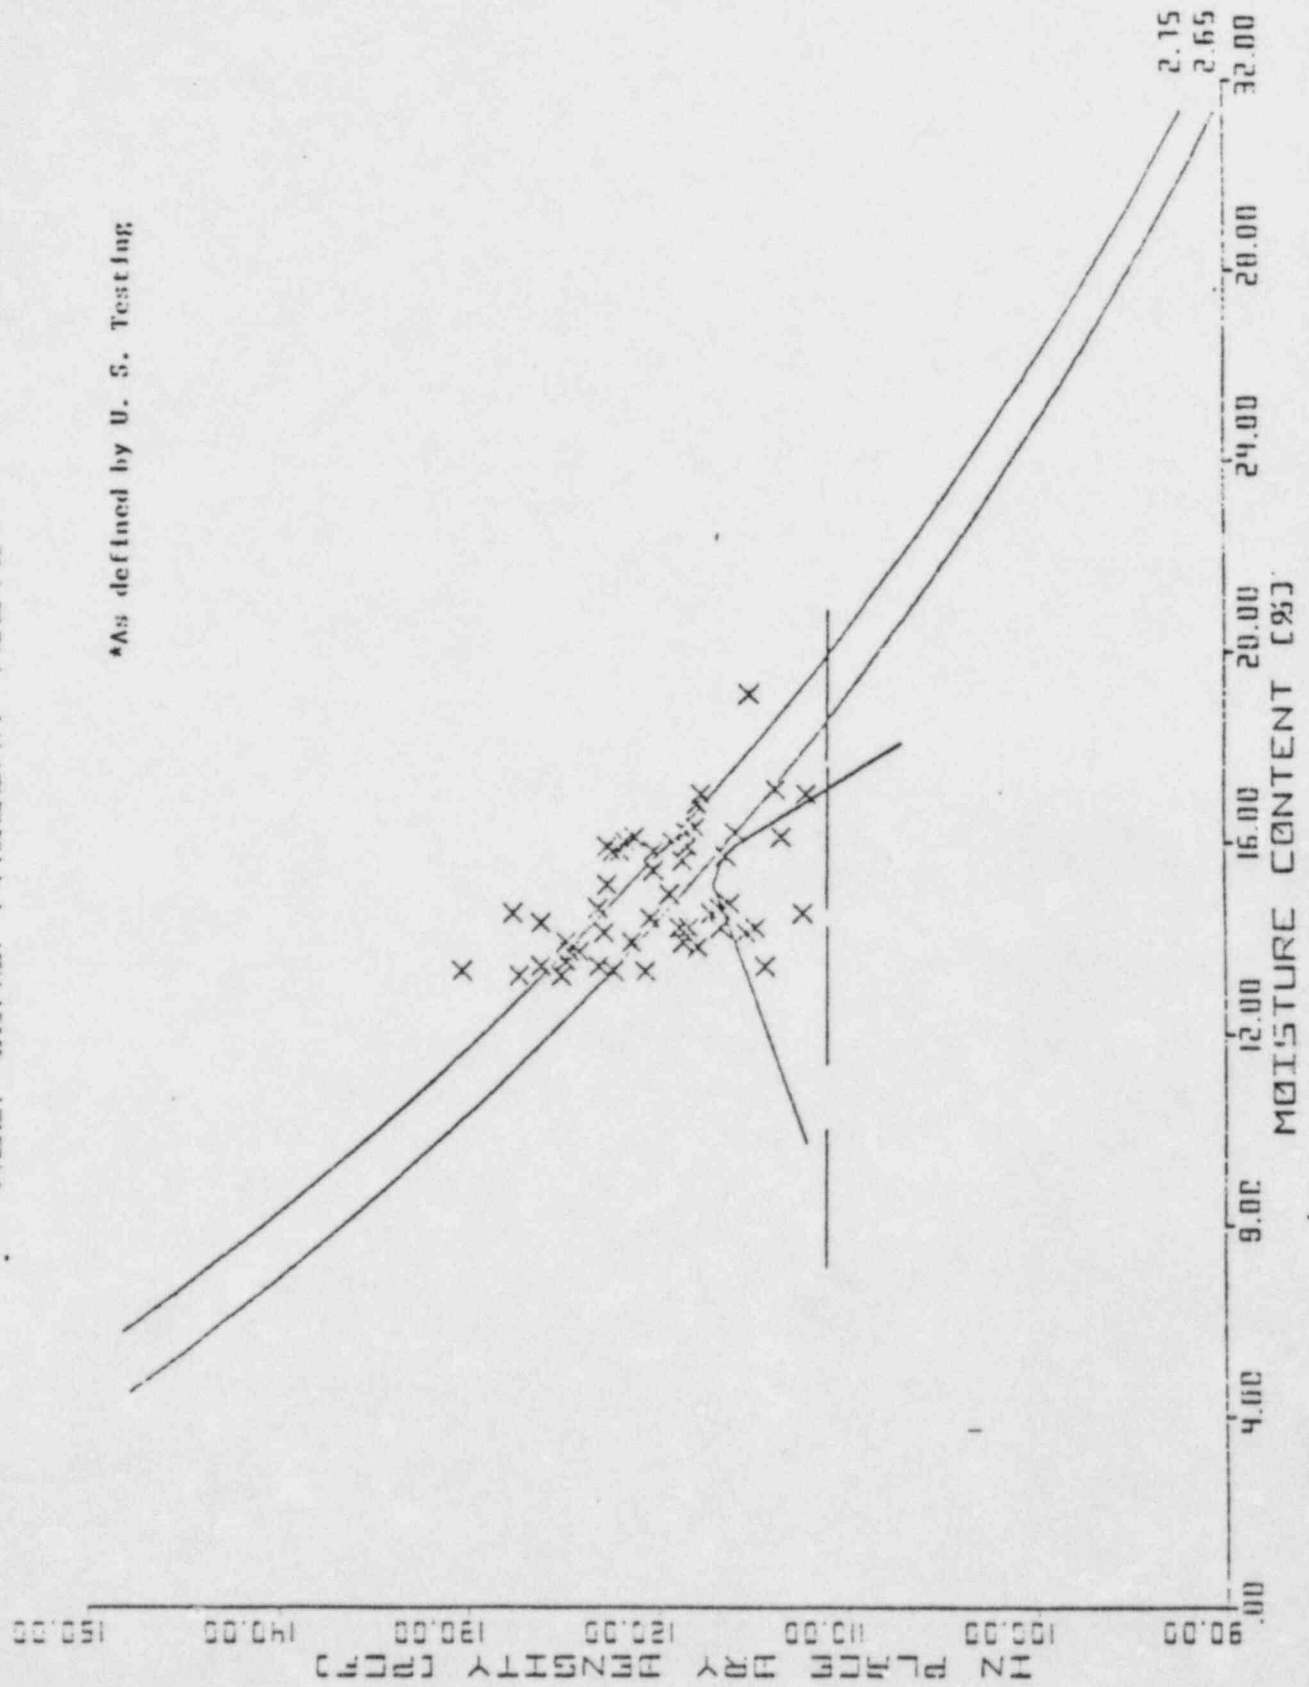
FIGURE 5

MOISTURE DENSITY FOR BMP 273
 SPECIFIC GRAVITY = 2.65
 NUC. DENS. PASSING TESTS*

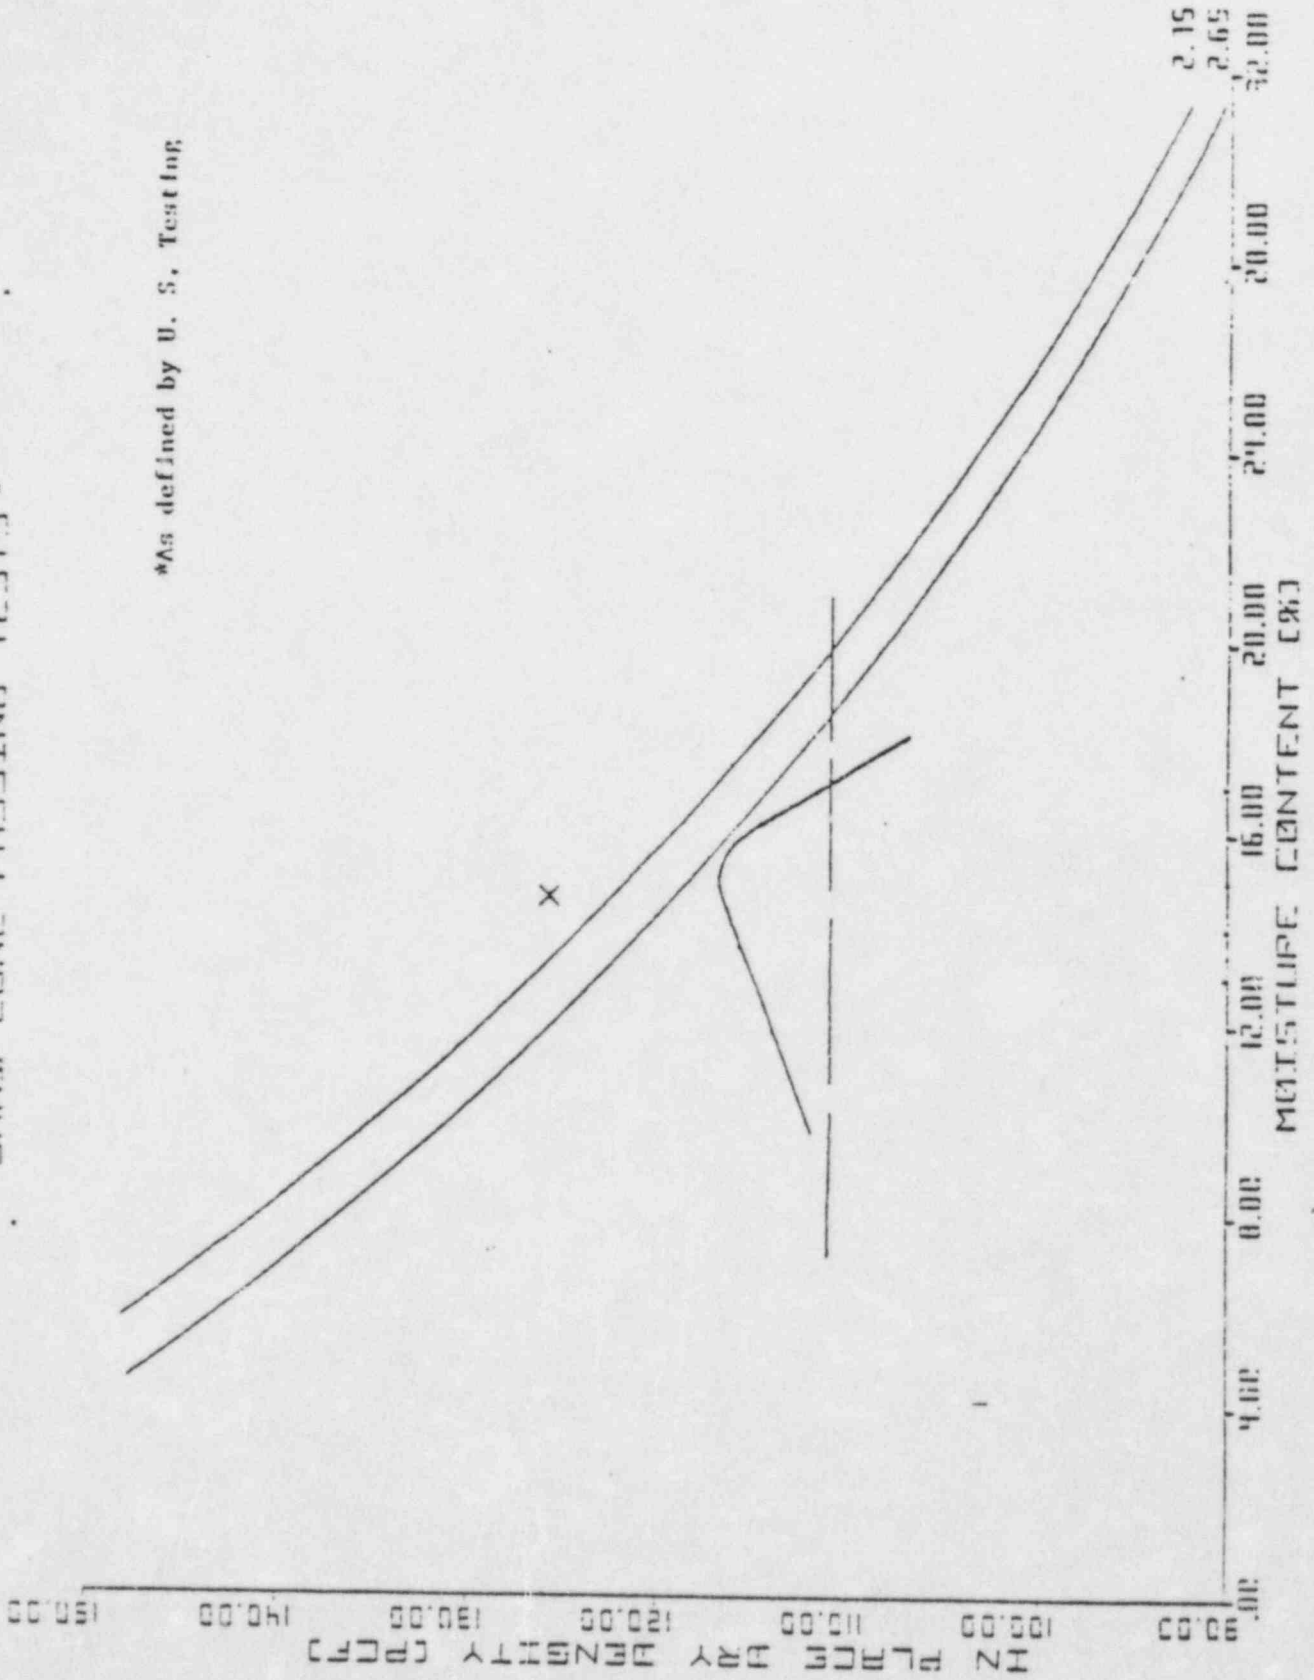
FIGURE 6

MOISTURE-DENSITY FOR B.M.P. 27.8
 SPECIFIC GRAVITY = 2.65
 SAND-CONE PASSING TESTS *

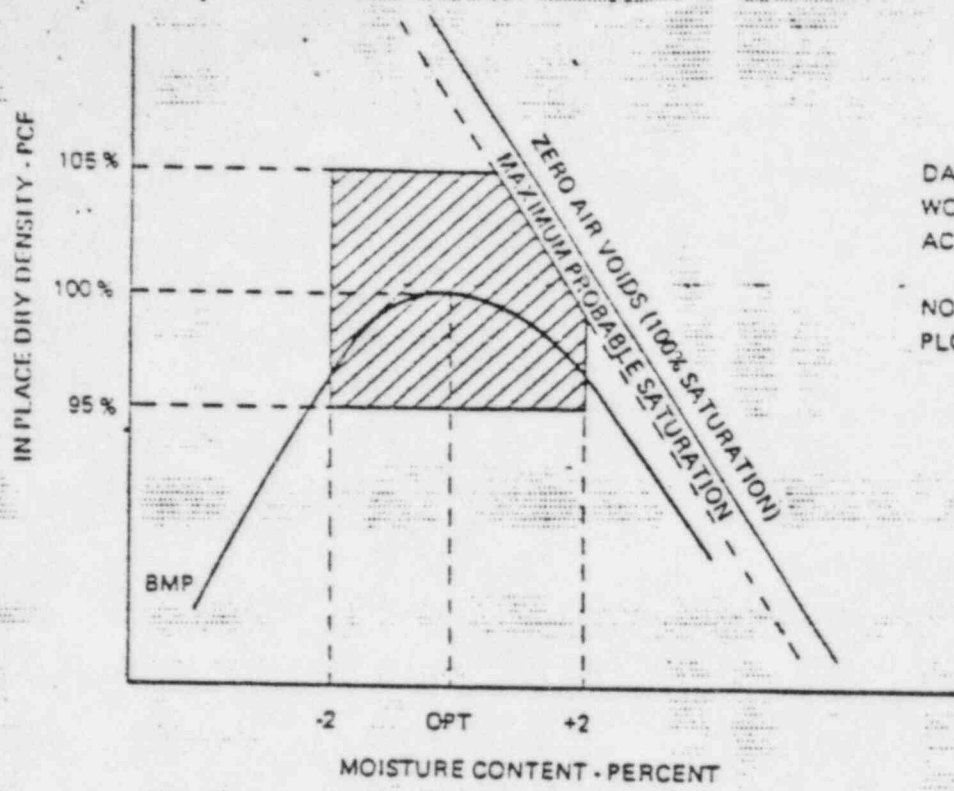
FIGURE 7-A-

For a field test result to be valid as well as "Passing" it must fall within a well defined area on the plot containing the laboratory compaction curve. This area or window of acceptability is shown for a hypothetical compaction curve on Figure 7a that would meet requirements of Specification 7220-C-210. It is defined by horizontal lines at 95 percent and 105 percent of specified density, vertical lines through ± 2 percent of optimum moisture content, and a line parallel to the zero voids line indicating saturation about half way between the compaction curve and 100 percent saturation (zero air voids curve). The upper limit of 105 percent of specified density is not defined in the specifications. It was arbitrarily chosen as an upper limit since engineers knowledgeable in soil compaction have observed that numbers greater than this give increasingly invalid comparisons between field test results and the specified laboratory test curve. Therefore, if all data points fall within the defined window there would be no reason to assume that they are wrong. However, when many data points fall outside the designated area there is something wrong with the information and then all data points become suspect. A review of all data indicates that about 25 percent of the cohesive soil test results fall within this area.

Data to the left of the "window" and below 95% would be identified as failing tests and retests would be made. Does not indicate errors.

DATA POINTS THAT PLOT IN SHADED AREA WOULD BE GENERALLY ACCEPTABLE ACCORDING TO SPECIFICATIONS

NOTE: ABOUT 25% OF ALL FIELD DATA PLOTS IN THE SHADED AREA

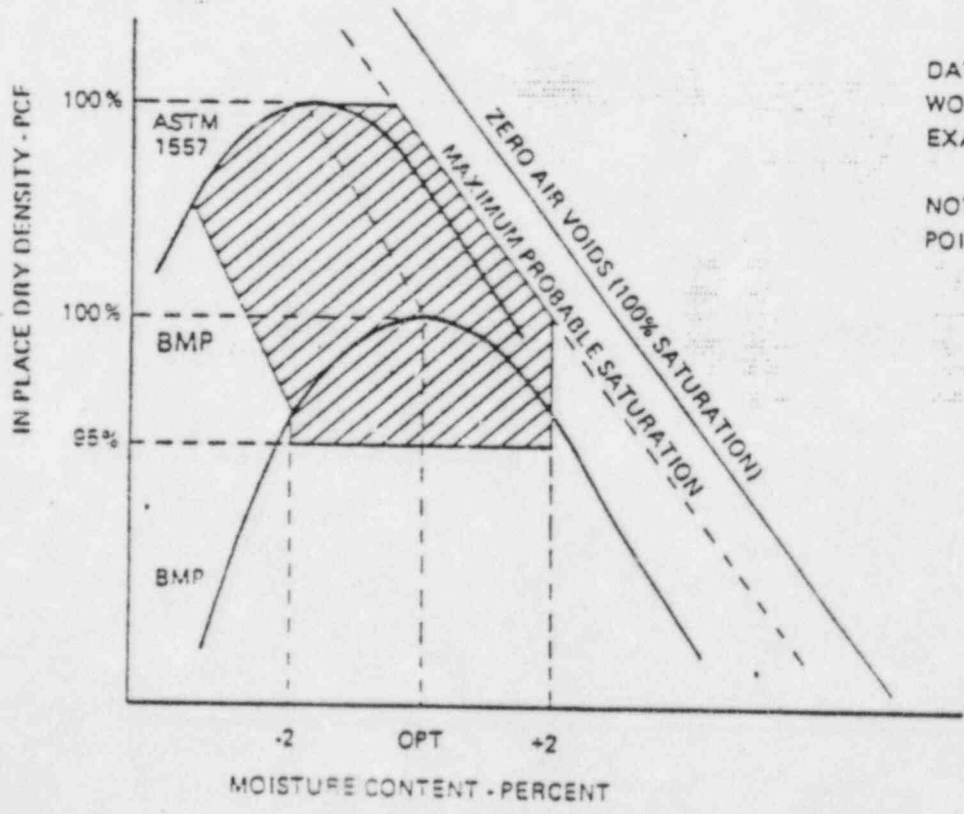
DATA POINTS THAT PLOT IN SHADED AREA WOULD BE ACCEPTABLE REGARDLESS OF EXACT SPECIFICATION WORDING

NOTE: ABOUT 40% OF ALL FIELD DATA POINTS PLOT IN THE SHADED AREA

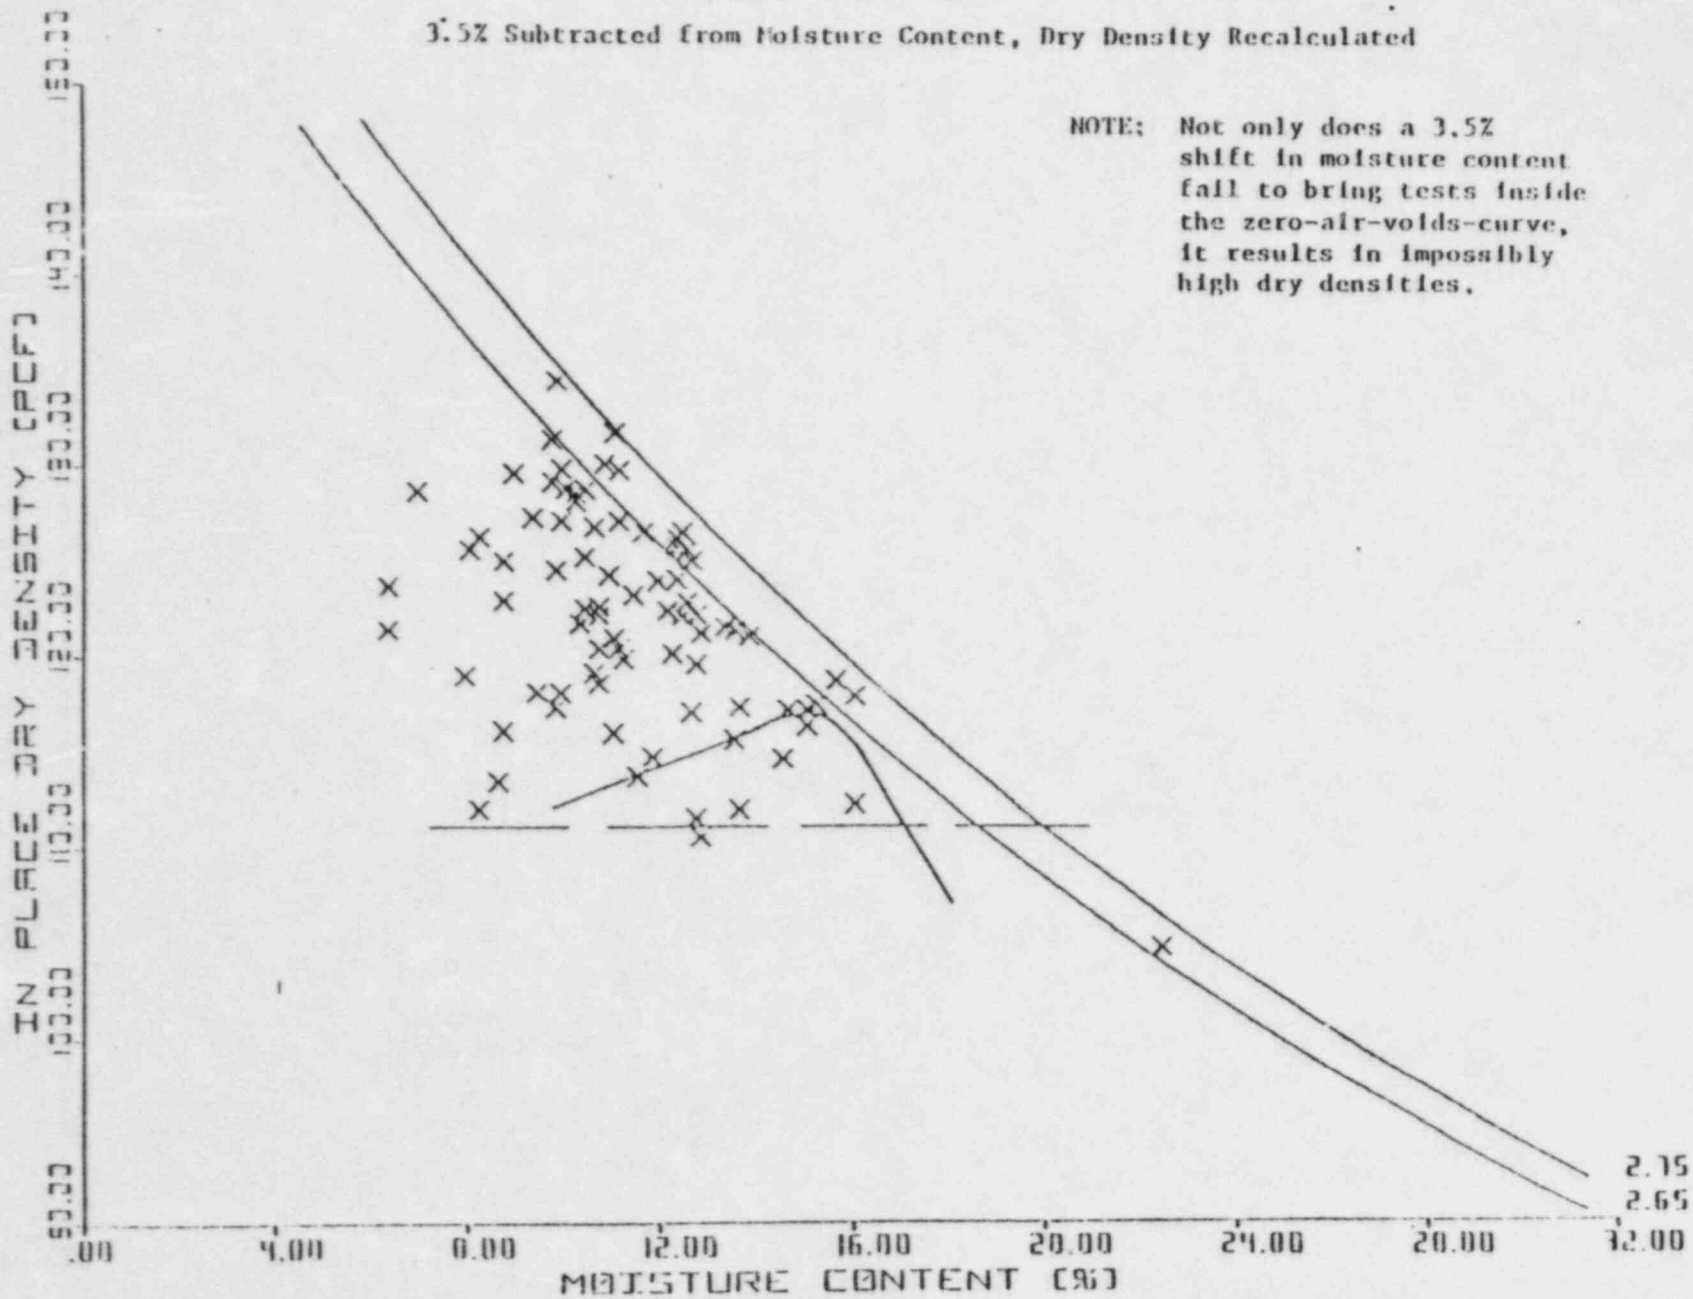
FIGURE 9

In a letter from U. S. Testing to Bechtel (dated May 30, 1974), the average deviation of the nuclear device from oven-dry moistures was +.12% for a set of 30 tests. However, the standard deviation is 1.77% for the data with the range of differences being from - 3.2% to +3.9%. Thus, accuracy of the nuclear device is questionable, and could translate into errors of roughly ± 4 pcf in the dry density calculation. (It should be noted that errors in the moisture content tend to shift the position of test results on a moisture density plot approximately parallel to the zero air voids curve, assuming the in-place wet density is correct, and thus do not explain the large number of points which plot outside this limit. See Figure 9).

3.5% Subtracted from Moisture Content, Dry Density Recalculated

NOTE: Not only does a 3.5% shift in moisture content fail to bring tests inside the zero-air-voids-curve, it results in impossibly high dry densities.

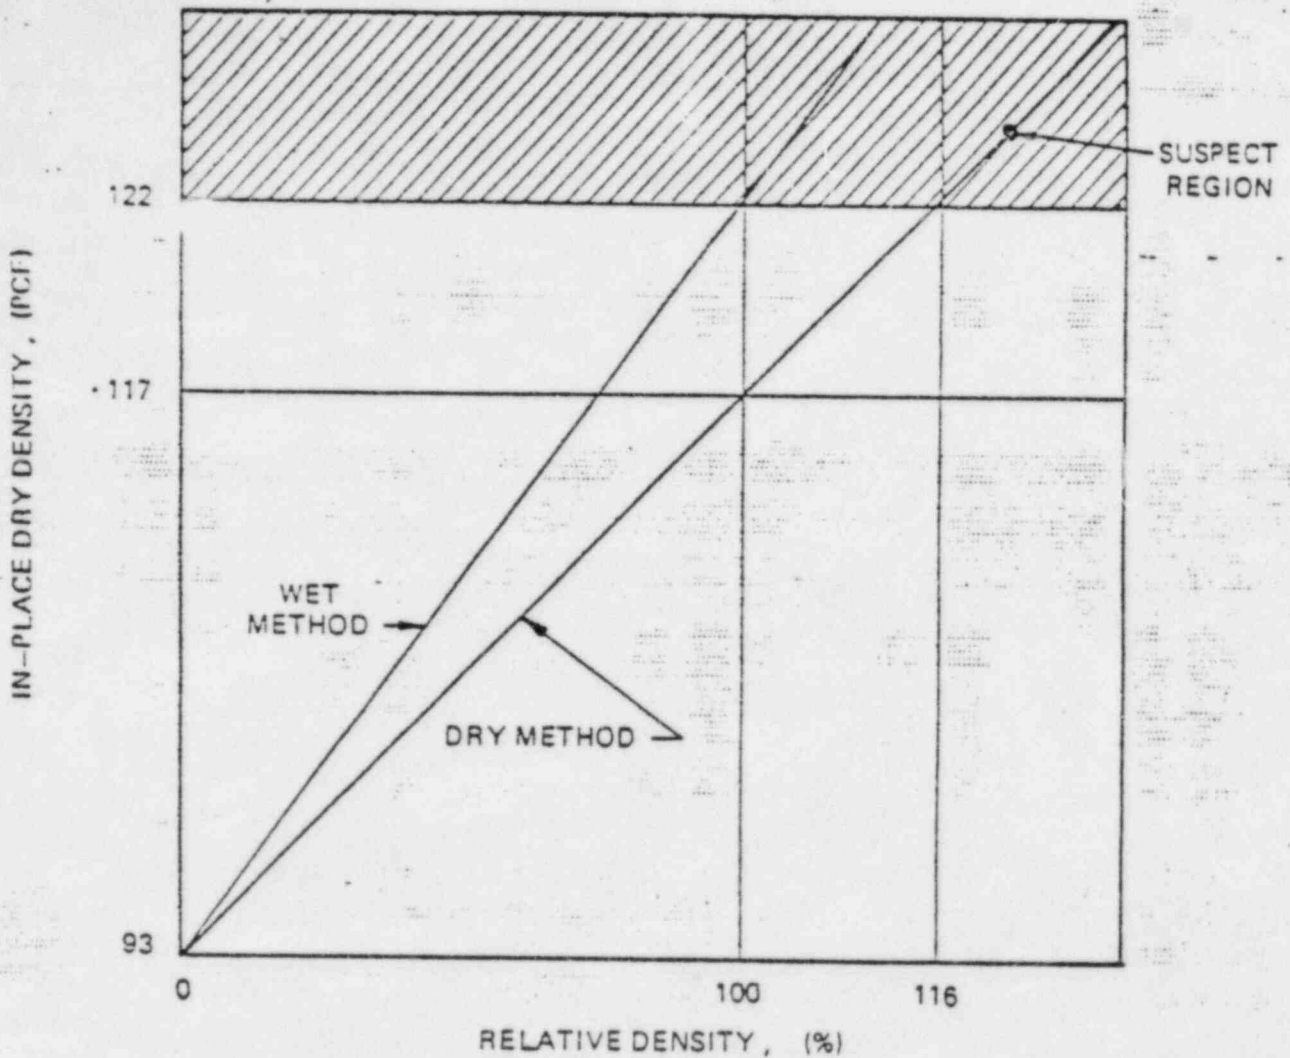
FIGURE 10
CHANGE IN RELATIVE DENSITY SCALE FROM DRY TO WET METHODS
OF OBTAINING MAXIMUM DENSITY, BASED ON RECENT LAB RESULTS

NOTE: VALUES FOR DRY DENSITY ARE TYPICAL OF A RANDOM FILL SAND. ANY TESTS SHOWING MORE THAN 117% RELATIVE DENSITY WOULD BE SUSPECT IN THIS EXAMPLE. STRUCTURAL SANDS TEND TO SHOW ONLY 2 OR 3 PCF INCREASE IN MAXIMUM DENSITY AND THUS RESULTS AT MUCH LOWER RELATIVE DENSITY WOULD BE SUSPECT, SAY 105 - 110 PERCENT

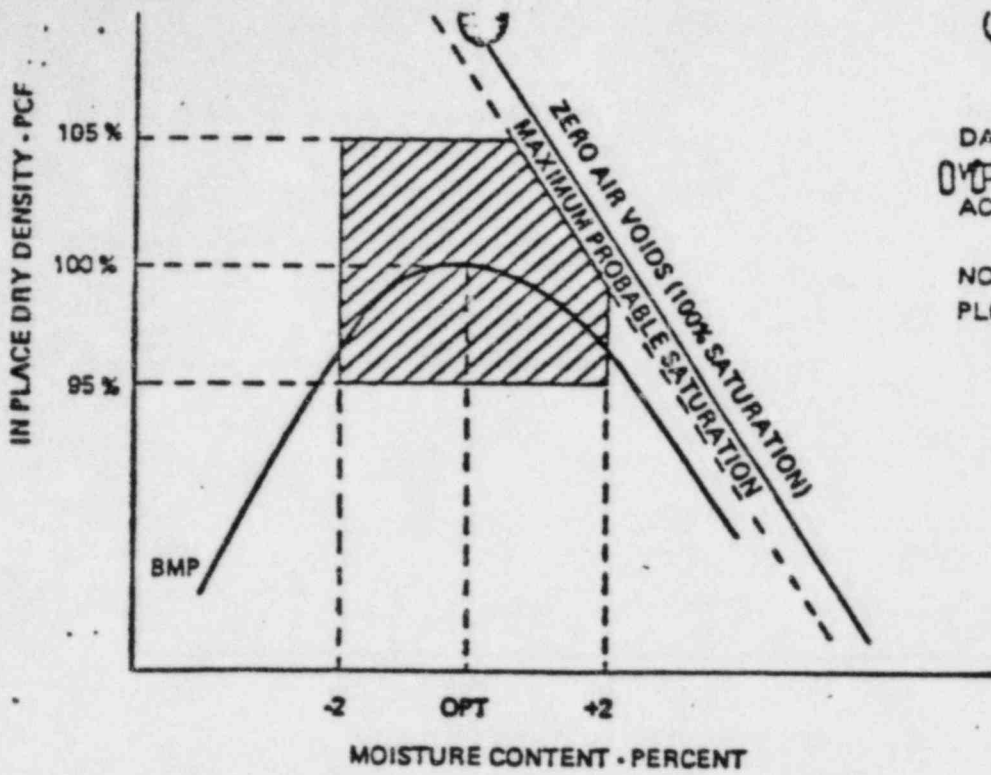
FIGURE 7-A

DATA POINTS THAT PLOT IN SHADED AREA
WOULD BE GENERALLY ACCEPTABLE
ACCORDING TO SPECIFICATIONS

NOTE: ABOUT 25% OF ALL FIELD DATA
PLOTS IN THE SHADED AREA

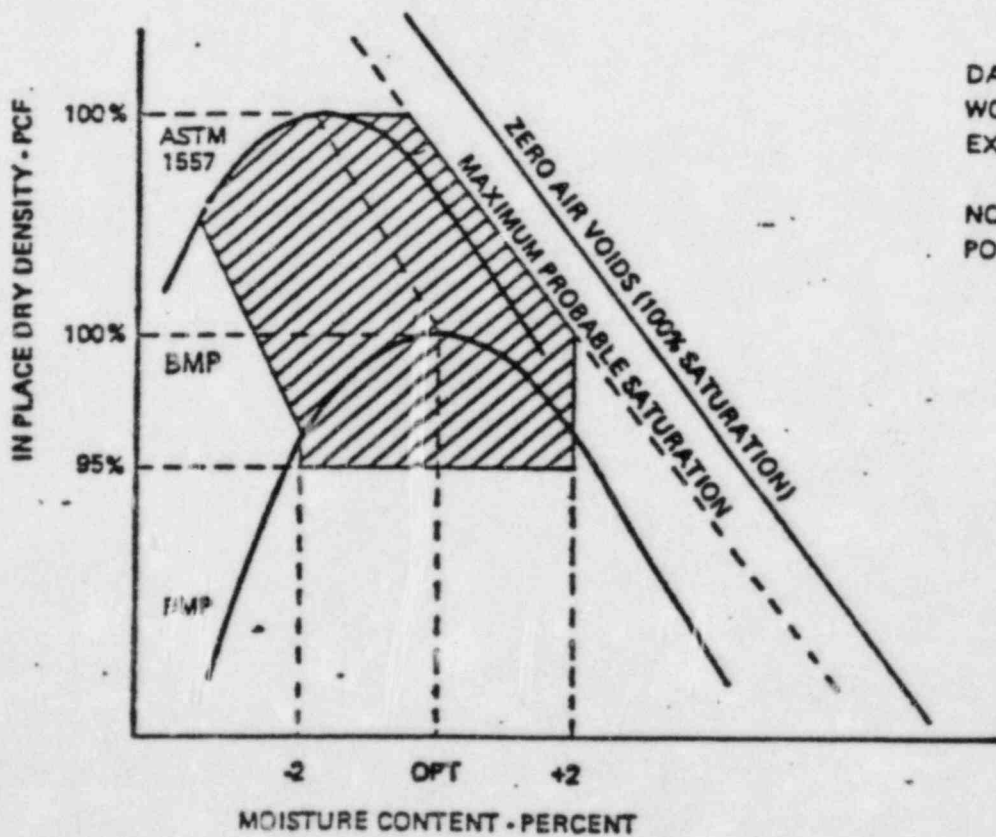
DATA POINTS THAT PLOT IN SHADED AREA
WOULD BE ACCEPTABLE REGARDLESS OF
EXACT SPECIFICATION WORDING

NOTE: ABOUT 40% OF ALL FIELD DATA
POINTS PLOT IN THE SHADED AREA
