MIDLAND UNITS 1 & 2
JOB NO. 7220

REVIEW OF U.S. TESTING
FIELD AND LABORATORY CONSTRUCTION
TEST DATA ON SOILS USED AS FILL

PREPARED BY
BECHTEL POWER CORPORATION
JUNE 12, 1979

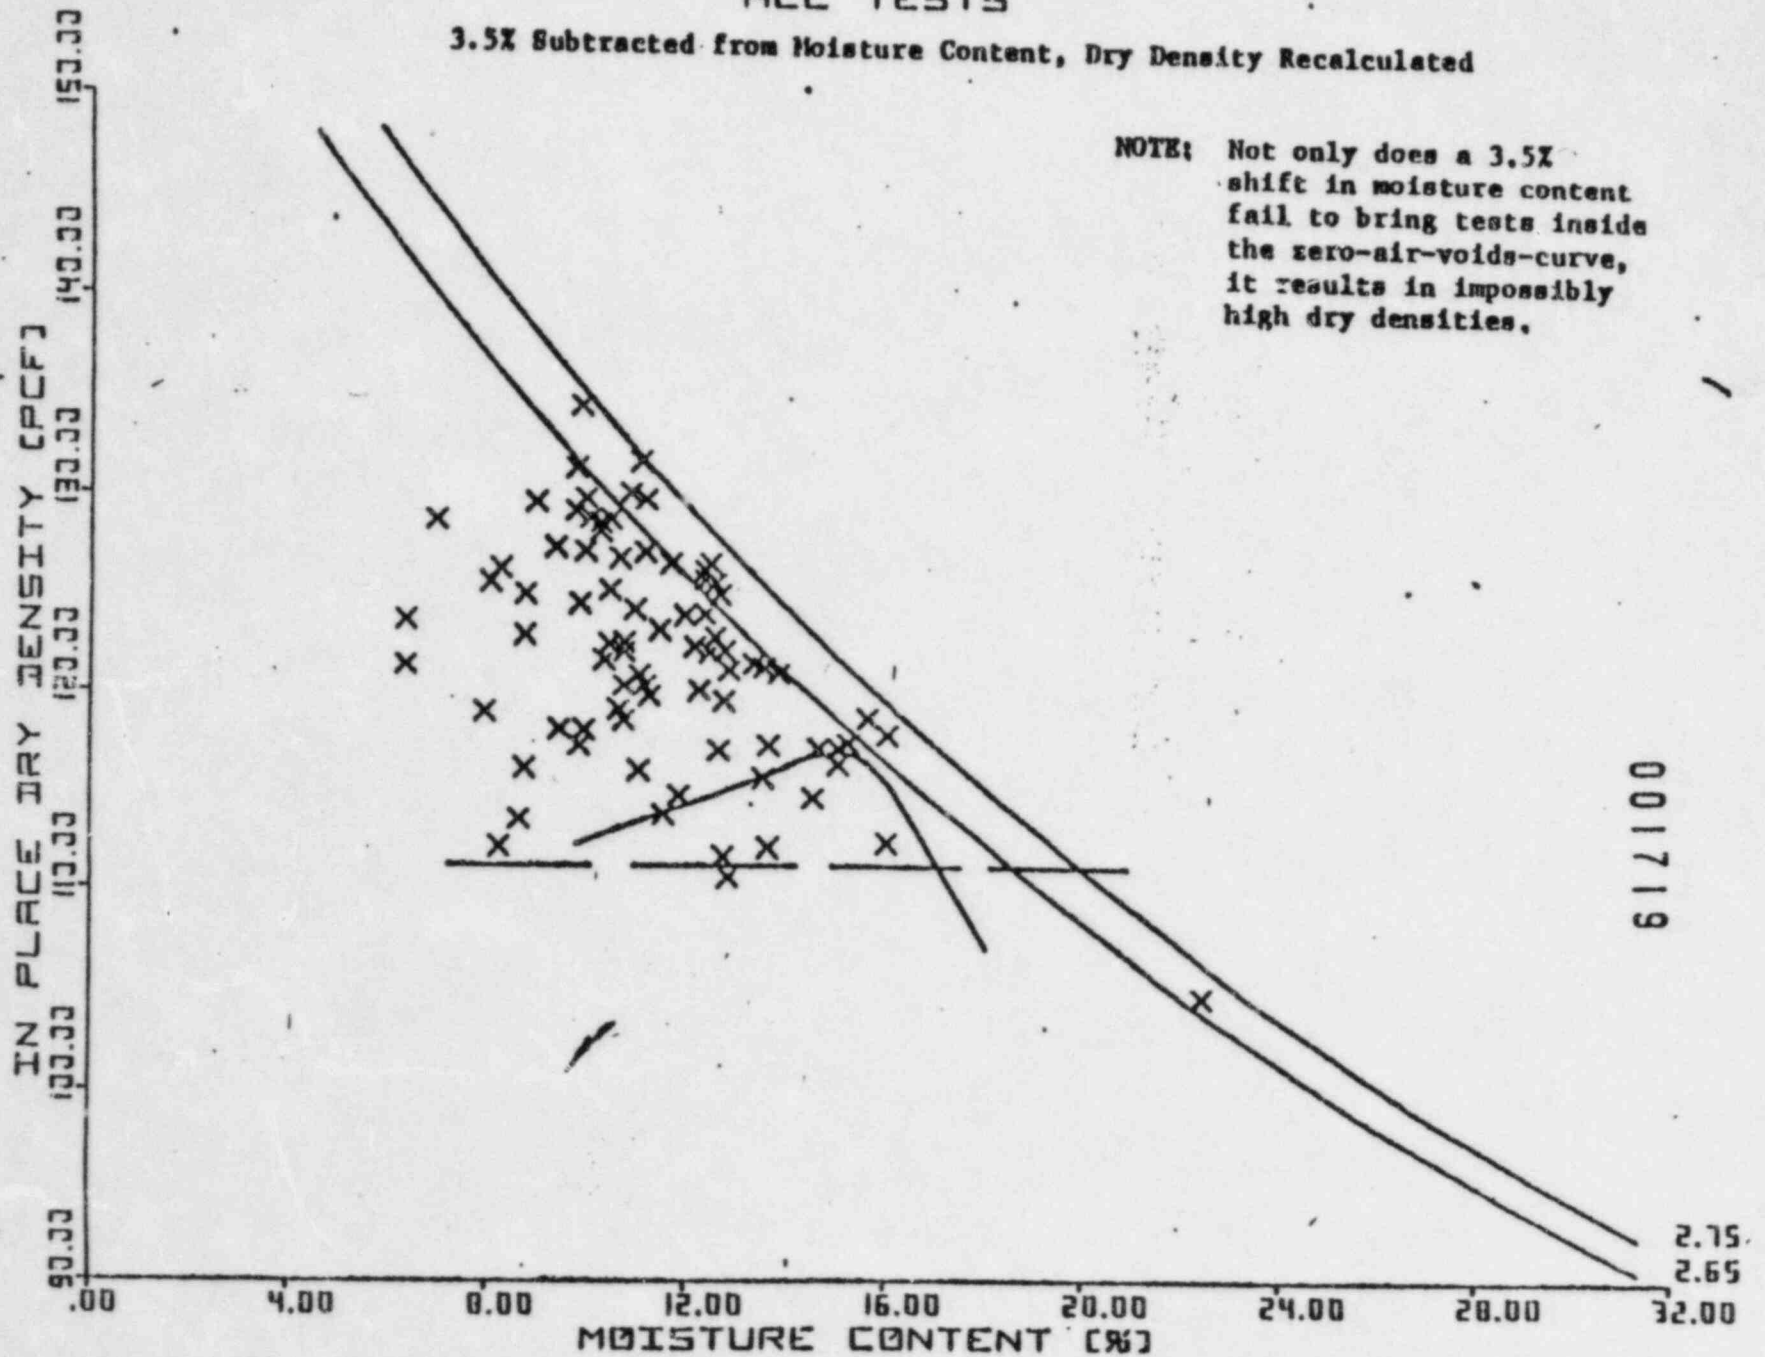
FIGURE 9

3.5% Subtracted from Moisture Content, Dry Density Recalculated

NOTE: Not only does a 3.5% shift in moisture content fail to bring tests inside the zero-air-voids-curve, it results in impossibly high dry densities.

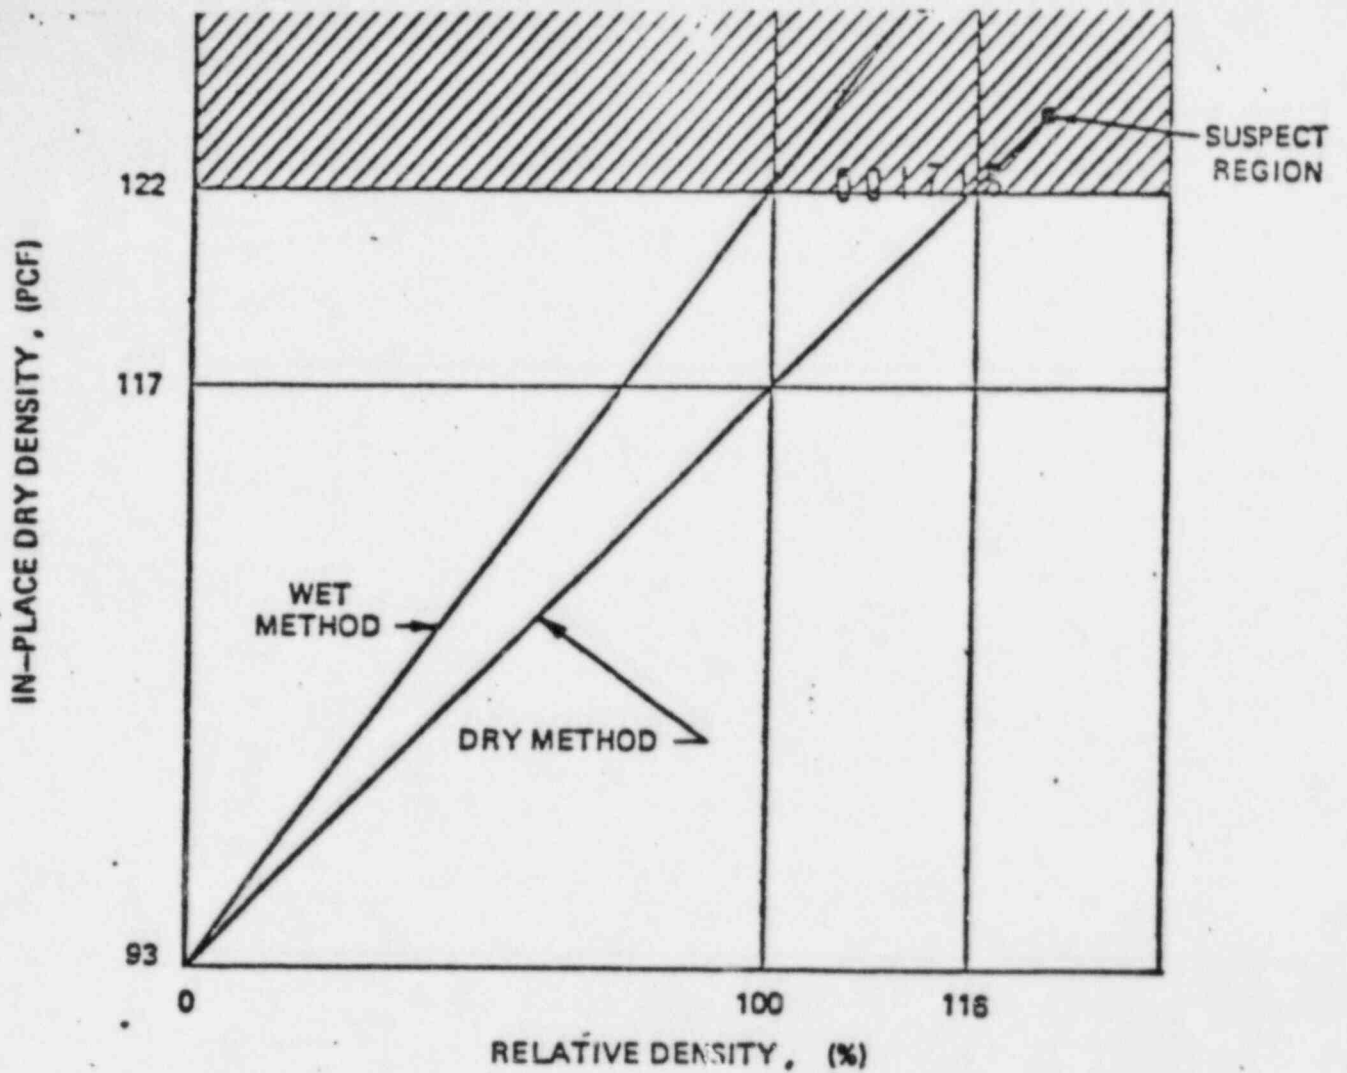
FIGURE 10

NOTE: VALUES FOR DRY DENSITY ARE TYPICAL OF A RANDOM FILL SAND. ANY TESTS SHOWING MORE THAN 117% RELATIVE DENSITY WOULD BE SUSPECT IN THIS EXAMPLE. STRUCTURAL SANDS TEND TO SHOW ONLY 2 OR 3 PCF INCREASE IN MAXIMUM DENSITY AND THUS RESULTS AT MUCH LOWER RELATIVE DENSITY WOULD BE SUSPECT, SAY 105 - 110 PERCENT
