This evaluation was undertaken in response to suggestions from Bechtel QA and Geotech that the Troxler Nuclear Guage was responsible for field density tests plotting outside the zero-air-void curve on moisture-density plots of cohesive fill placed in the Midland plant area. It was felt that the initial studies which resulted in approval of the Troxler might give some indication of its accuracy. Primary reference is Item "I" attached to a letter from K. Rademacher of U. S. Testing Co. to E. Felton of Bechtel, dated 5/30/74, (see Appendix A).

Report on failure of grade beam @
0.4 line - Administration Building.

DIESEL GENERATOR BUILDING TASK GROUP

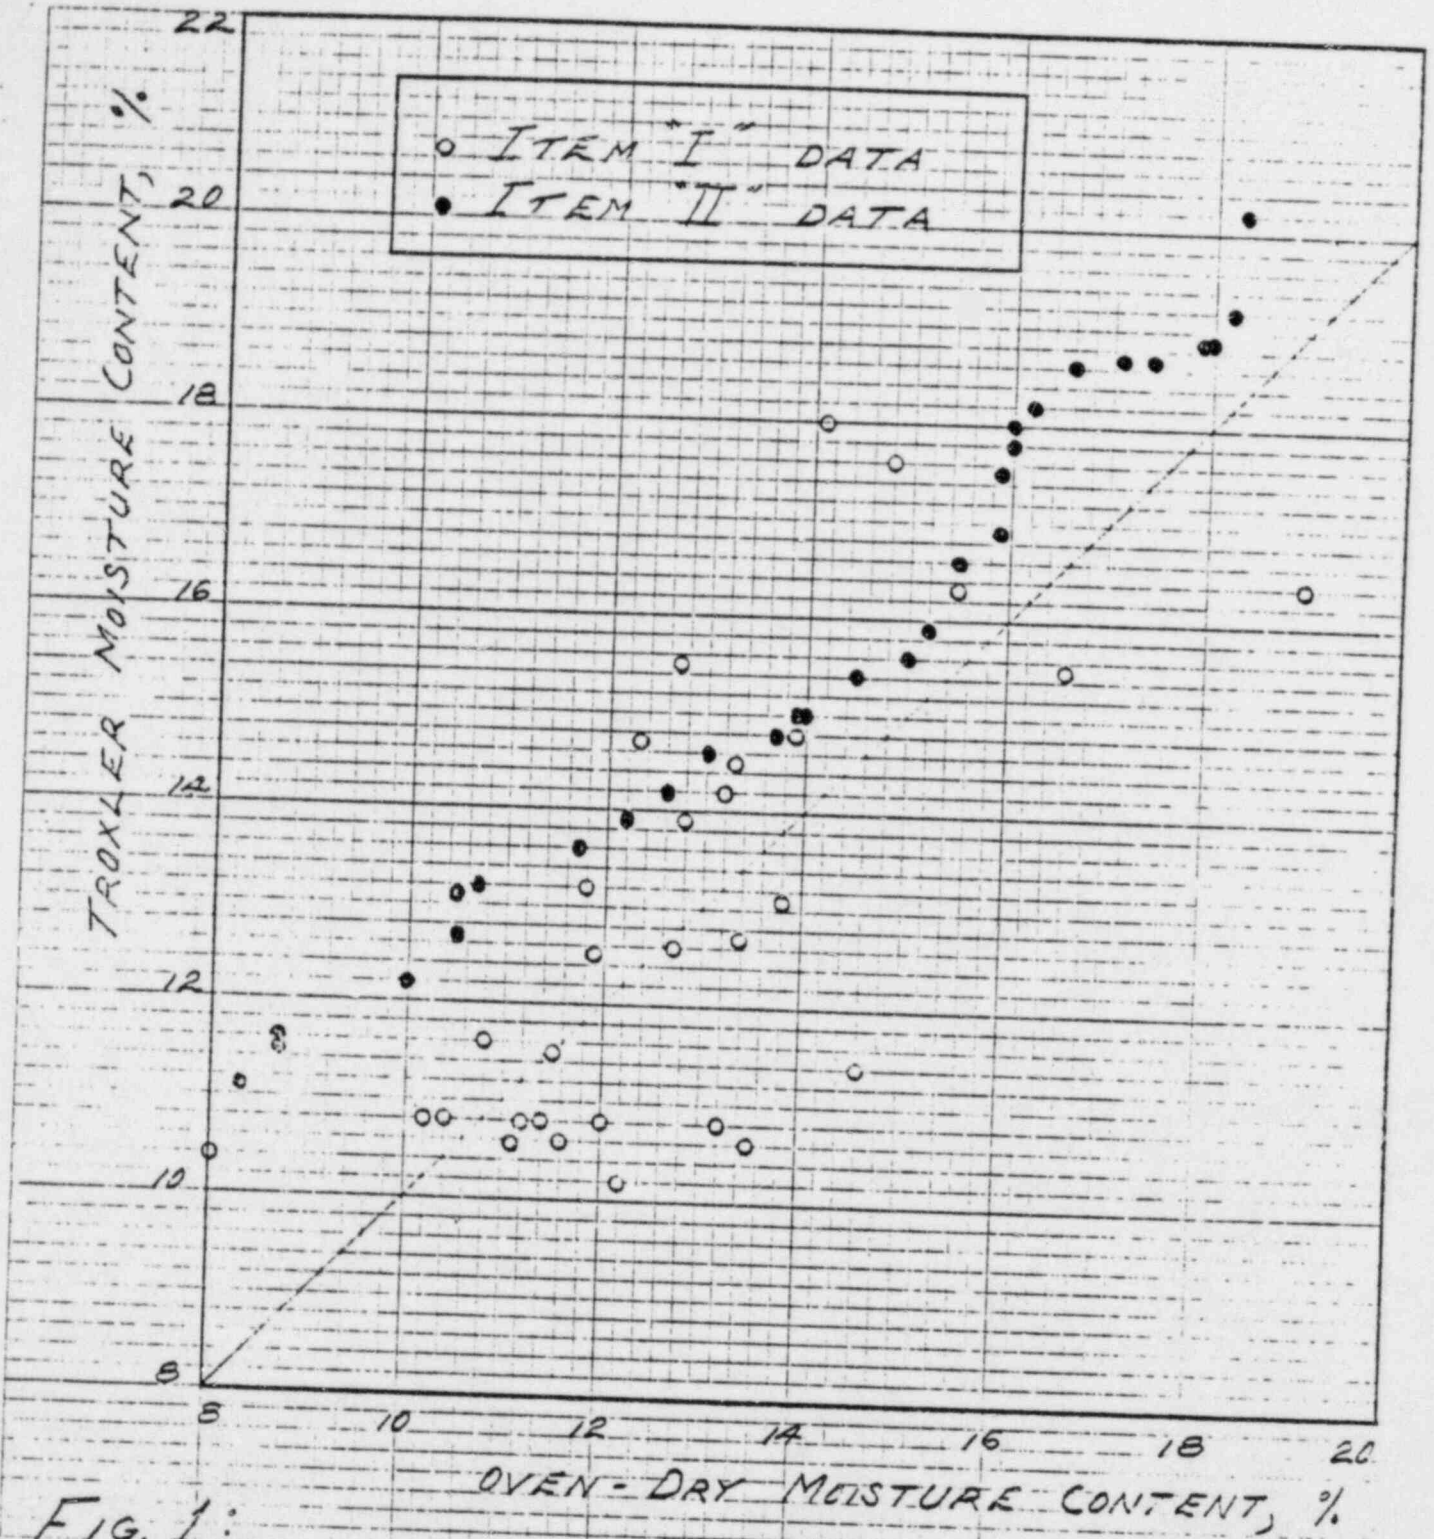
FIG. 1:

In evaluating the second finding, again arithmetic errors were found in the U. S. Testing report. However, as the correlation of .98 was ~~apparently~~ not calculated for the same data as shown in Item "I" nor did it appear reasonable based on the broad scatter of the data shown in the attached graph, the coefficient was recalculated. (see Fig. 1)

A correlation coefficient of .637 would indicate a moderate relationship at best between the Troxler and oven-dry methods. In addition, the standard error of estimate indicates that 95% of all Troxler values will be within $\pm 3.6\%$ of the oven dry, 68% with $\pm 1.8\%$. This in turn means that errors of ± 5 pcf can be anticipated in dry density calculations based on the Troxler moisture determination.

Thus the conclusion here is that the Troxler nuclear densometer was not accurate enough for use in field moisture determination and that the U.S. Testing findings did not properly represent the condition of the data.

PLOTS OF TWO DATA SETS
USED IN U. S. TESTING CO.
REPORT

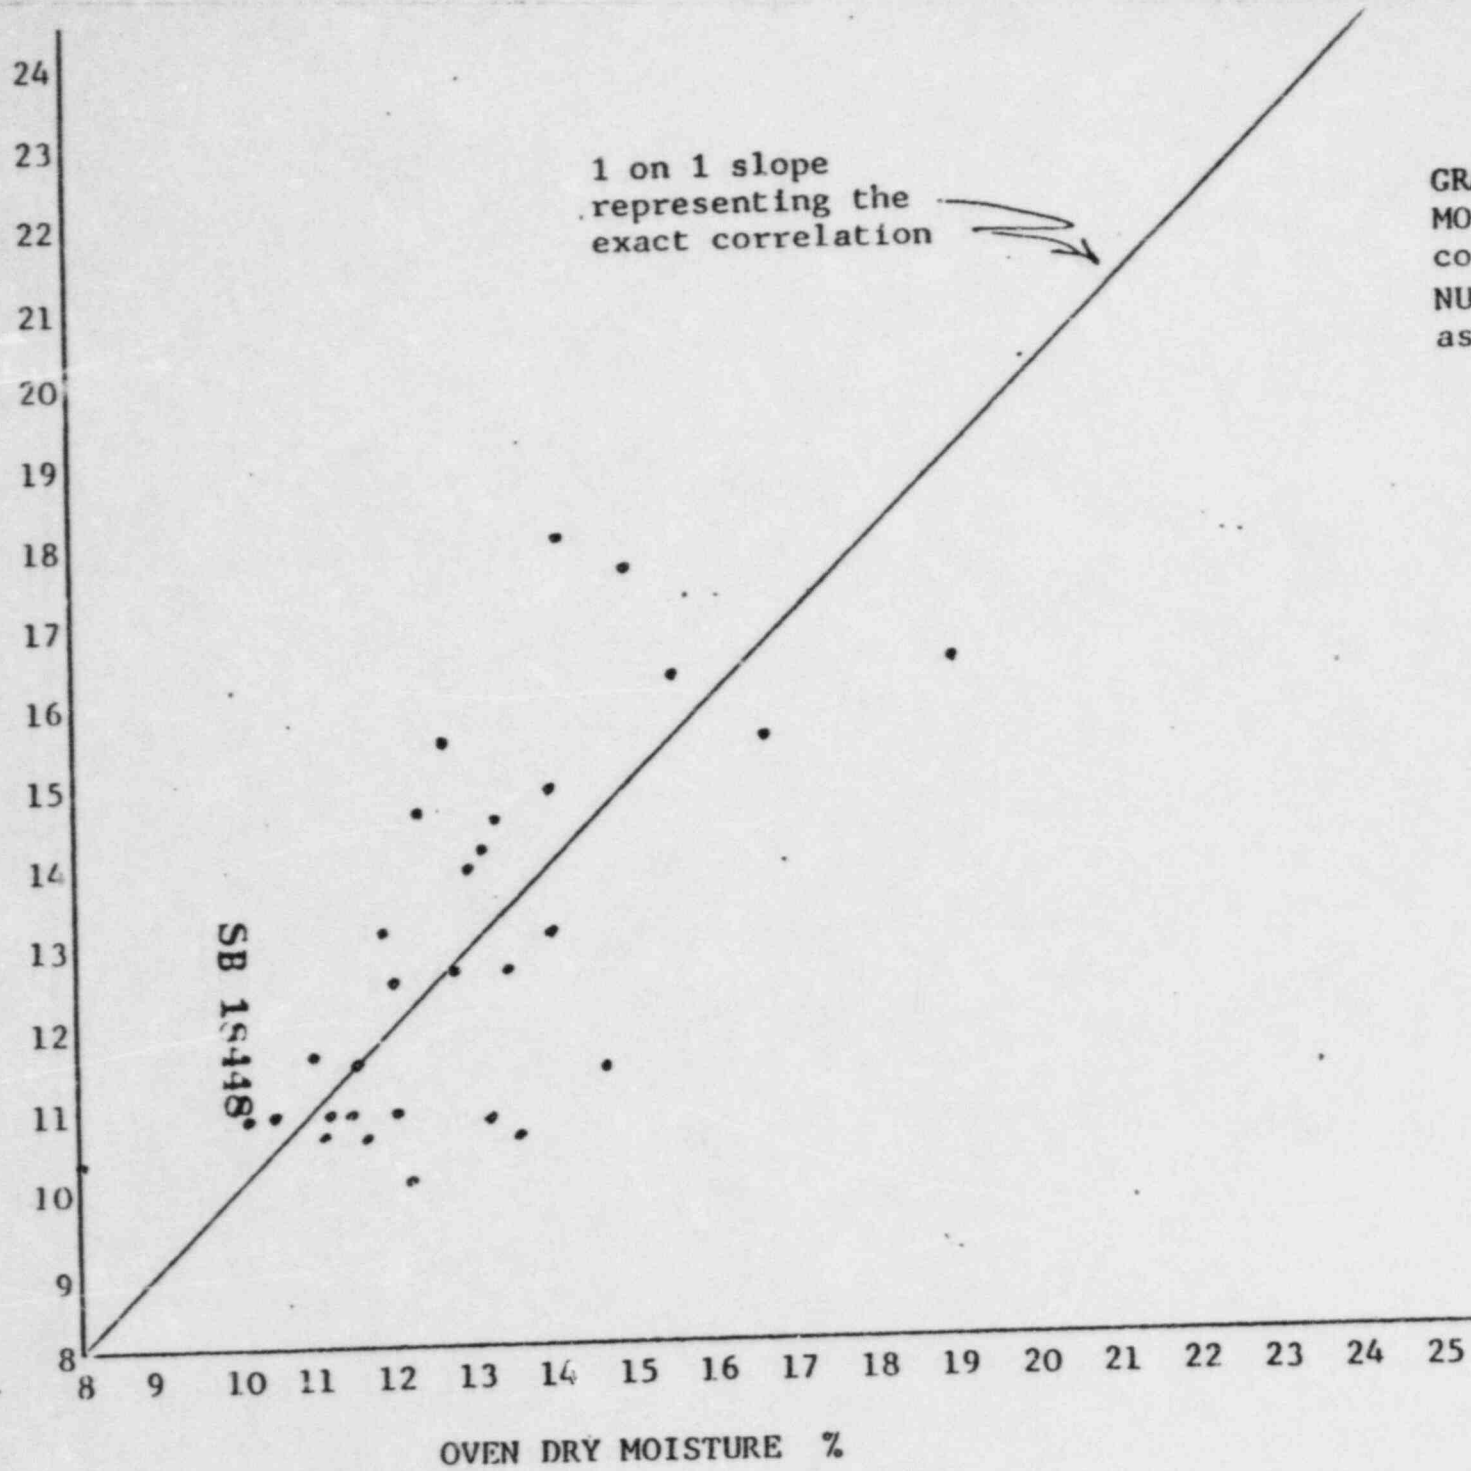
+3.7 ÷ 30 = +.12% Ave.
 Deviation

GRAPH REPRESENTATION of
MOISTURE CONTENTS using
corresponding TROXLER
NUCLEAR and OVEN DRY RESULT
as co-ordinates

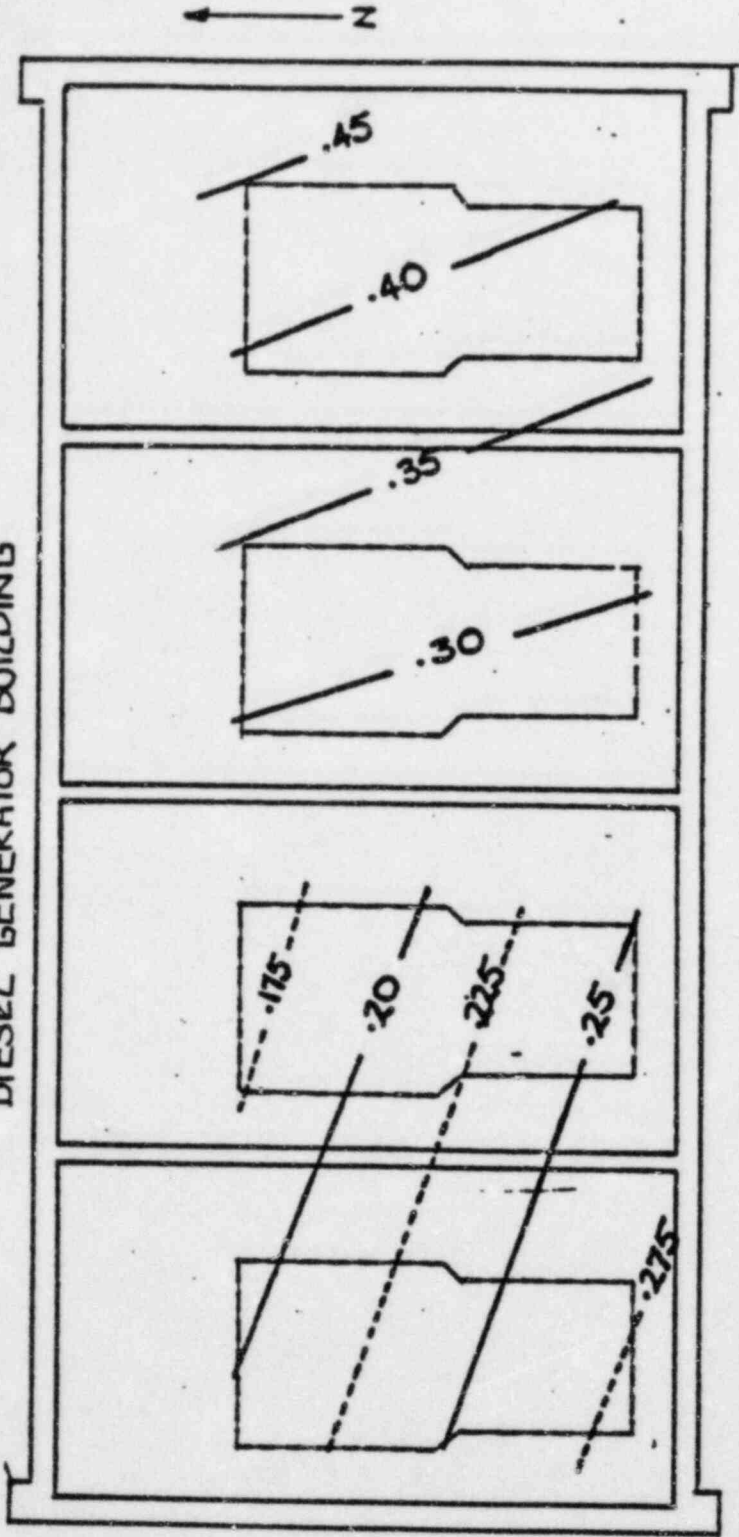
SETTLEMENT MARKERS: TOTAL SETTLEMENT OF PEDESTALS to 3-16-79
Readings in Feet; Total Surcharge of 1100 psf (10 Feet)

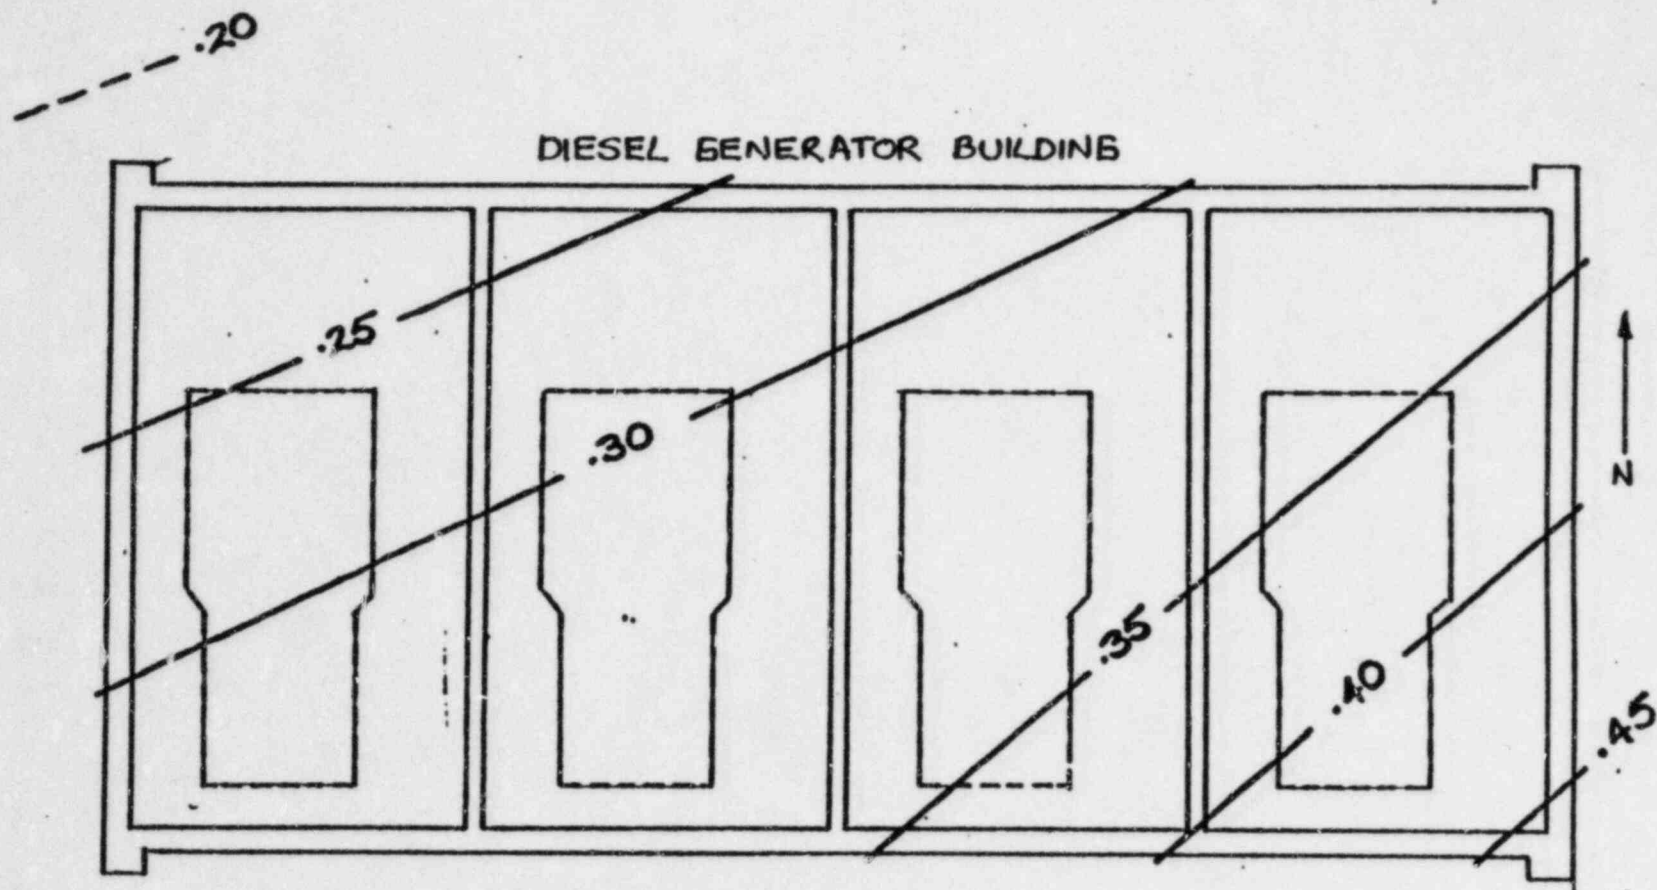
SETTLEMENT MARKERS : TOTAL SETTLEMENT OF BUILDING WALLS to 3-16-79
 Readings in Feet ; Total Surcharge of 1100 psf (10 Feet)

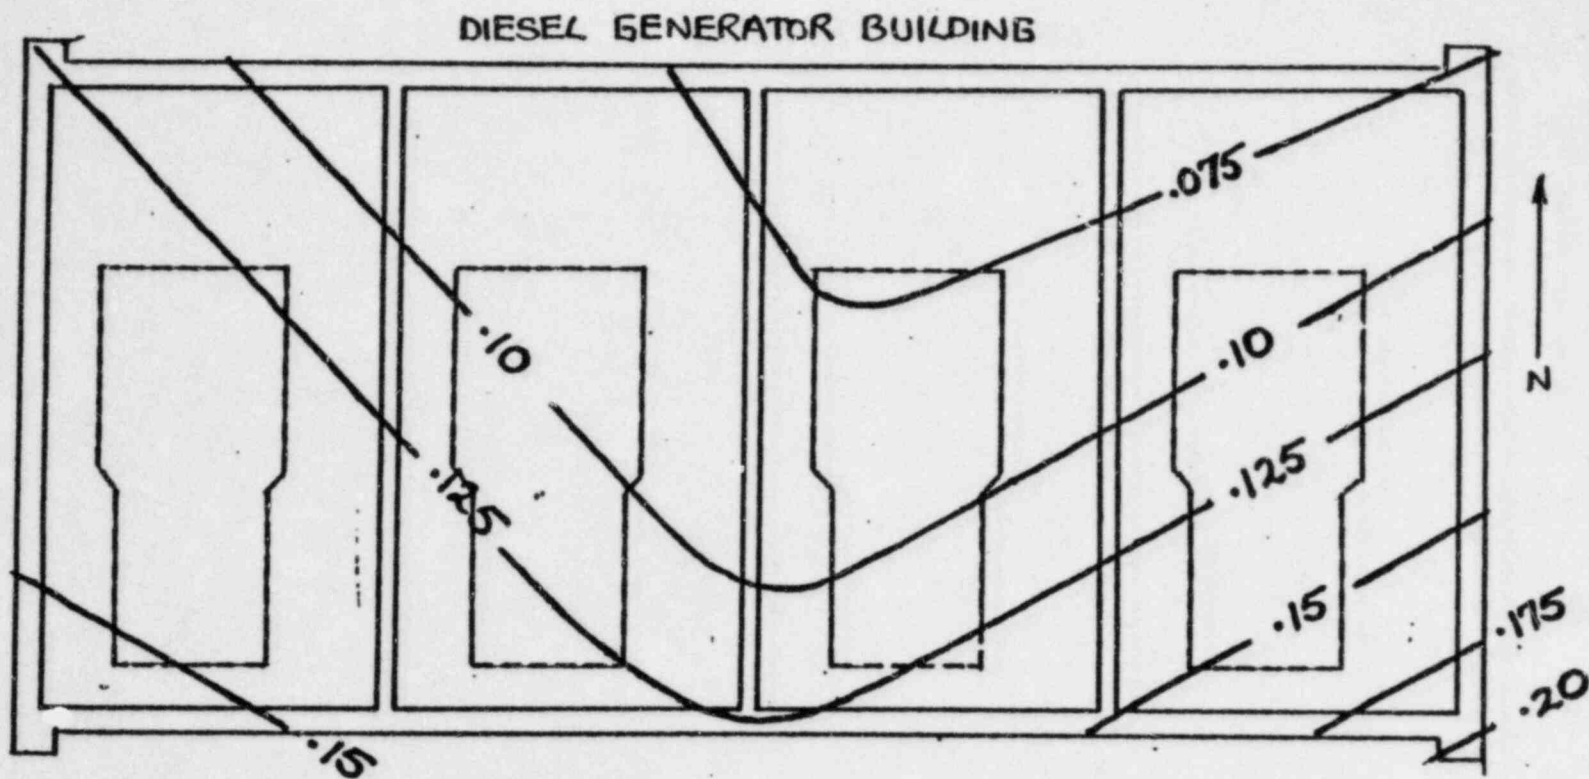
SETTLEMENT MARKERS: TOTAL SETTLEMENT OF BUILDING WALLS to 7-15-78
Readings in Feet; No Surcharge; Electrical Ducts Attached

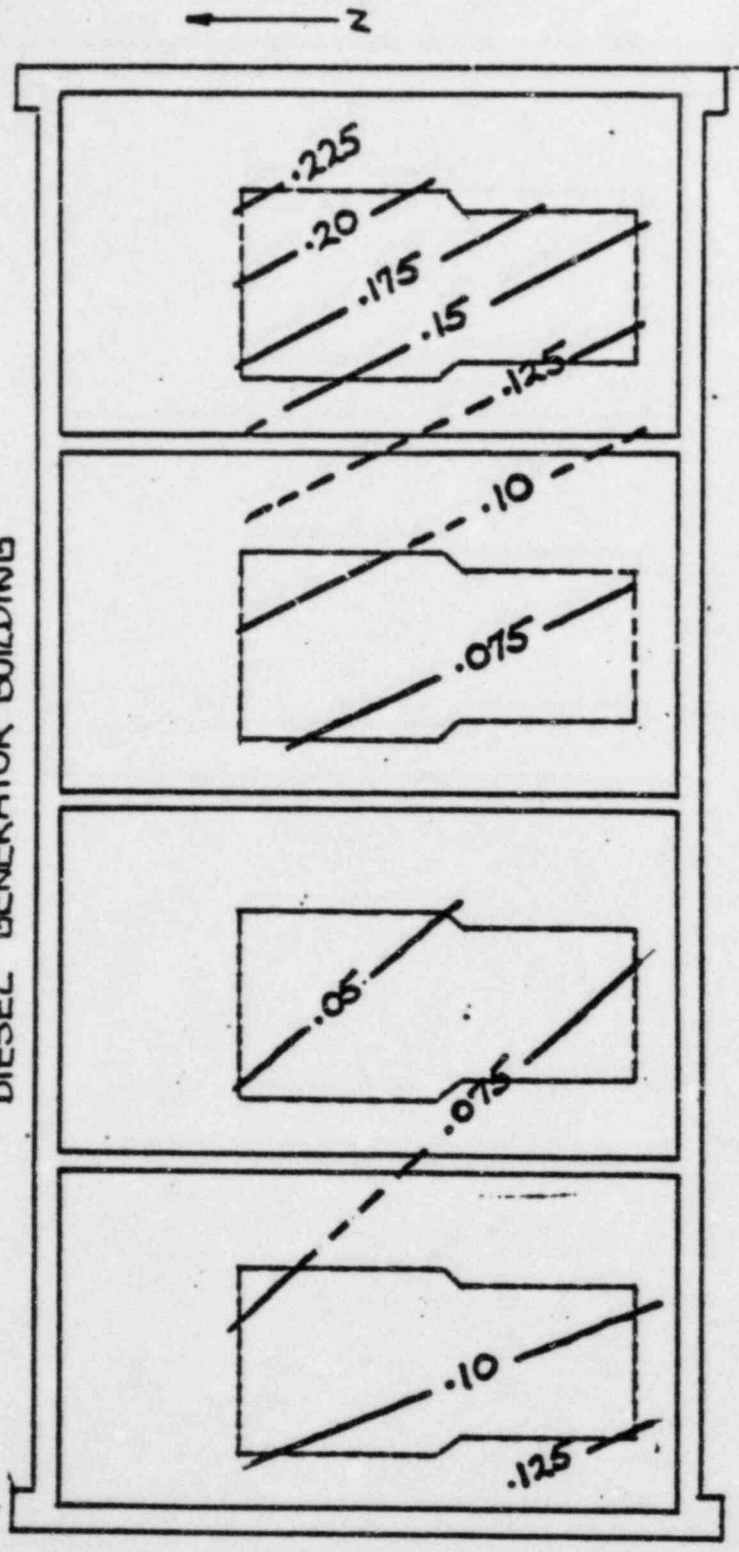
SETTLEMENT MARKERS: TOTAL SETTLEMENT OF PEDESTALS to 9-15-78
Readings in Feet; No Surcharge; Electrical Ducts Attached.

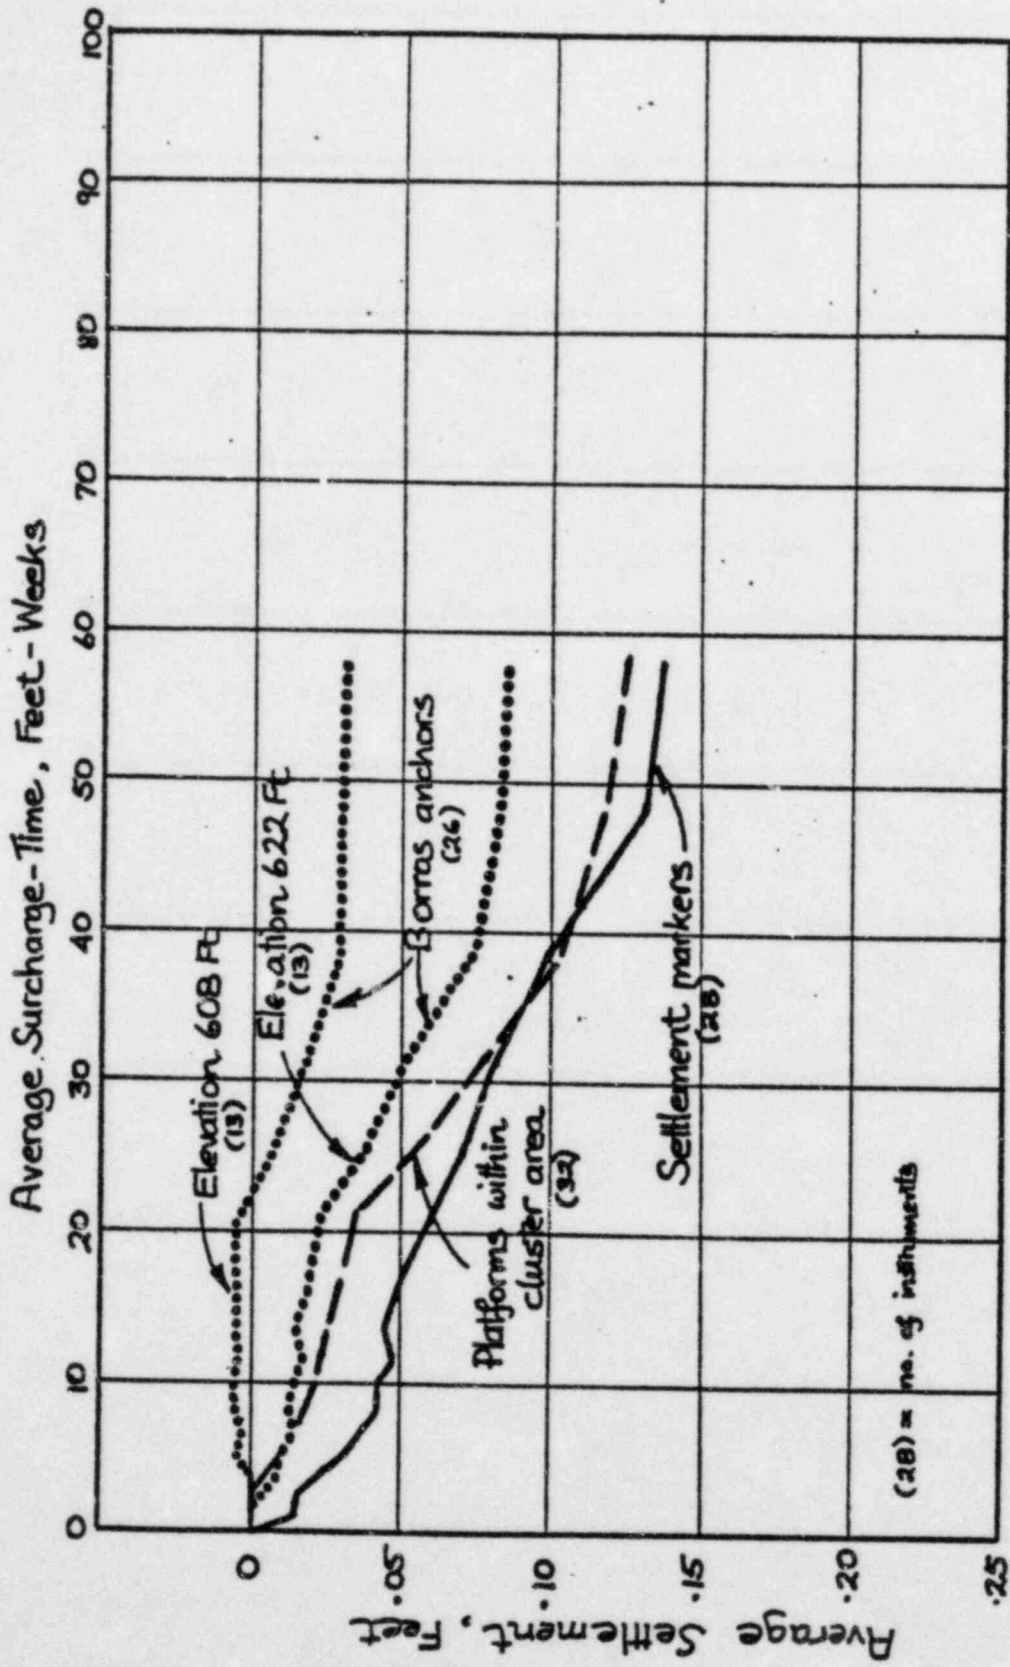
DIESEL GENERATOR BUILDING : AVERAGE SETTLEMENT VS. SURCHARGE -TIME

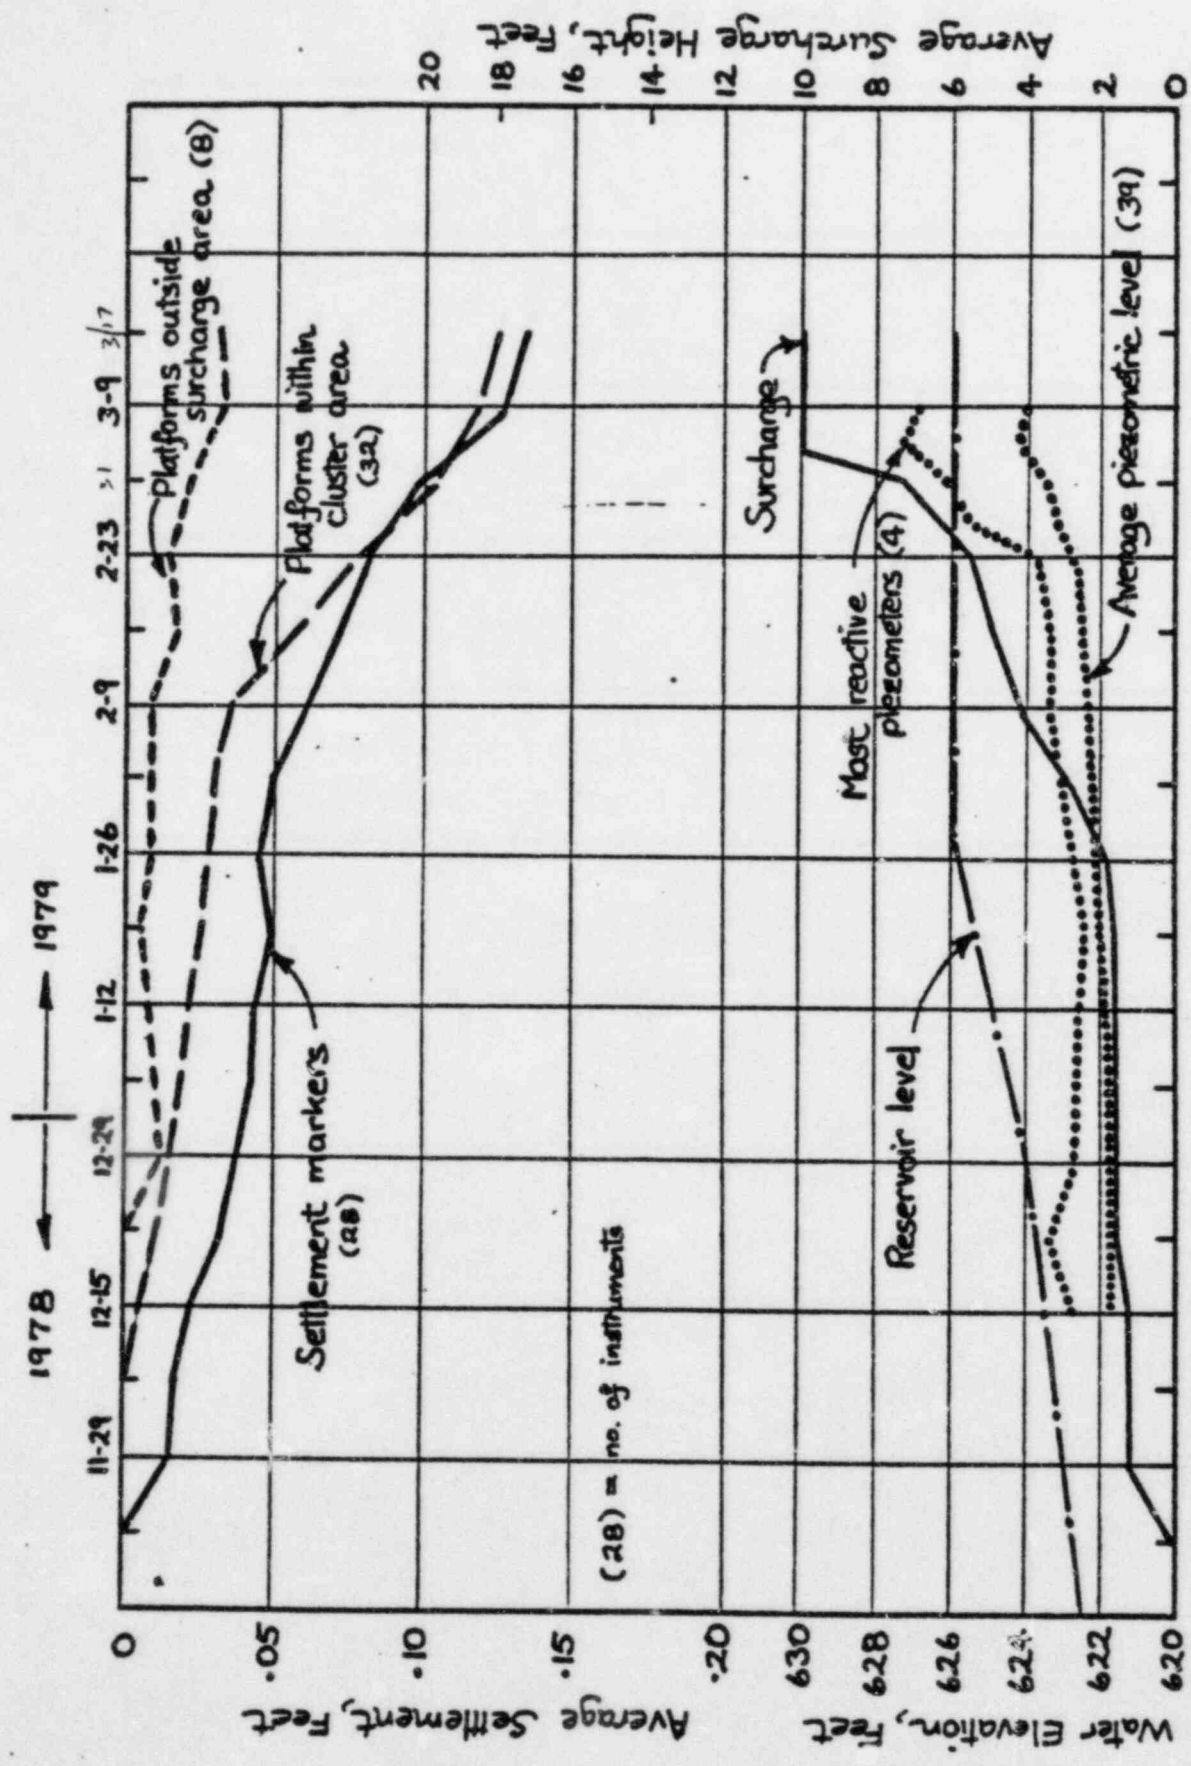
DIESEL GENERATOR BLDG : AVG SETTLEMENT, SURCHARGE & WATER LEVEL VS TIME

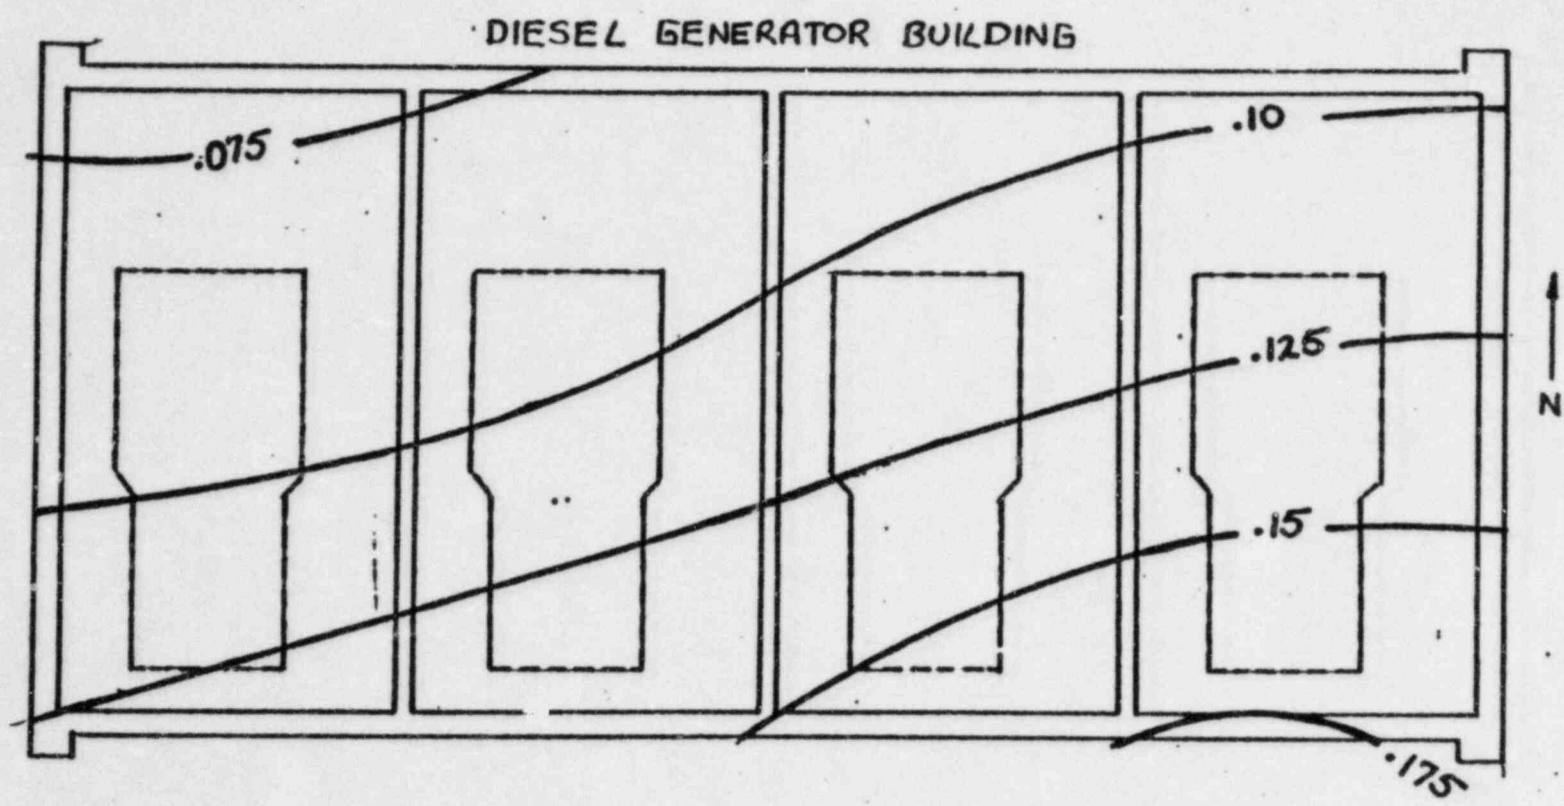
SETTLEMENT MARKERS : DIFFERENTIAL SETTLEMENT, 12-8-78 to 3-16-79
Readings in Feet ; 950 psf Surcharge added in Period
BUILDING WALLS & PEDESTALS

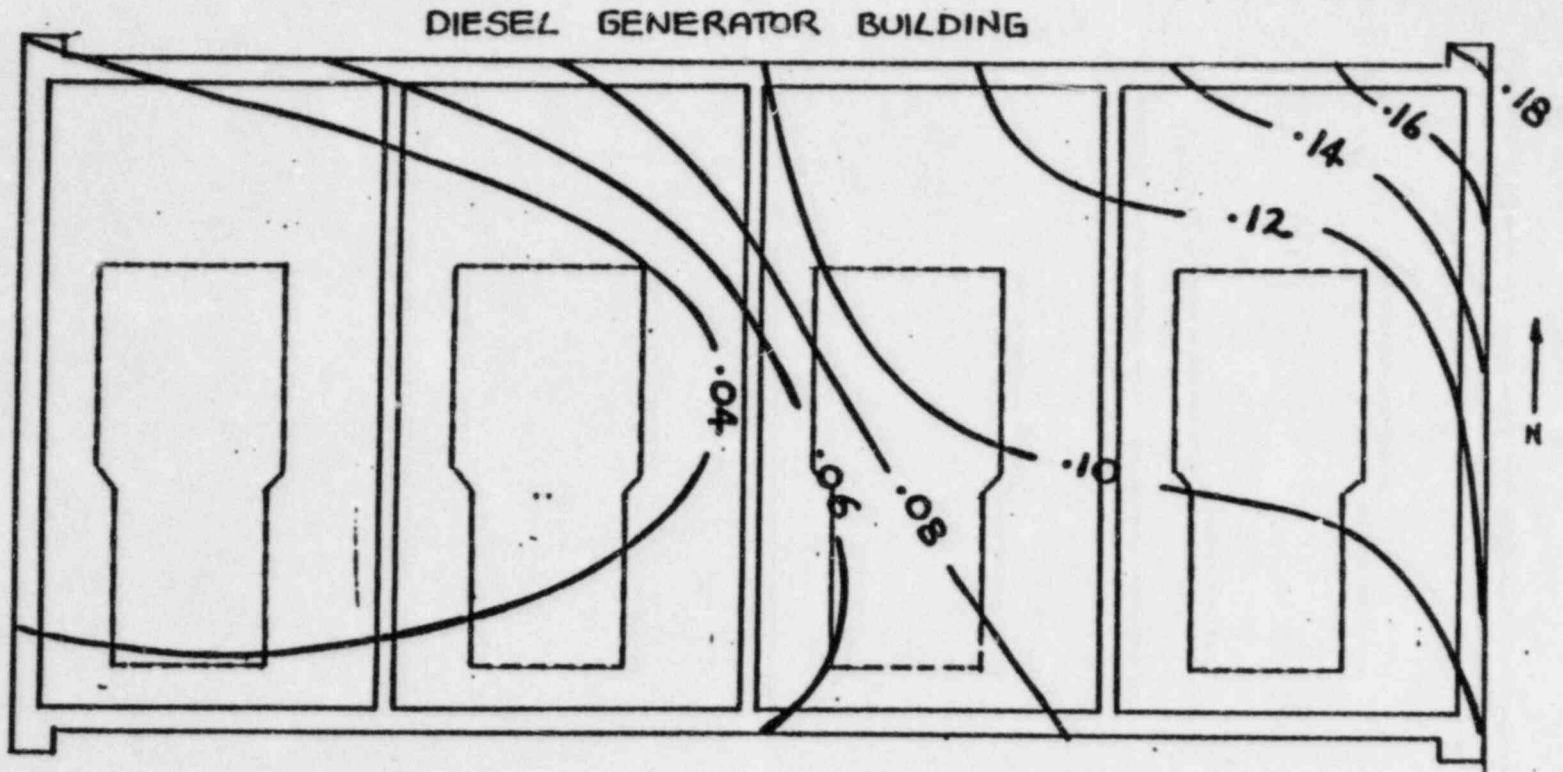
SETTLEMENT MARKERS: DIFFERENTIAL SETTLEMENT, 9-15-78 to 12-8-78
Readings in Feet; Electrical Ducts Isolated in Period
BUILDING WALLS & PEDESTALS

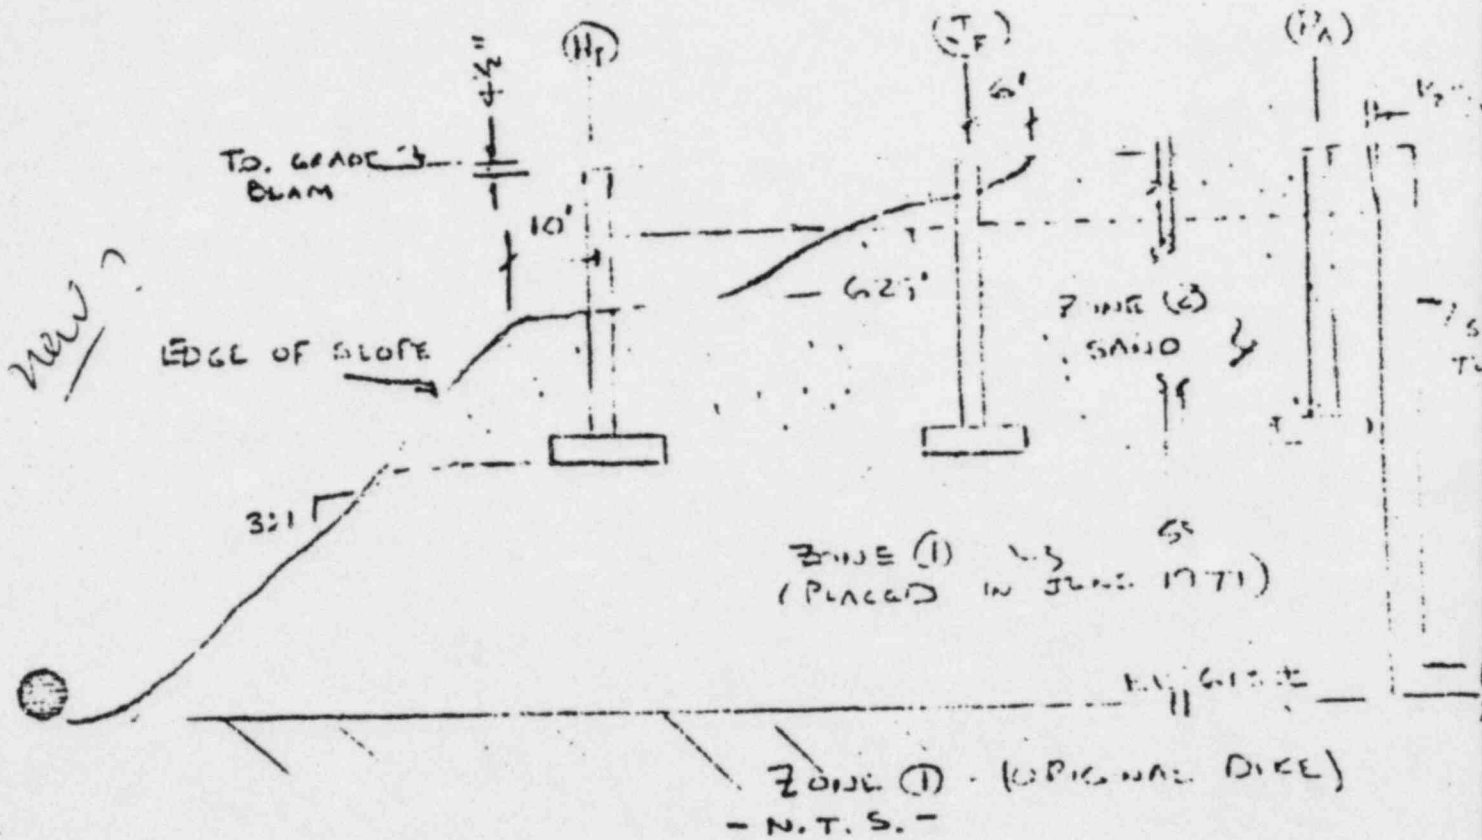
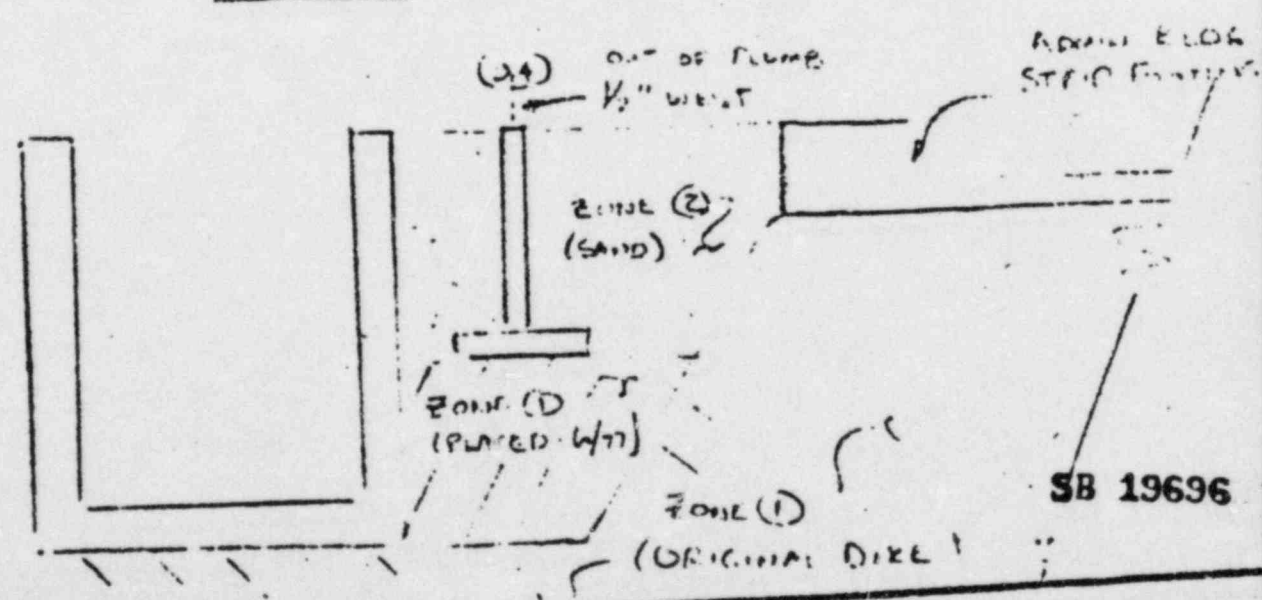
SECTION THRU O.4 LINE - LOOKING EAST

By routine survey check of August 23, 1977, the top surface at col line on the north end of subject grade beam was found to be 3 1/2" below its design elevation. The south end of the beam at its tie into the steam tunnel wall was at its design elevation, however, there was approximately 1/2" separation between the beam and the wall. The beam was not structurally cracked. Soil conditions at the time of the failure were per the attached sketch. There was no visible evidence of soil heaving, cracking, sluffing, or water flow at any point on the 3:1 slope to the north of the subject beam, nor was there any visible soil disturbance on either side of the beam looking from the top.

To confirm that the beam was not incorrectly surveyed originally the beam was surveyed again the week of August 29. Additional settlement of approximately 1/2" was noted and the beam was approximately 1/2" out of ^{plumb} ~~plumb~~, leaning to the west.

It is evident that the low bearing capacity of the zone 1 material placed in June of 1977 between elevation 614 and 622 is the cause of this failure. If the unconfined bearing is taken to be: $\bar{q}_c = .5 \frac{\text{kips}}{\text{sq ft}}$ AND $\bar{q}_u = 1 \frac{\text{kips}}{\text{sq ft}}$ the 12 feet of sand overburden on the footings (Approximately 12 ft Depth @ $120 \frac{\text{lb}}{\text{ft}^3} = 1440 \frac{\text{lb}}{\text{ft}^2}$) would overstress this material.

The cause of the reduced bearing capacity of this material cannot be conclusively established. The materials high moisture content apparently contributed to the reduced bearing capacity. When compacted to 95% of the optimum density this material is relatively impermeable to water and even when saturated, it would allow a maximum of about 15% moisture.

After evaluation of the conditions by both Field and Project Engineering, it was determined that the 0.4 line foundation could not be economically stabilized and replaced.

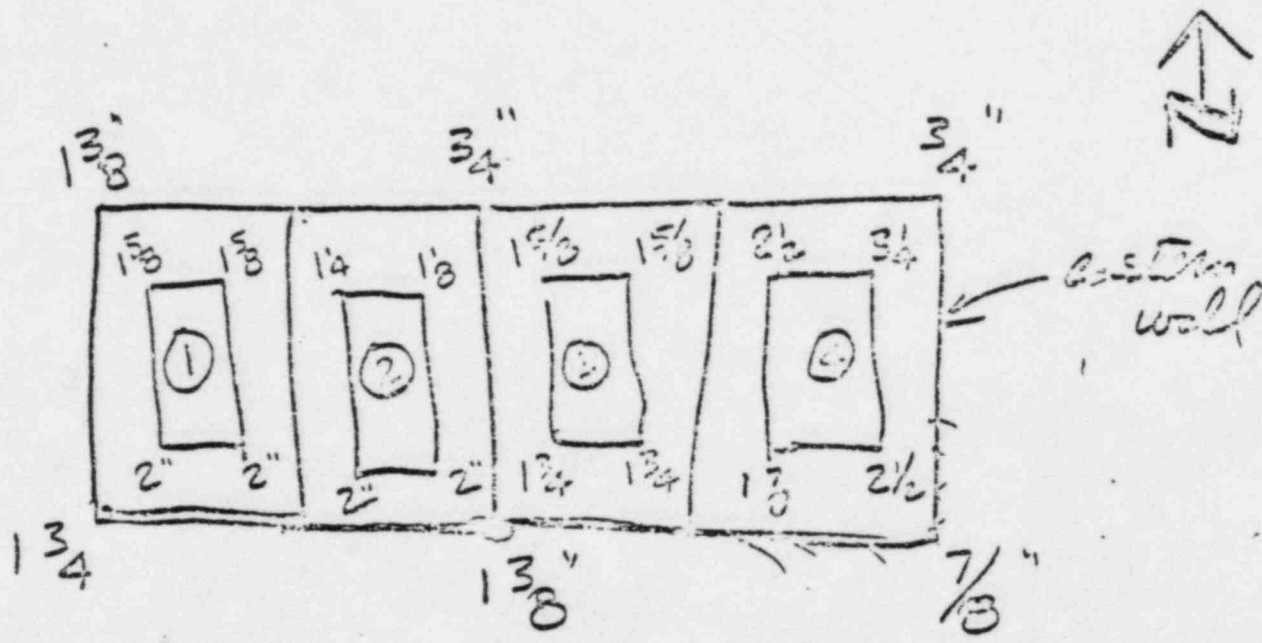
- 1) no crushing @ the edge
- 2) worked settling, the eastern wall appears to be spanning
- 3) D/C Bldg up to Elev. 650 ±, no slab present yet for mezz floor
- 4) - - - - -

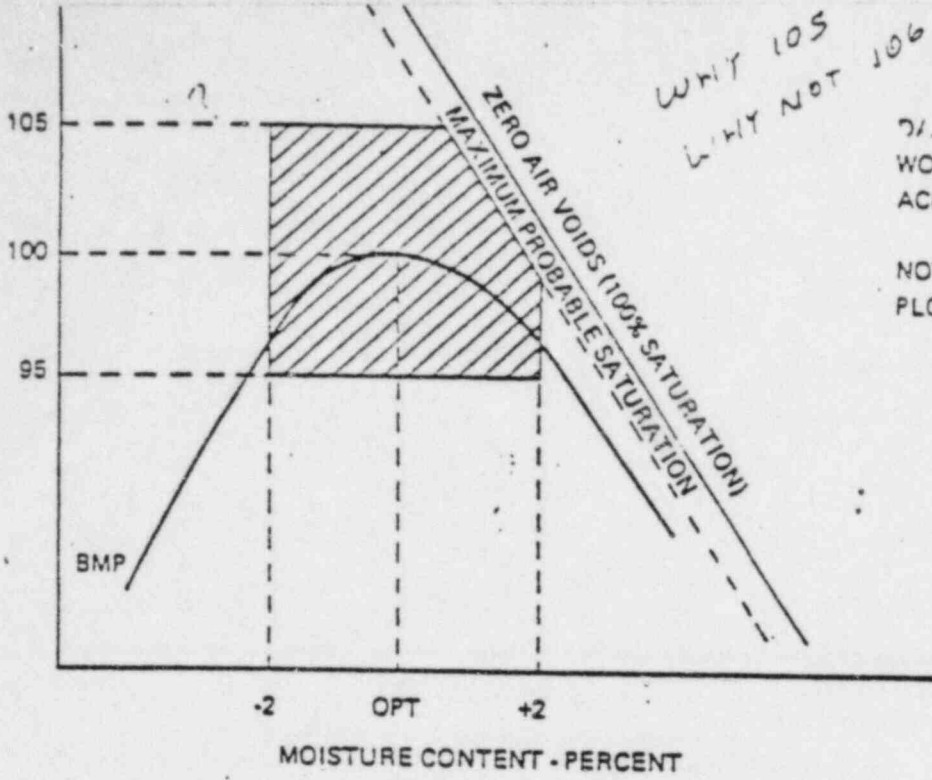
FIGURE 7-A.

DATA POINTS THAT PLOT IN SHADED AREA WOULD BE GENERALLY ACCEPTABLE ACCORDING TO SPECIFICATIONS

NOTE: ABOUT 25% OF ALL FIELD DATA PLOTS IN THE SHADED AREA

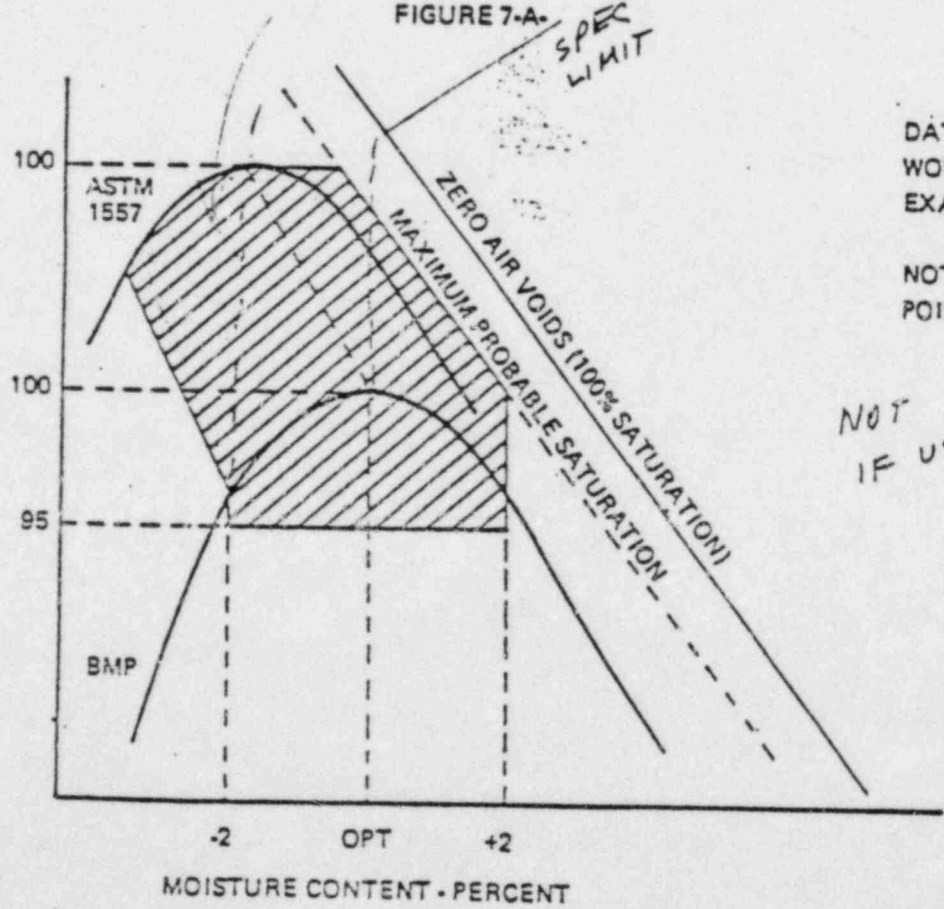
DATA POINTS THAT PLOT IN SHADED AREA WOULD BE ACCEPTABLE REGARDLESS OF EXACT SPECIFICATION WORDING

NOTE: ABOUT 40% OF ALL FIELD DATA POINTS PLOT IN THE SHADED AREA
