FURCO
Company

REPORT NO E-77-32

PLANT: Midland UNIT 1 &
SUBJECT OF AUDIT: Soil Placement
Records

I. AUDIT SCOPE

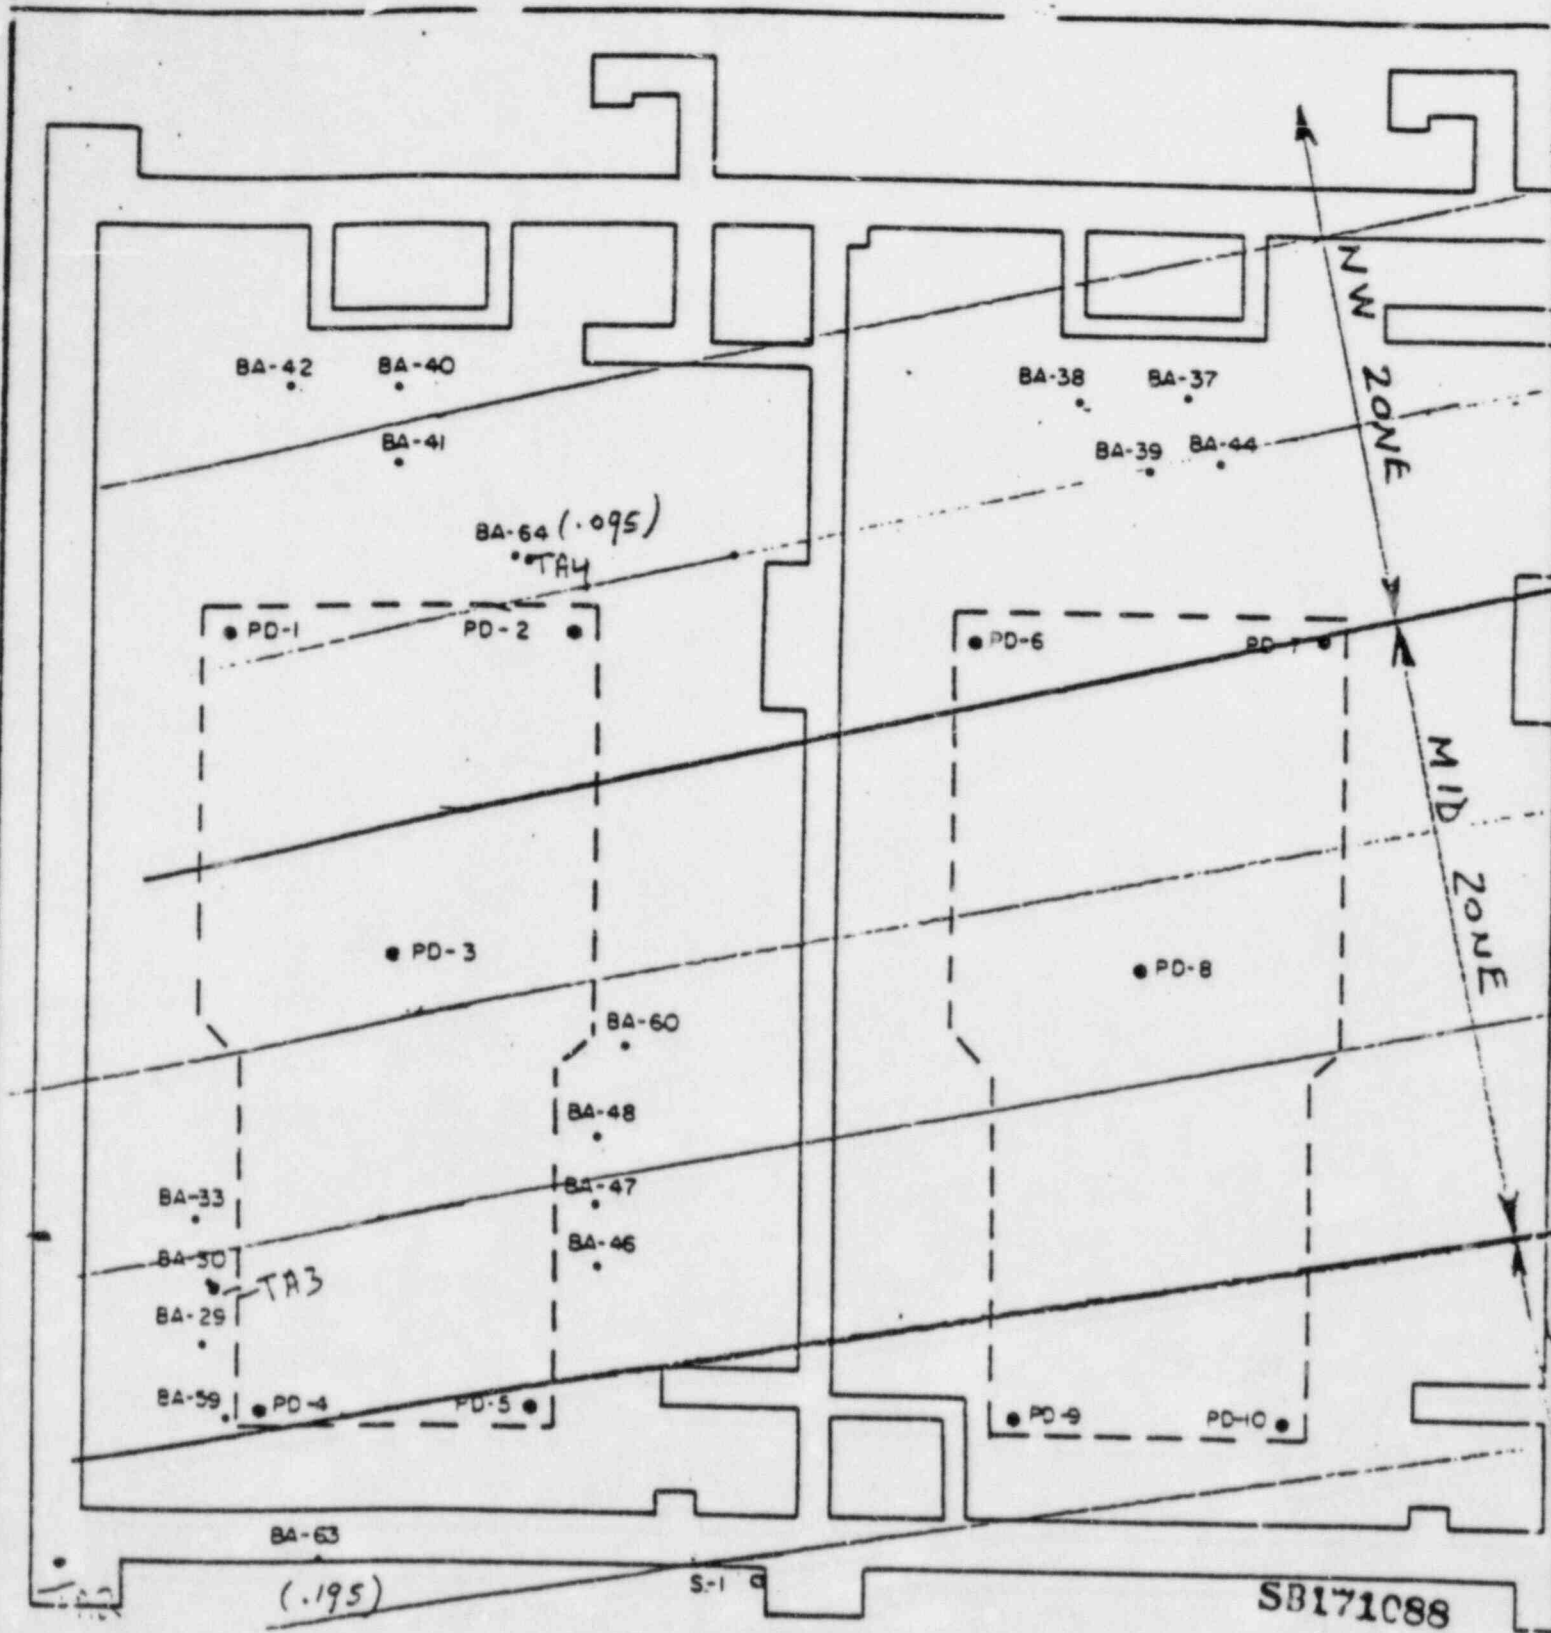
Contours of absolute settlement of mezz floor br
 time 60 to 120 days (day zero = Apr. 7, 1979),
 based on BA 61 thru BA 64 data, assuming the
 four anchors at elev. 535 ft are adequate benchmark

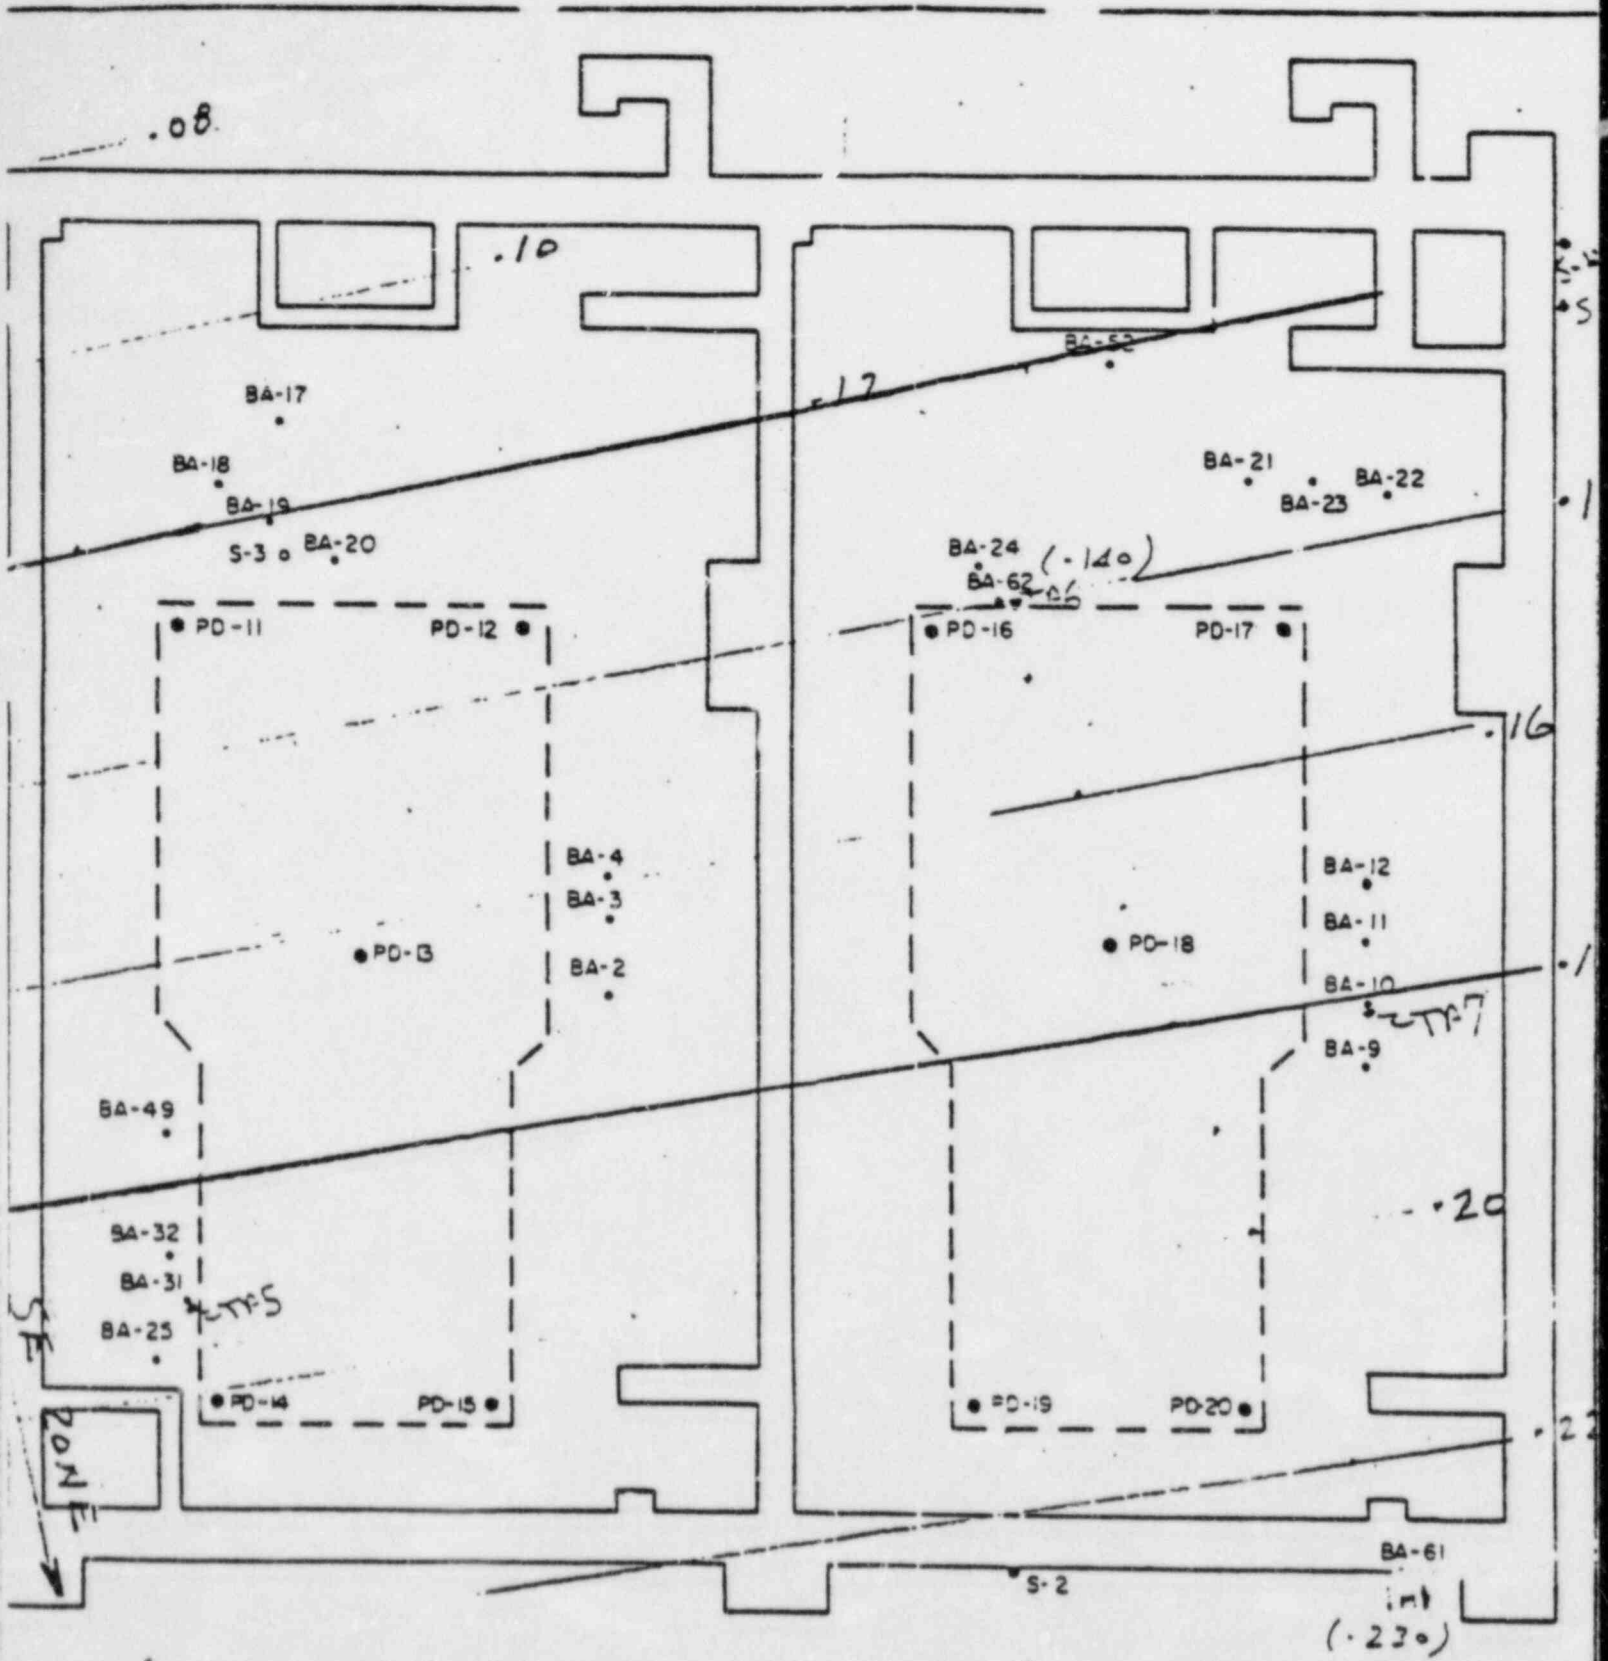
DIESEL GENERATOR BUILDING SB171089
 MIDLAND PLANT - MIDLAND, MICHIGAN
 LOCATIONS OF MODIFIED BORROS ANCHORS

See comment #3 in letter

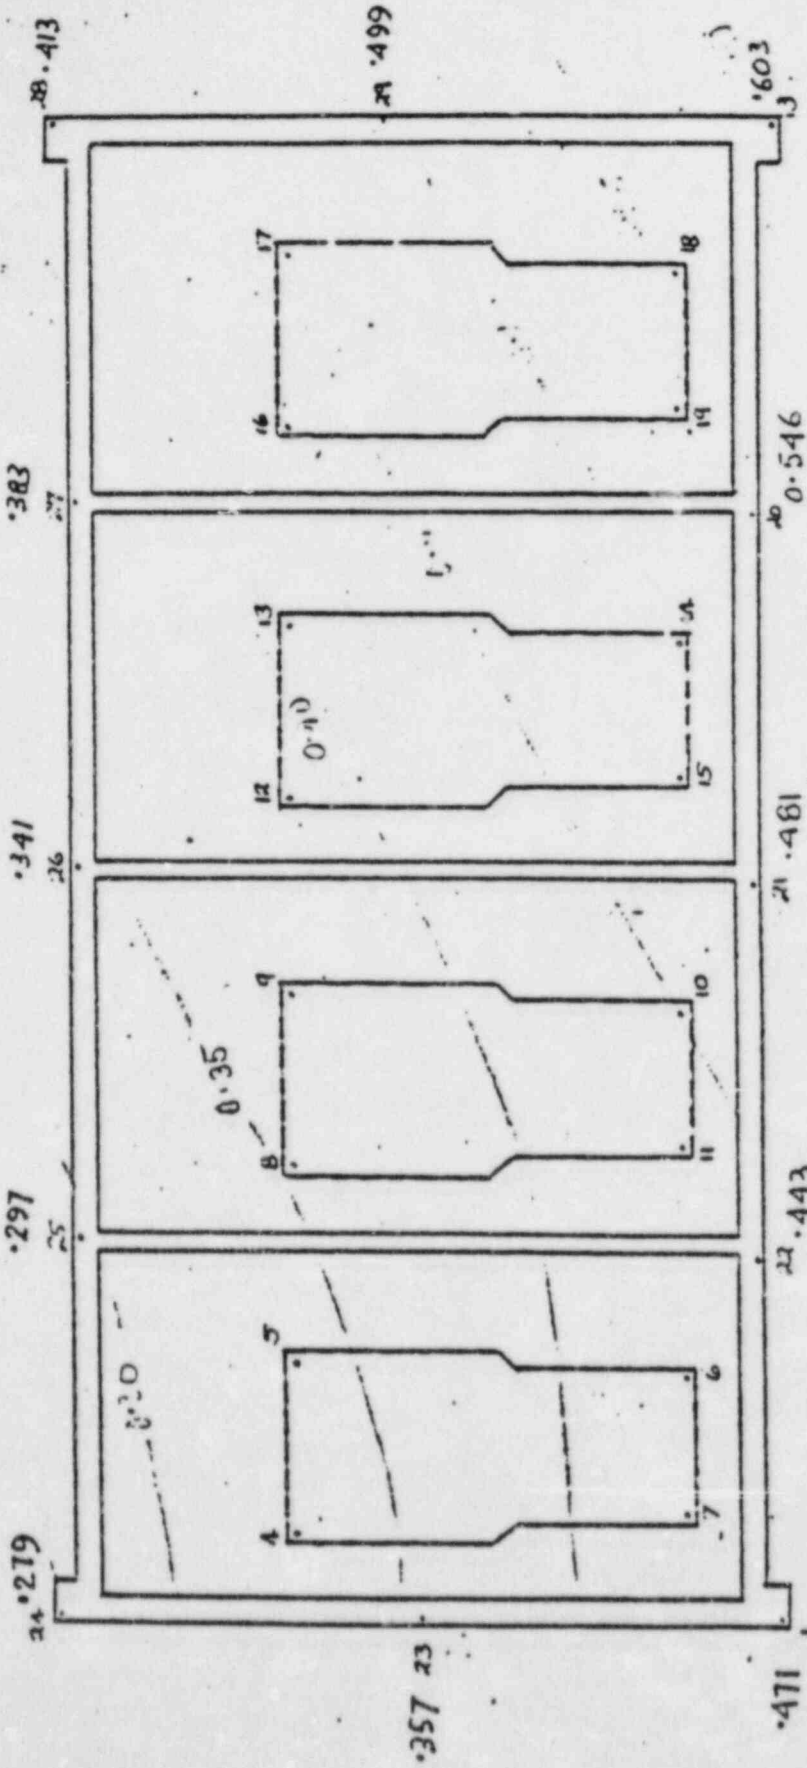
Figure 3

SETTLEMENT MARKERS : TOTAL SETTLEMENT OF WALLS TO 6-7-79
 READING IN FEET; TOTAL SURCHARGE OF 2.5 FT. (2200 PSF).

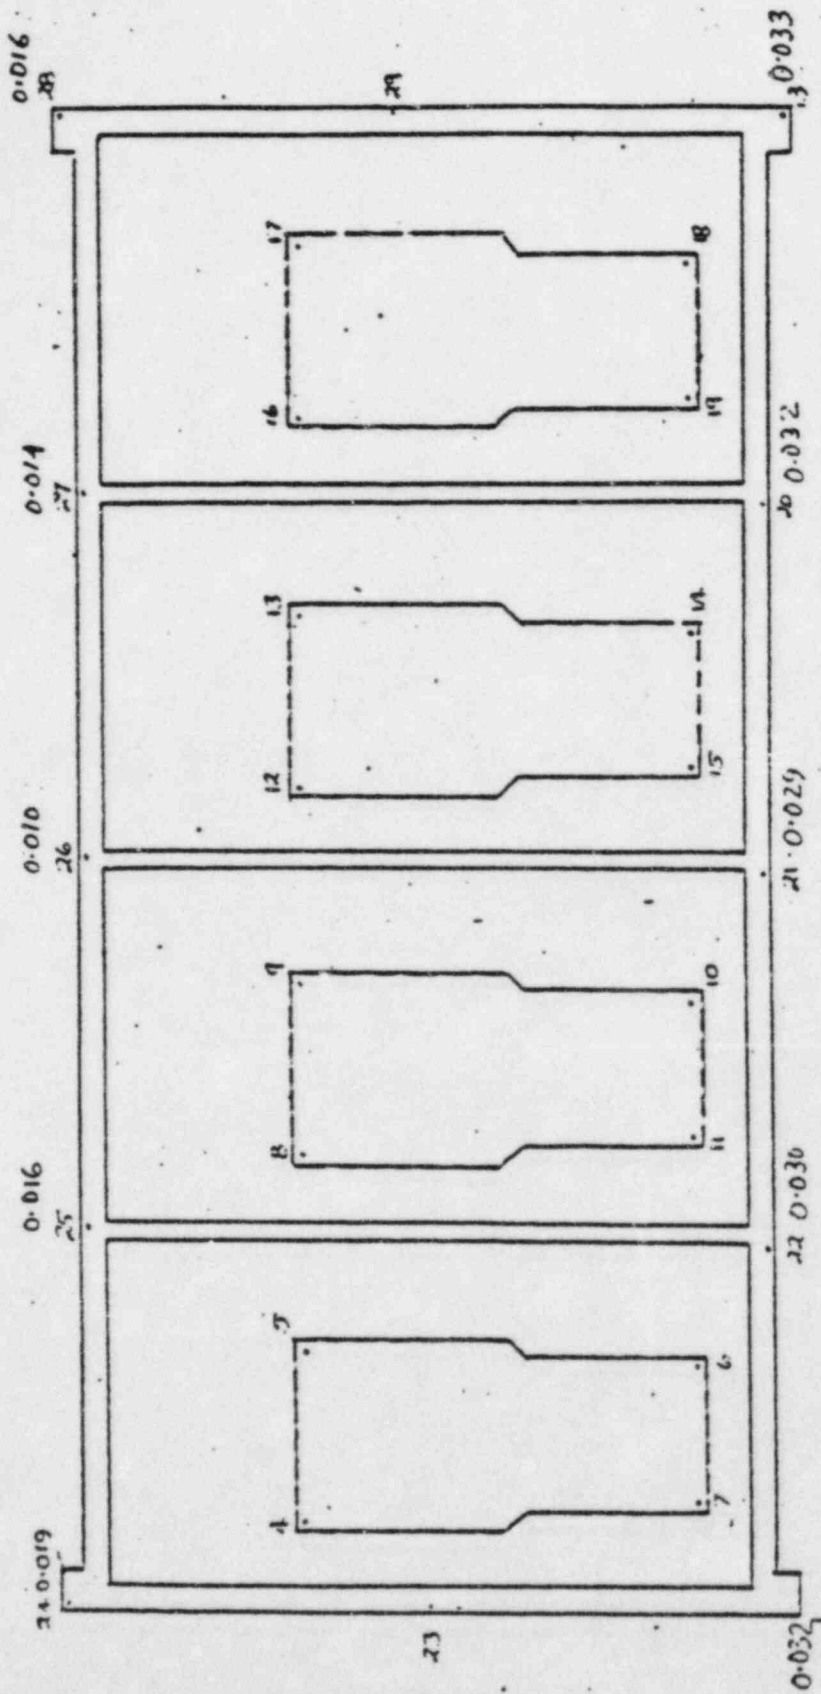
Figure 4

SETTLEMENT MARKERS: TOTAL SETTLEMENT OF WALLS FROM 4-13-79 TO 6-7-79.

Reading in feet; 0 feet of surcharge added during this period
 SURCHARGE OF 20ft. (2200 ccf).

Contours appear E-W.

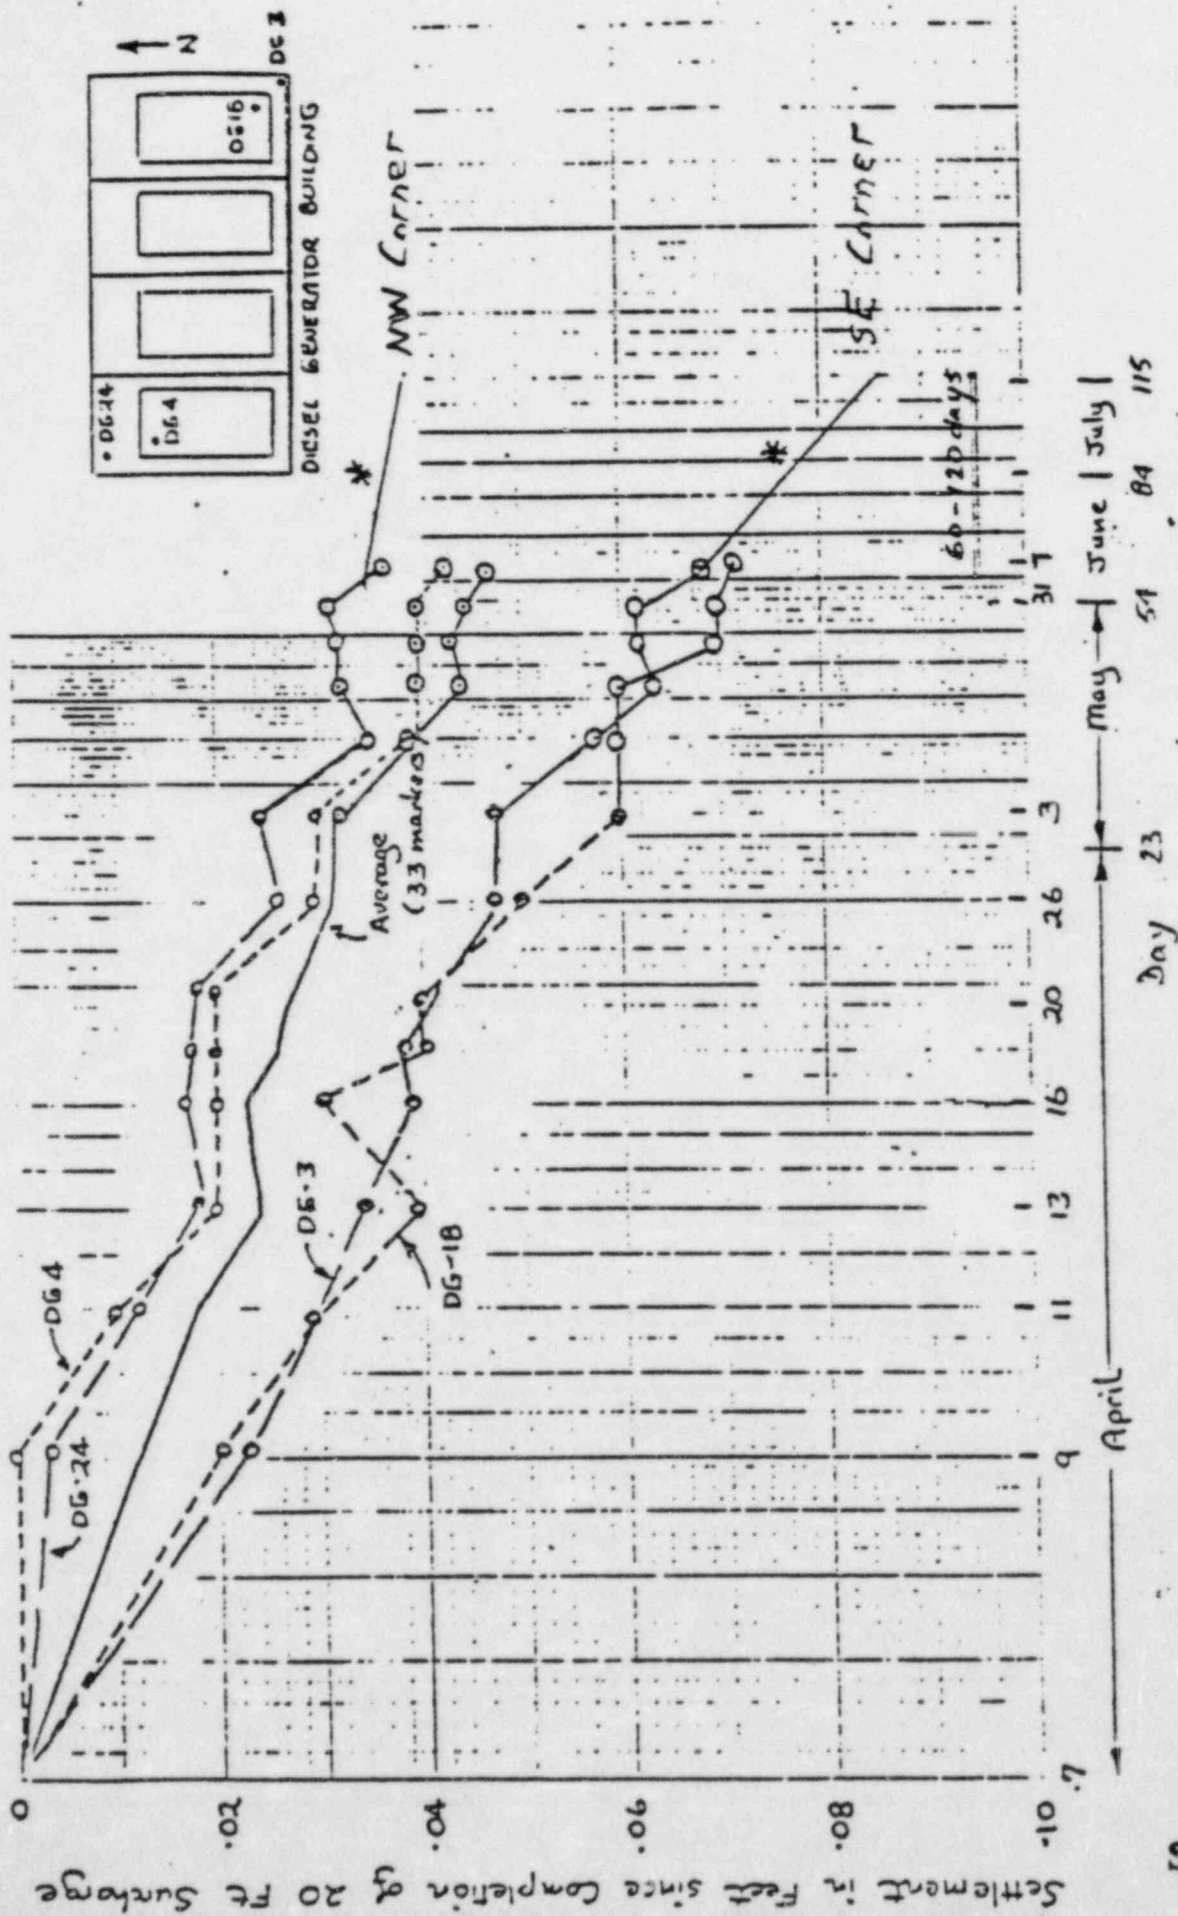
DIESEL GENERATOR BUILDING : SETTLEMENT VERSUS LOG TIME

* Data from modified BA 61 thru 64, using plot of absolute settlement contours (Fig. 1)

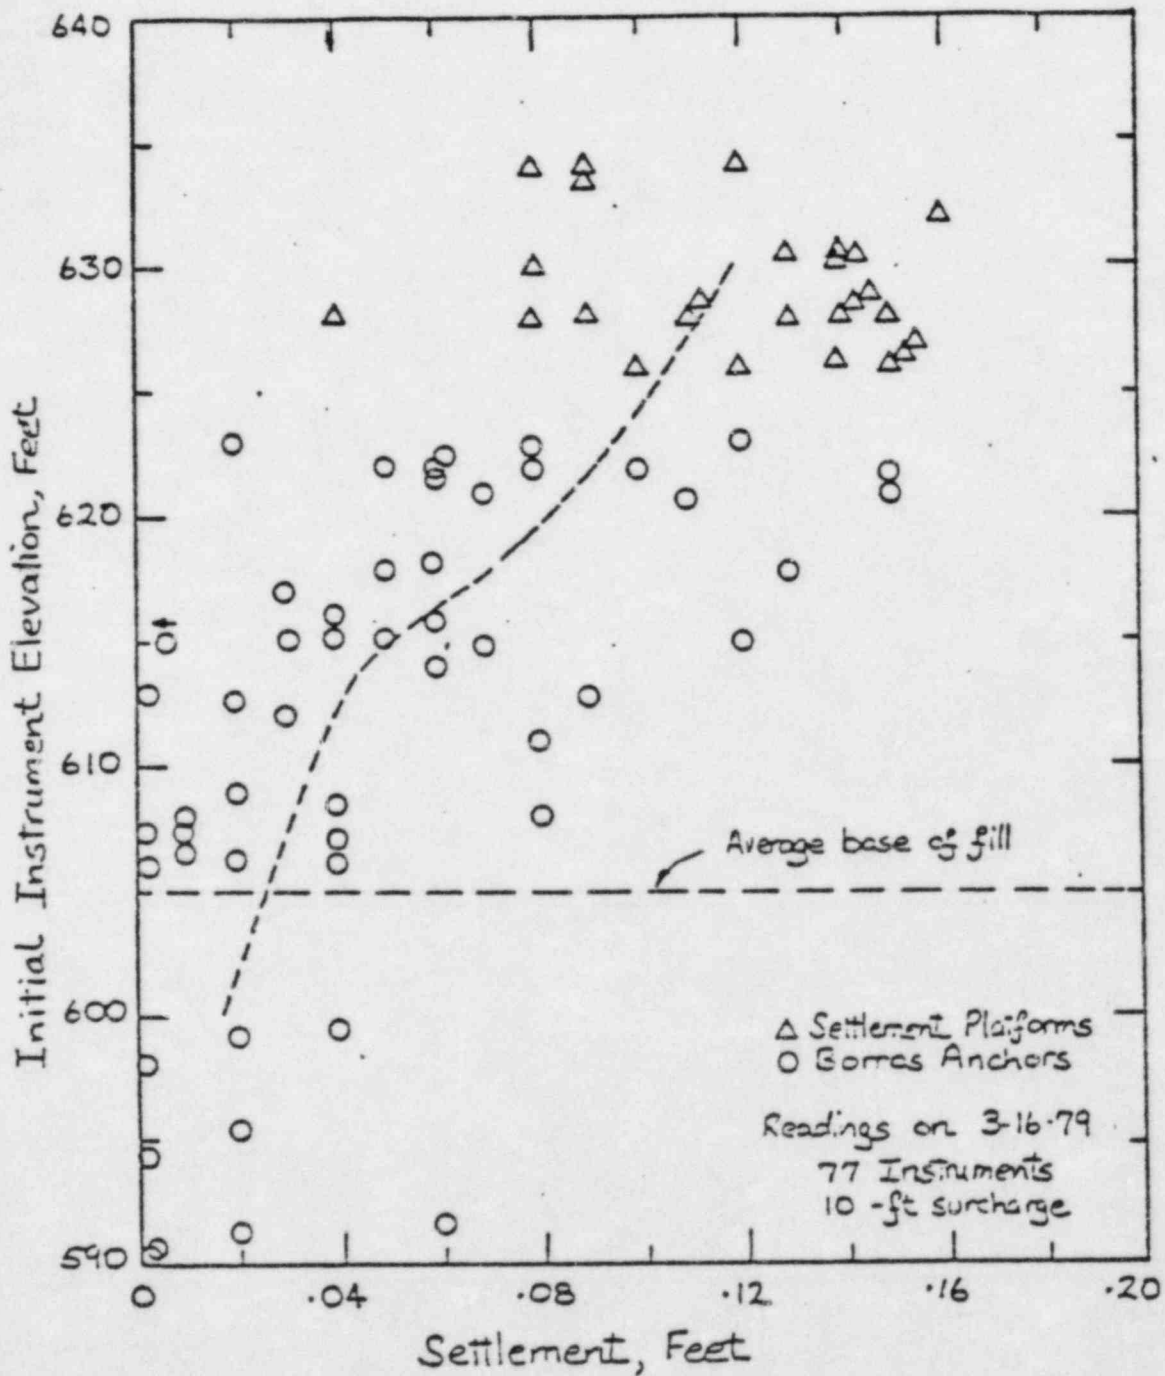
Figure 6

DIESEL GENERATOR BUILDING
GORROS ANCHORS & SETTLEMENT PLATFORMS
