U. S. NUCLEAR REGULATORY COMMISSION

Report No.: 50-306/92005

Facility Name: Prairie Island Nuclear Generating Plant

Special, unannounced safety inspection by an NRC Augmented Inspection Team to determine the facts and to perform evaluations relating to a loss of residual heat removal system event at the Unit 2 reactor which occurred on February 20, 1992. Information was collected for an independent risk assessment. The onsite inspection effort concluded with a public "exit" meeting.

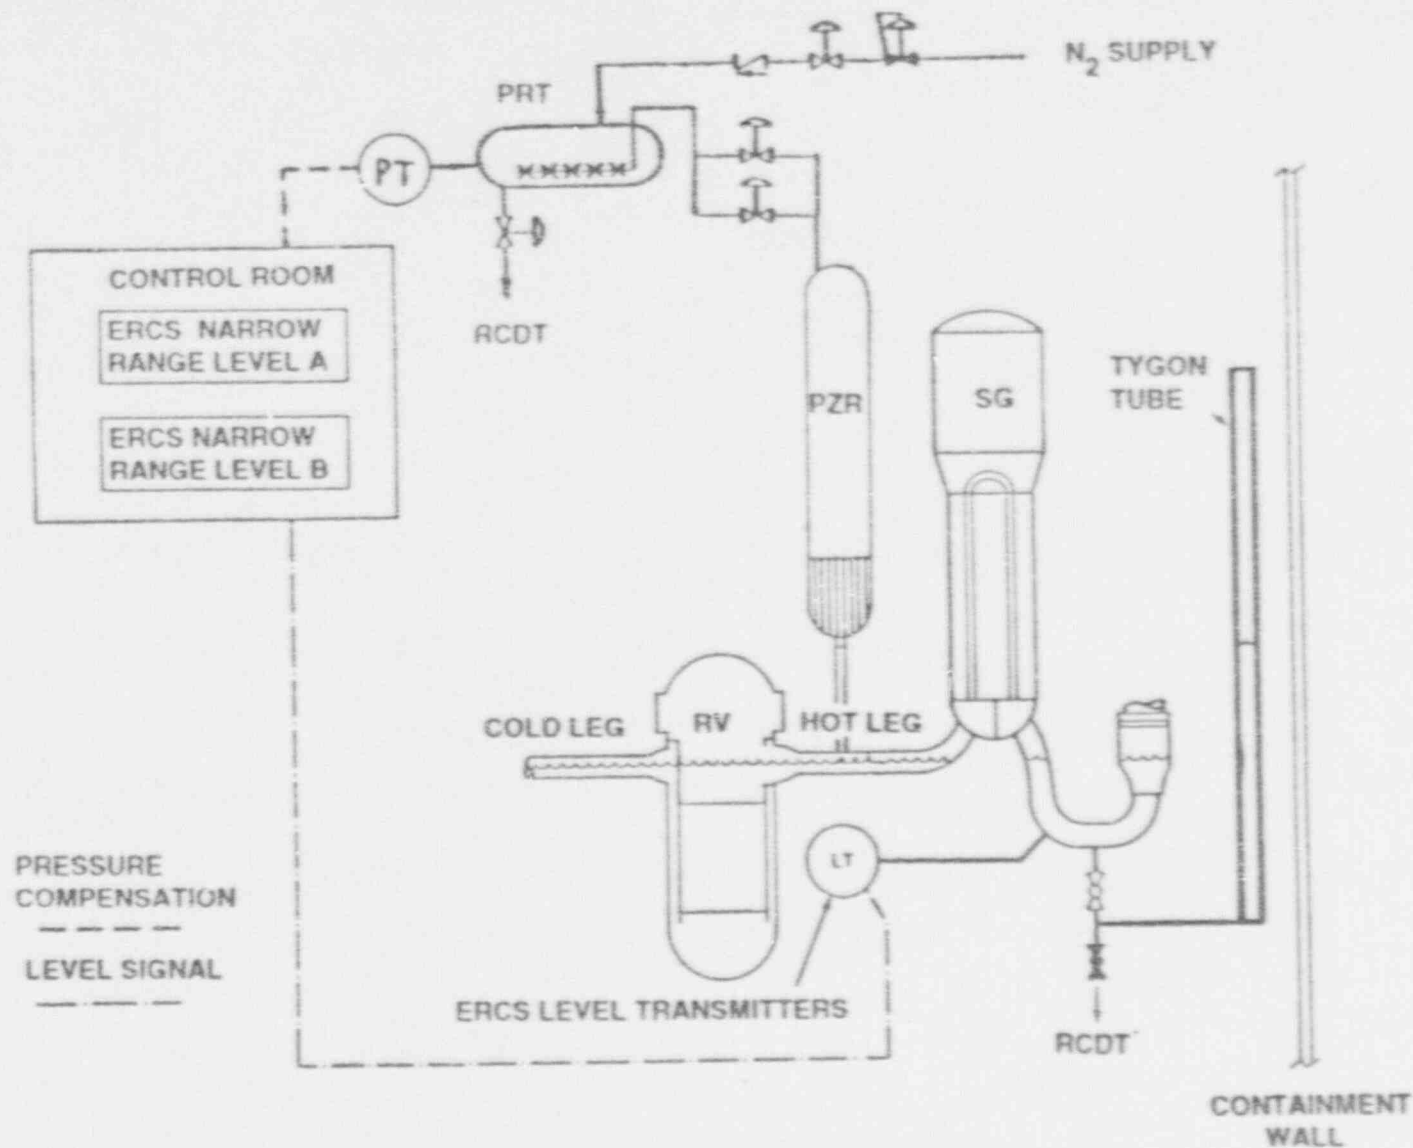
Reactor coolant level indication for reduced inventory operations is provided by electronic pressure transmitters located in each of the reactor coolant loops. Process line connections for the transmitters are at the intermediate leg in the reactor coolant pump loop slightly above the loop low point. An additional level indication is provided by a simple, permanently installed, "Tygon tube" in which the water level can be observed locally inside the containment building. The tube taps off the drainpipe from the reactor coolant loop A crossover leg at the bottom of the reactor coolant pump loop. The lower section of this tube is stainless steel while the vertical section, where level readings are observed, is made of clear, plastic, Tygon tube. The wall behind the Tygon tube is marked with reference marks to obtain a direct measurement of the water level. All three level measuring devices are referenced to the containment atmosphere. Figure 1 provides a diagram of the level instrumentation.

A major design weakness was identified with the level measurement system involving a lack of redundancy. Both the electronic level transmitters and the Tygon tube use the same pressure sensor input for overpressure compensation. Failure of the single pressure sensor would result in incorrect level indications, even though the three instruments might be in agreement. Level indication could also be impacted by boiling in the reactor coolant, as this could pressurize the system with steam or lead to incorrect level indication due to water "slugs" in the reactor coolant system. This design weakness did not affect the February 20
