November 8, 1977  
IE Bulletin 77-05

## ELECTRICAL CONNECTOR ASSEMBLIES

TRIP REPORT  
by  
W. R. Rutherford

ELECTRICAL CONNECTOR ASSEMBLIES

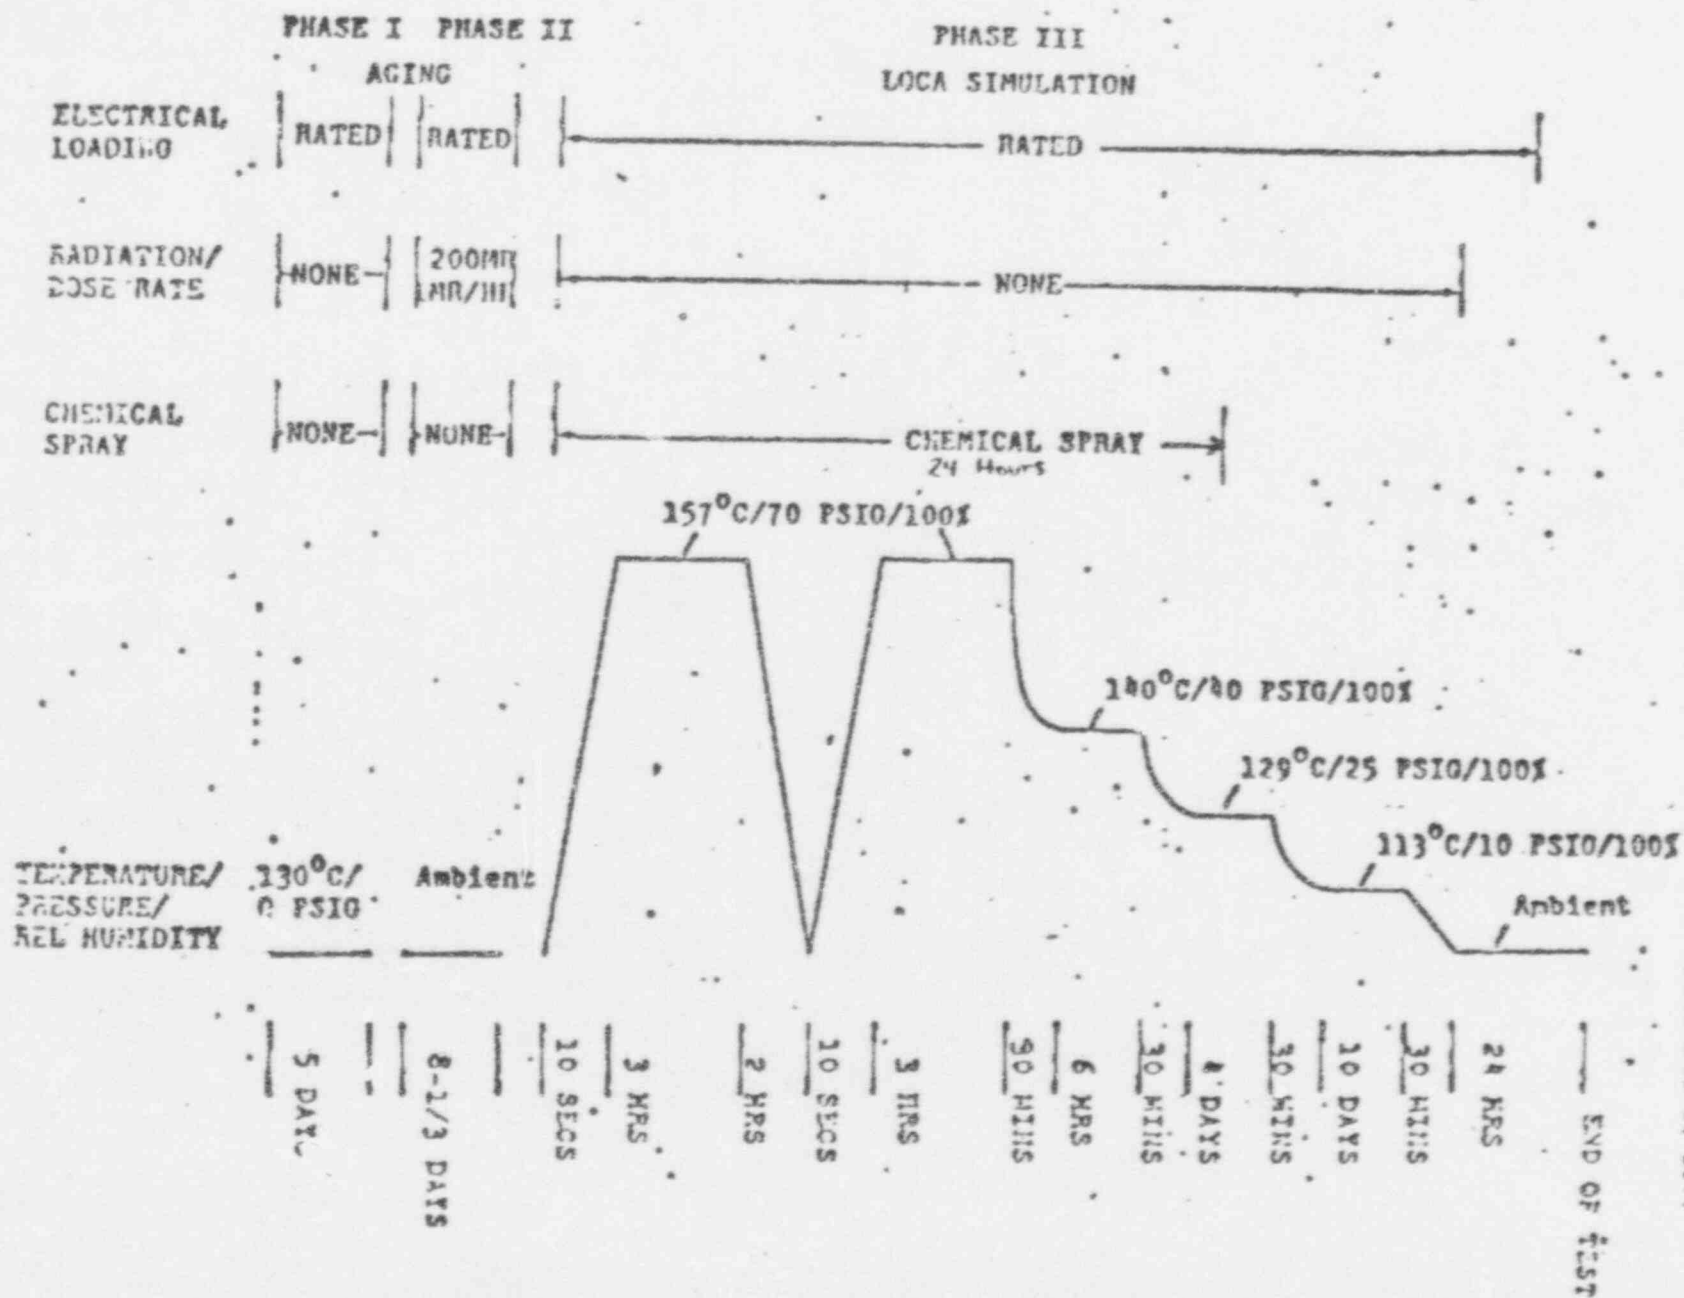
Figure 1

The three tests performed by Sandia were composed of two sequential and one simultaneous exposure to LOCA environments. In each case the equipment was exposed to radiation and thermal aging prior to operating under the simulated LOCA conditions. Figures 1 and 2 describe the test profiles for sequential and simultaneous tests respectively (Sandia tests were designed to study synergistic effects). Each of the tests satisfy the intent of IEEE 323-1974. The assemblies were electrically loaded to 20 amperes and 600 volts at the start of the tests. Insulation resistance and capacitance measurements were recorded during the tests to indicate damage.

# SEQUENTIAL TEST PROFILE

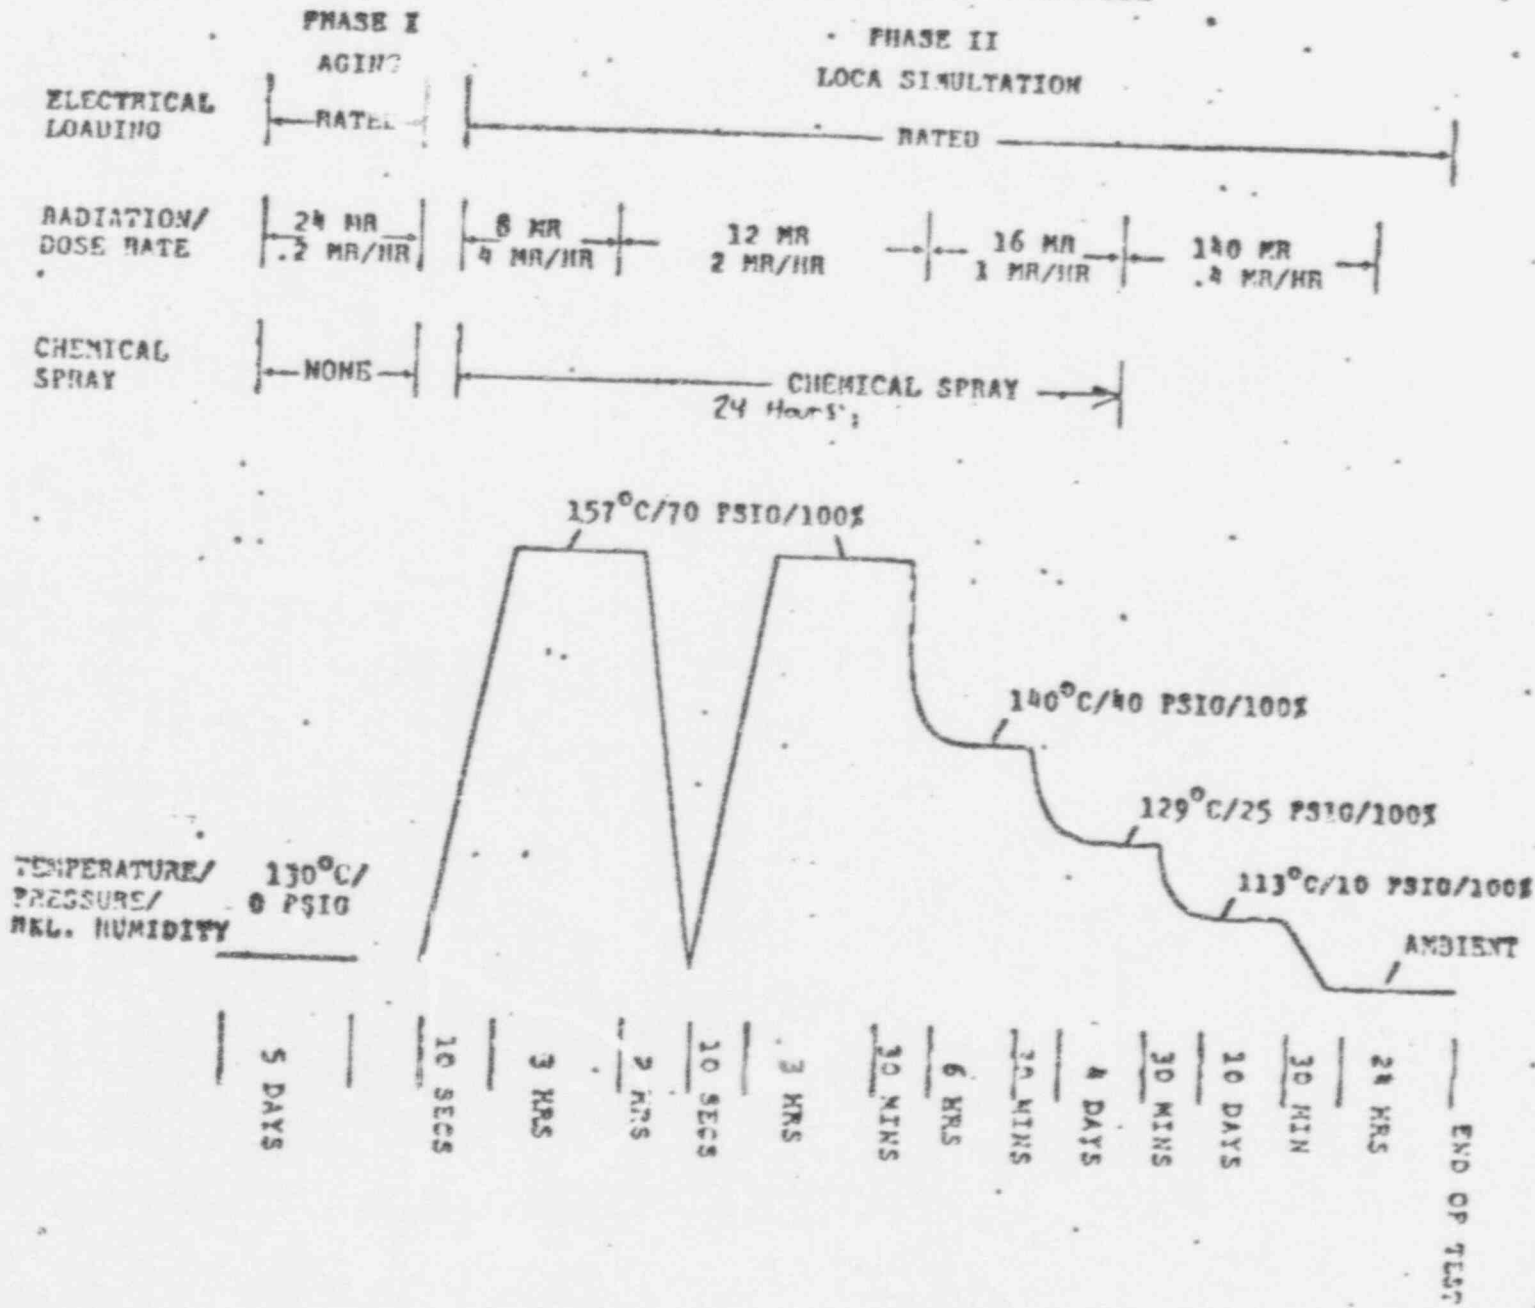
Figure 2

SIMULTANEOUS TEST PROFILE
