NUREG/CR-5762
WYLE 60101

Comprehensive Aging Assessment of Circuit Breakers and Relays

Wyle Laboratories

Prepared for
U.S. Nuclear Regulatory Commission

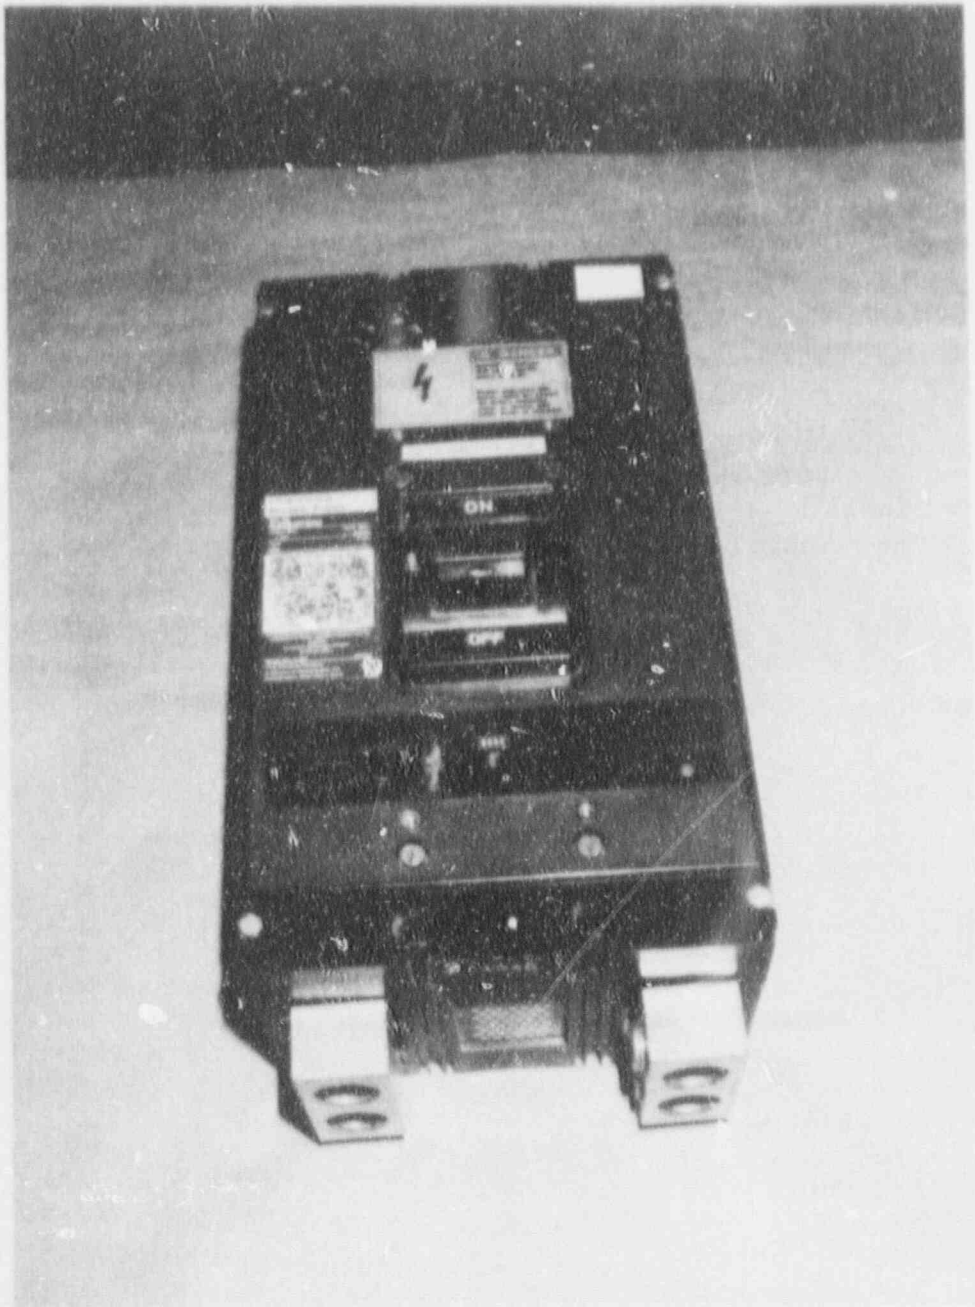
The ITE KMB2F800 was a 800 amp, 600 VAC adjustable magnetic trip circuit breaker. The adjustable magnetic trip range was 3200 to 5600 amps. The specimen was clean except for dust on the top near the arc chutes and dust and cobwebs inside the cover on the line side of the breaker. The load and line poles of pole number one were significantly discolored and had evidence of having been overheated. The operating handle was cracked at the base. The breaker was manually closed and then opened with the manual trip button, which operates the instantaneous trip mechanism for pole number 2. The breaker operated properly when manually set, tripped and reset. The history of this breaker was that it had been tripping at less than rated loads, which had been traced to a loose

Figure 3-56. ITE KMB2F800, 800 Amp
Molded Case Circuit Breaker

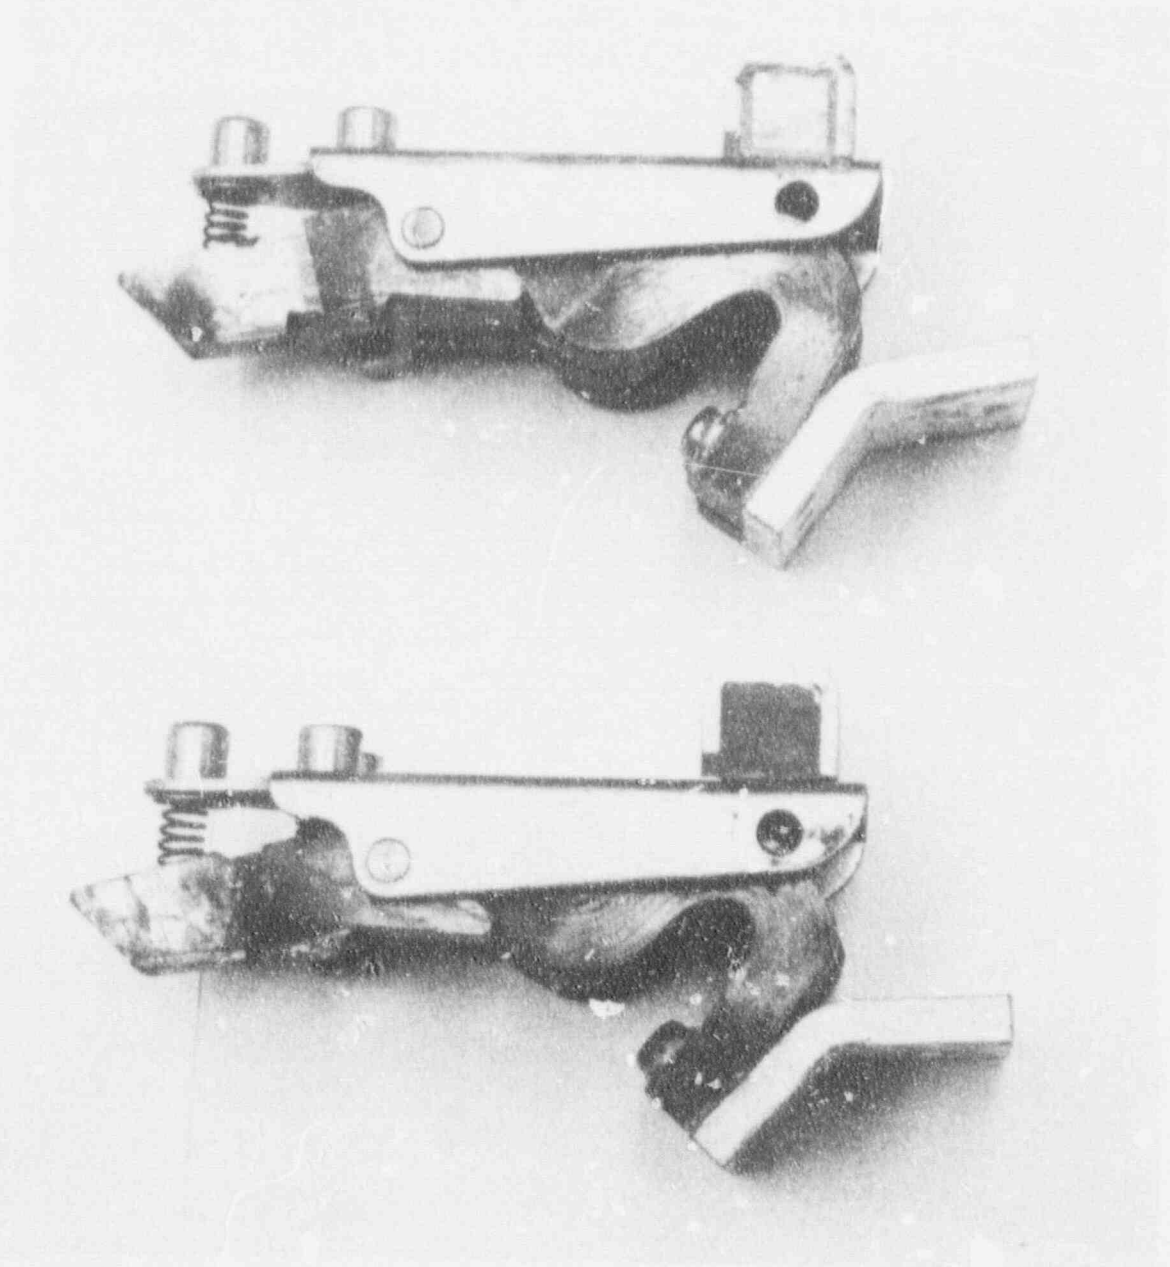
Figure 3-60. Thermal Trip Elements
of ITE KMB2F800 Molded Case Circuit Breaker
(Pole 1 on Bottom, Pole 2 on Top)

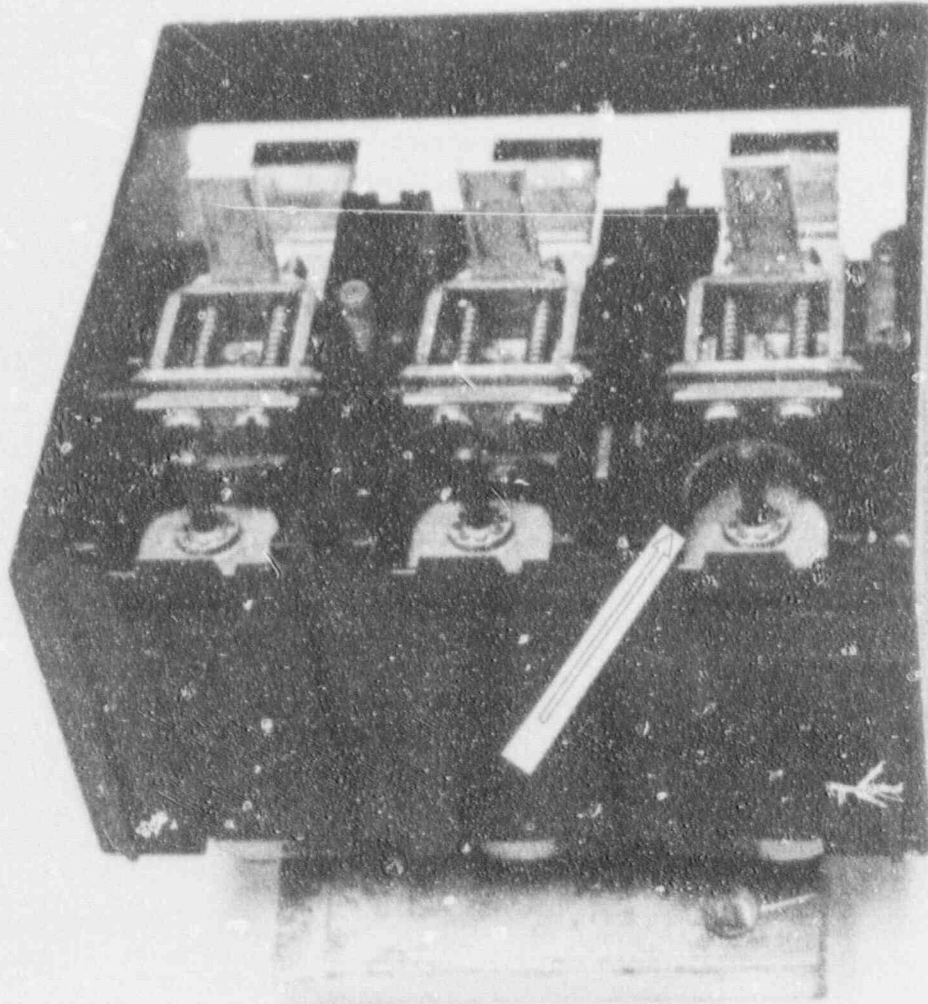
A root cause failure analysis of the Klockner-Moeller NZMH6-100 was performed. The root cause was also overheating. The overheating caused shrink tubing on all three poles to shrink further and interfere with the thermal element. The shrink tubing was located in the thermal and magnetic trip assembly in the base of the molded case circuit breaker. On pole number 1, the shrink

Figure 3-61. Root Cause Failure Analysis
of Thermal and Magnetic Trip Assembly of
Klockner-Moeller NZMH6-100 Molded Case Circuit Breaker,
Showing Heat Shrink Tubing

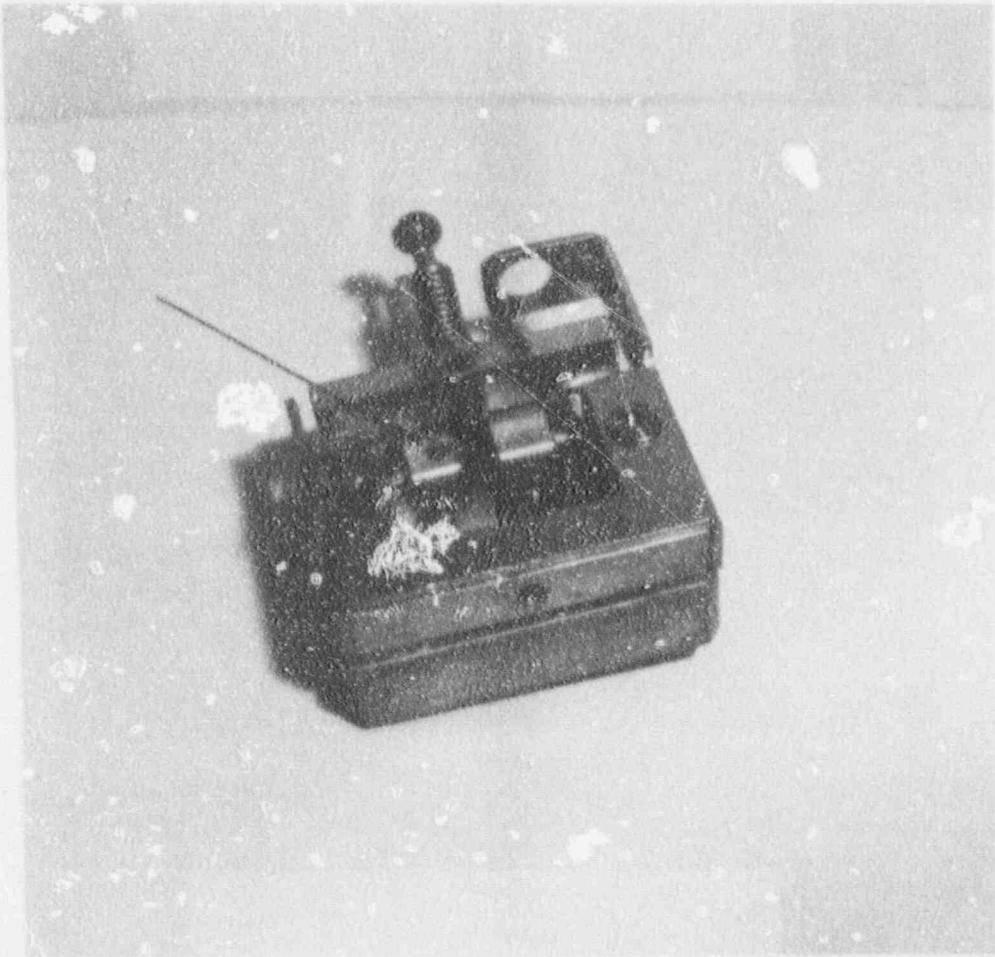
Figure 3-63. Root Cause Failure Analysis of Instantaneous Trip Plunger Assembly on Pole 1 of ITE KMB2F800 Molded Case Circuit Breaker, Showing Burned Spot

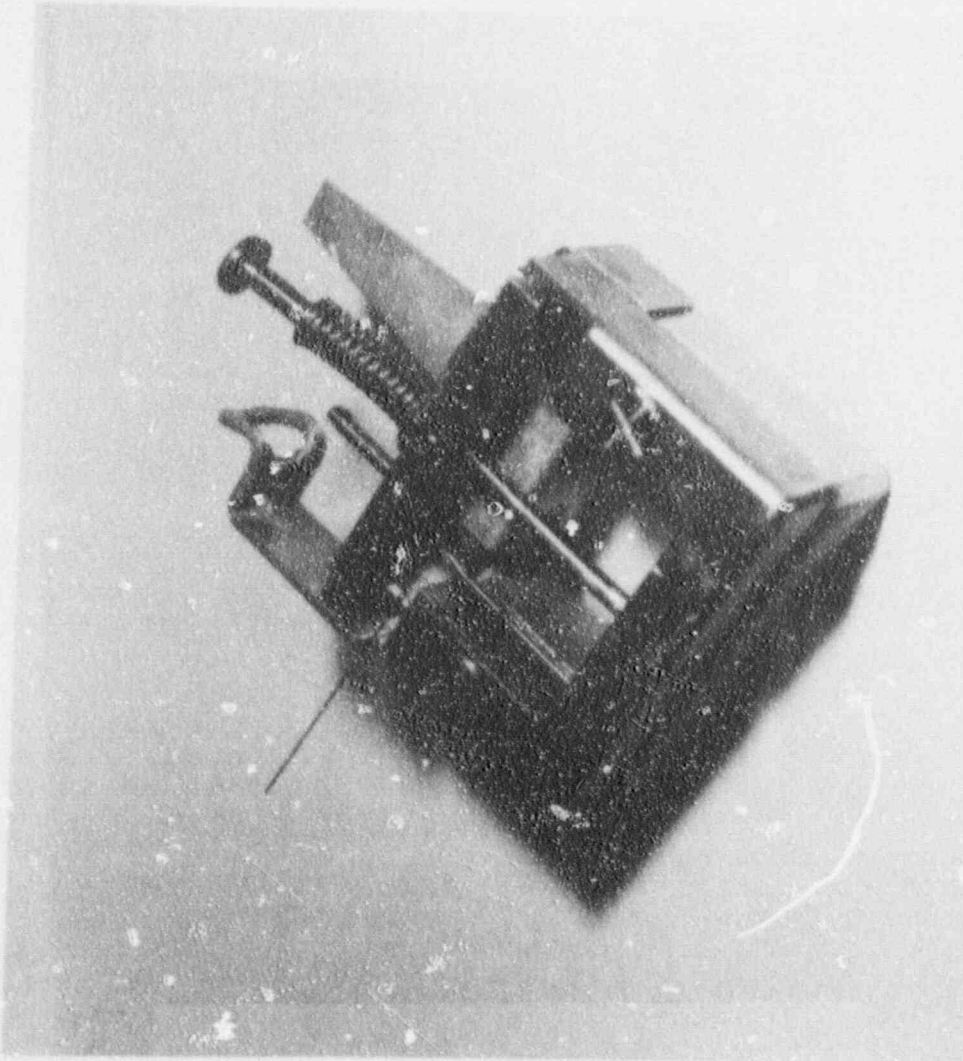
Figure 3-64. Root Cause Failure Analysis of Instantaneous Trip Plunger Assembly on Pole 2 of ITE KMB2F800 Molded Case Circuit Breaker, Showing Solidified Grease

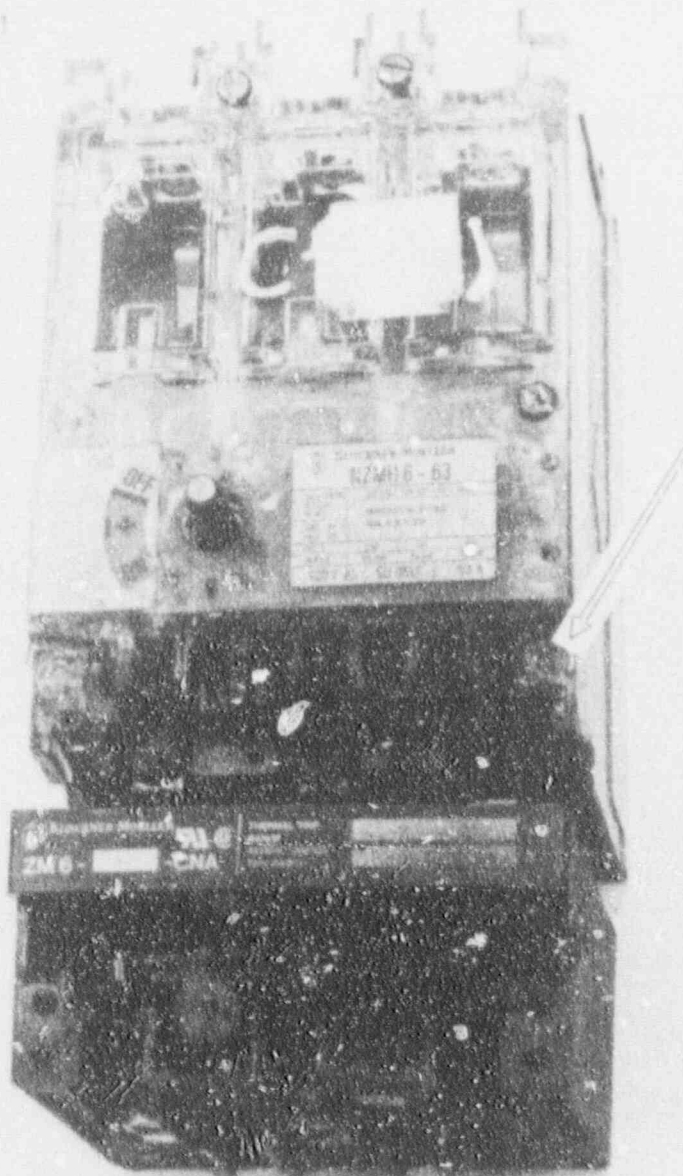
Figure 3-65. Melted Pole 3 of Klockner-Moeller
NZMH6-40 Molded Case Circuit Breaker

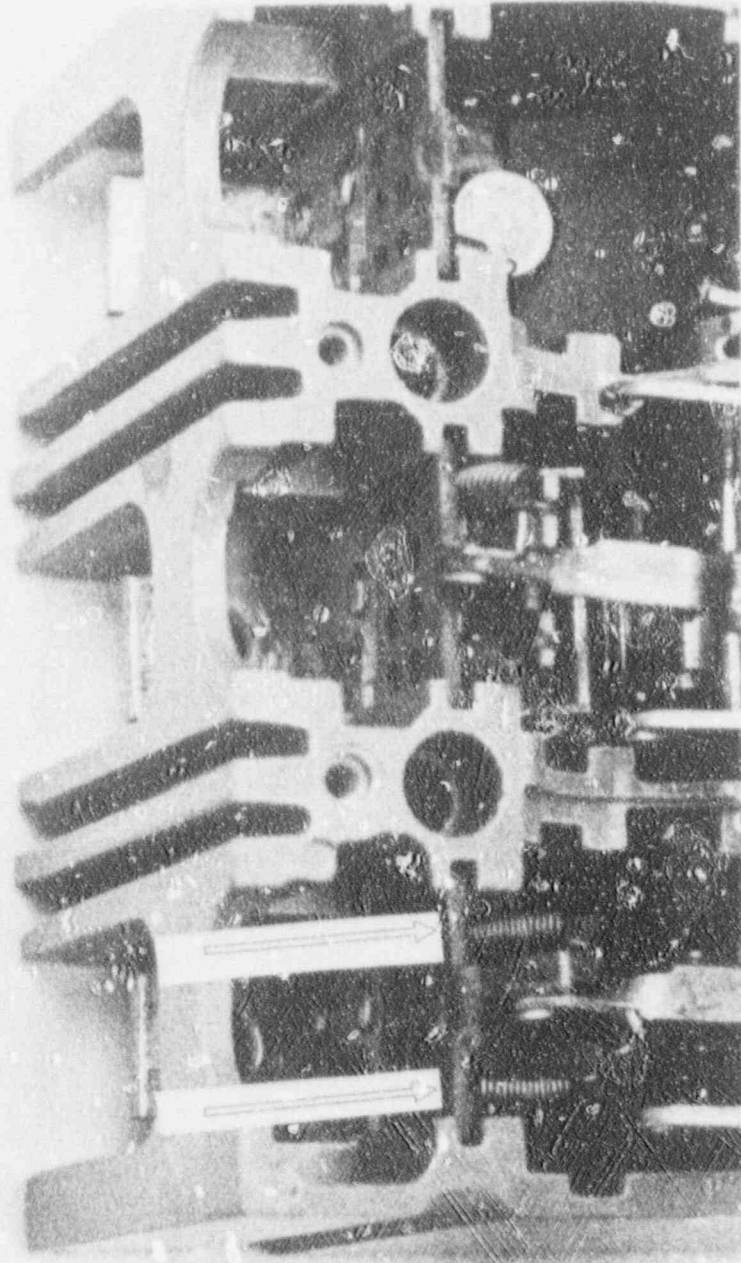
A root cause failure analysis of molded case circuit breaker Westinghouse HFB31550 was performed. The root cause was determined to be a missing spring on pole 1 of the instantaneous trip mechanism. The armature in the instantaneous trip assembly for each pole normally contains two springs, Figure 3-67. Only one spring was found on the armature of pole 1. With only one spring, the armature assembly was twisted and higher current was required to trip the breaker. The root cause for the other breaker's out of specification condition was indeterminate.

Figure 3-67. Typical Two Springs on Pole 1 of a Westinghouse HFB 31550 Molded Case Circuit Breaker

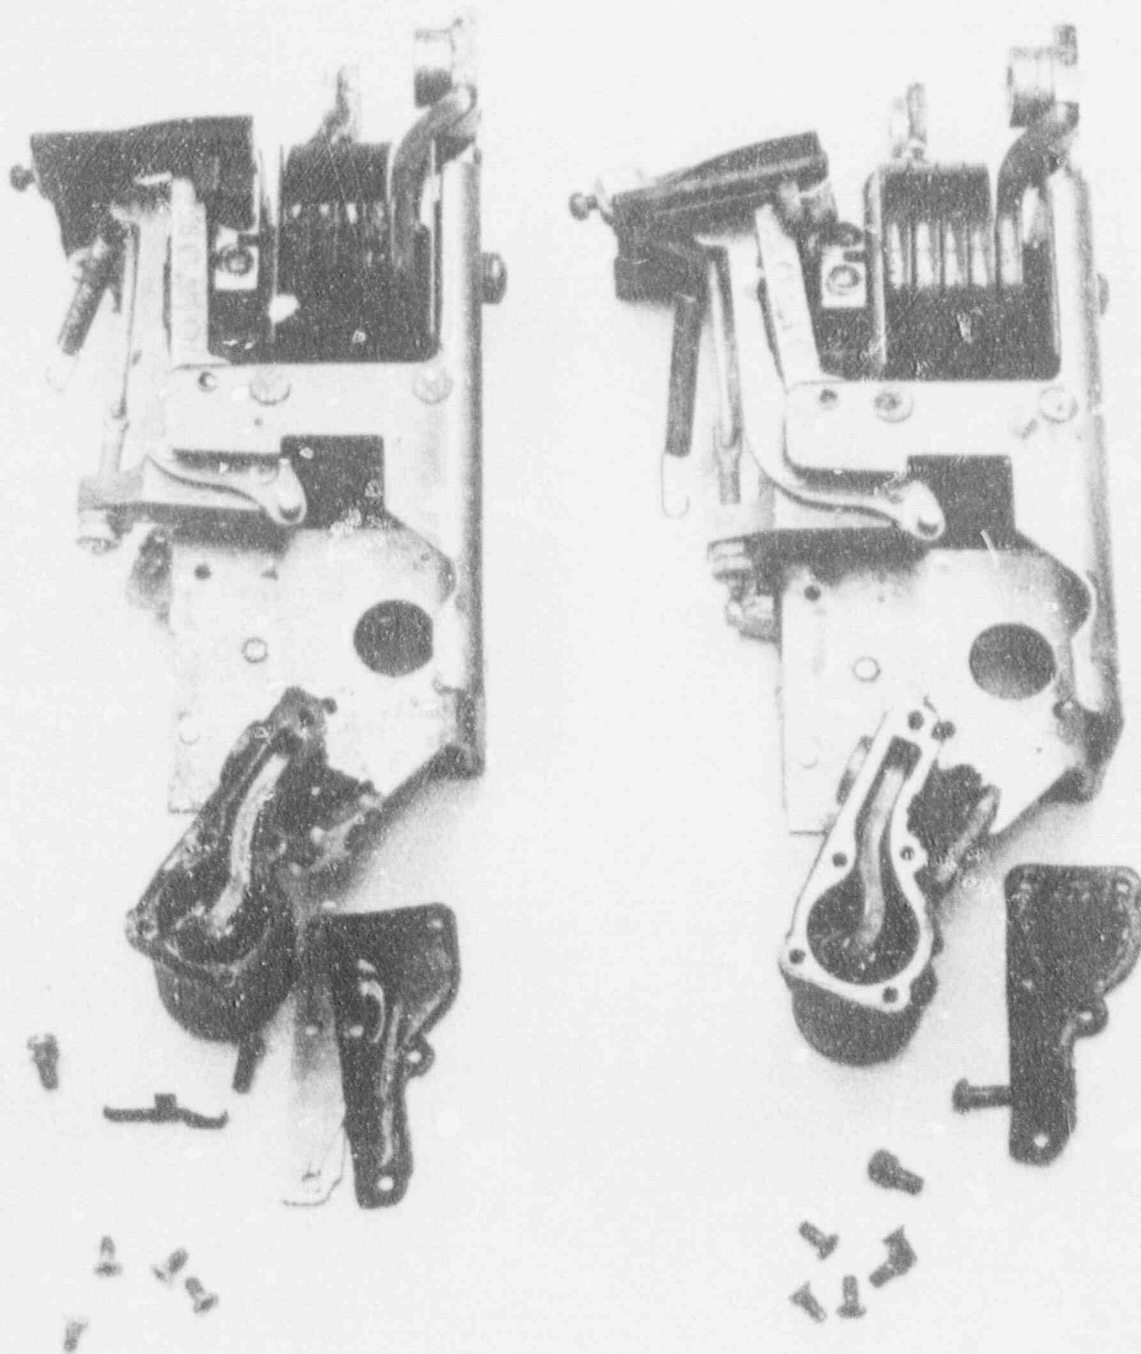
For the AK-2S-25-M breaker, one pole was tested for over 426 seconds and never tripped. Smoke was visible from the area around the arc chutes. The other pole tripped in 5.69 seconds while at rated current and therefore three times the setting was not attempted. The long time delay overcurrent function was accomplished by the EC-1 Series Overcurrent Tripping Device. Root cause failure analyses of the EC-1 tripping devices were performed to determine the cause for the significant differences in trip characteristics. The root cause of the failure to trip on long time delay was caused by binding in the dash pot. The dash pot was bound and the dash pot arm would not move. The dash pot was full of oil and appeared to have been overheated since the metal in contact with the gasket had discolored the seal area, Figure 3-69. Additionally, the coil insulation had been overheated as noted by its black color.

Figure 3-69. General Electric EC-1 Series
Overcurrent Tripping Devices
(Left Device Failed to Trip;
Right Device had No Long Time Delay)

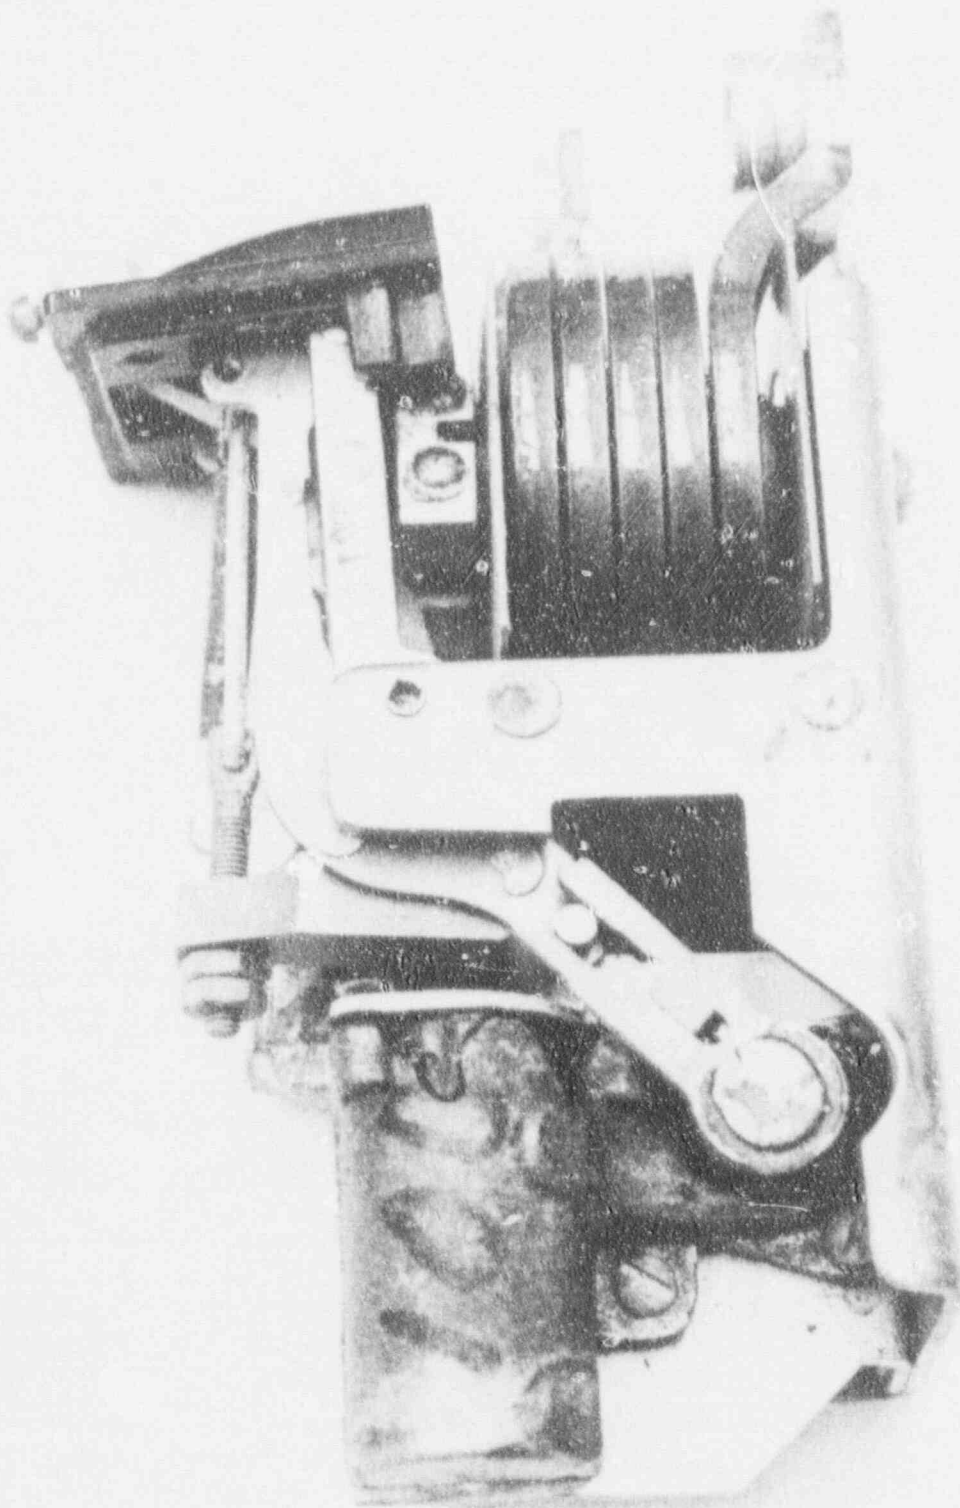
Figure 3-70. General Electric EC-1 Series
Overcurrent Tripping Device
Note Evidence of Oil Leakage and Dirt on Side of Dashpot

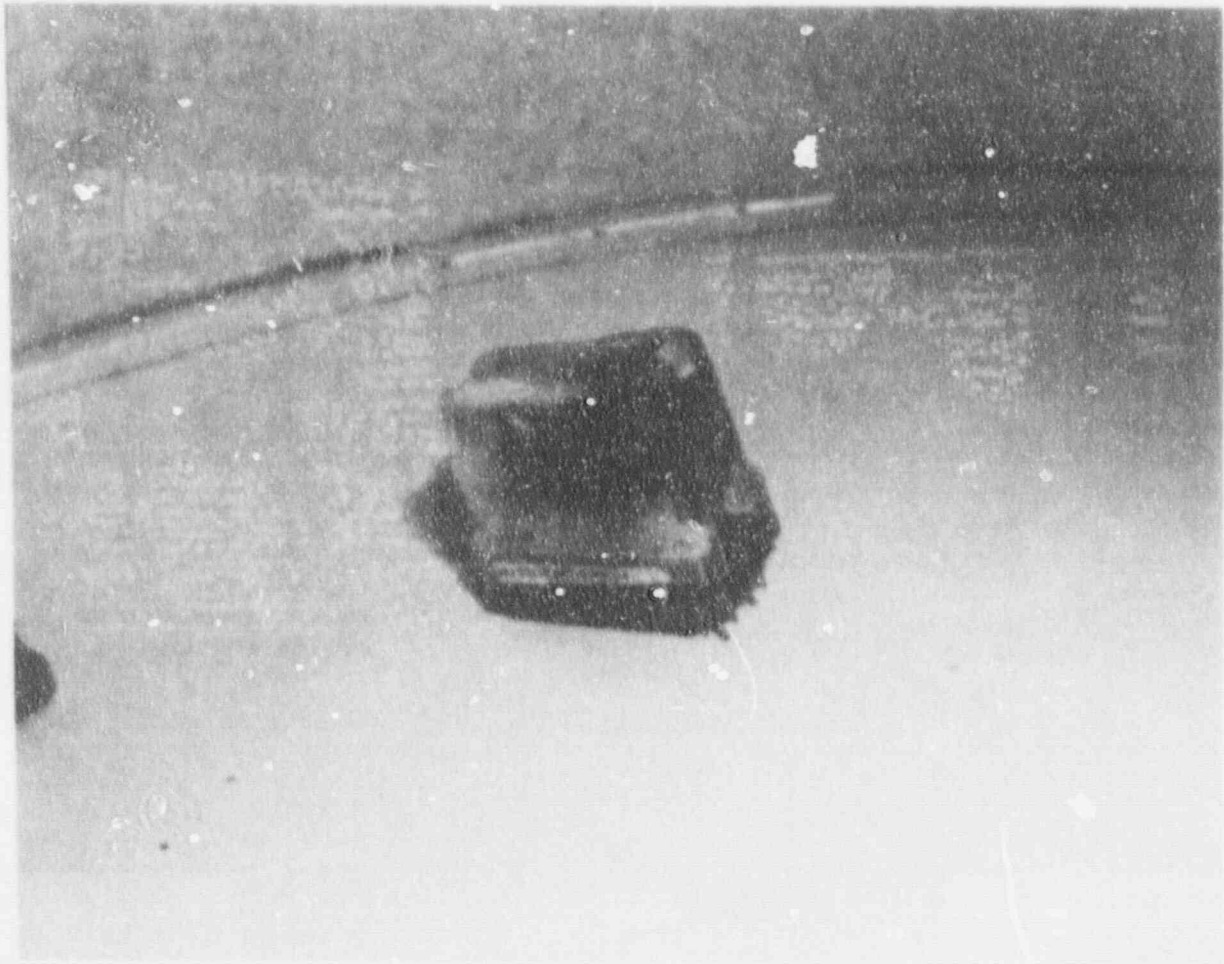
Figure 4-26. Overheated Degraded Condition of
Struthers-Dunn 219 Control Relay

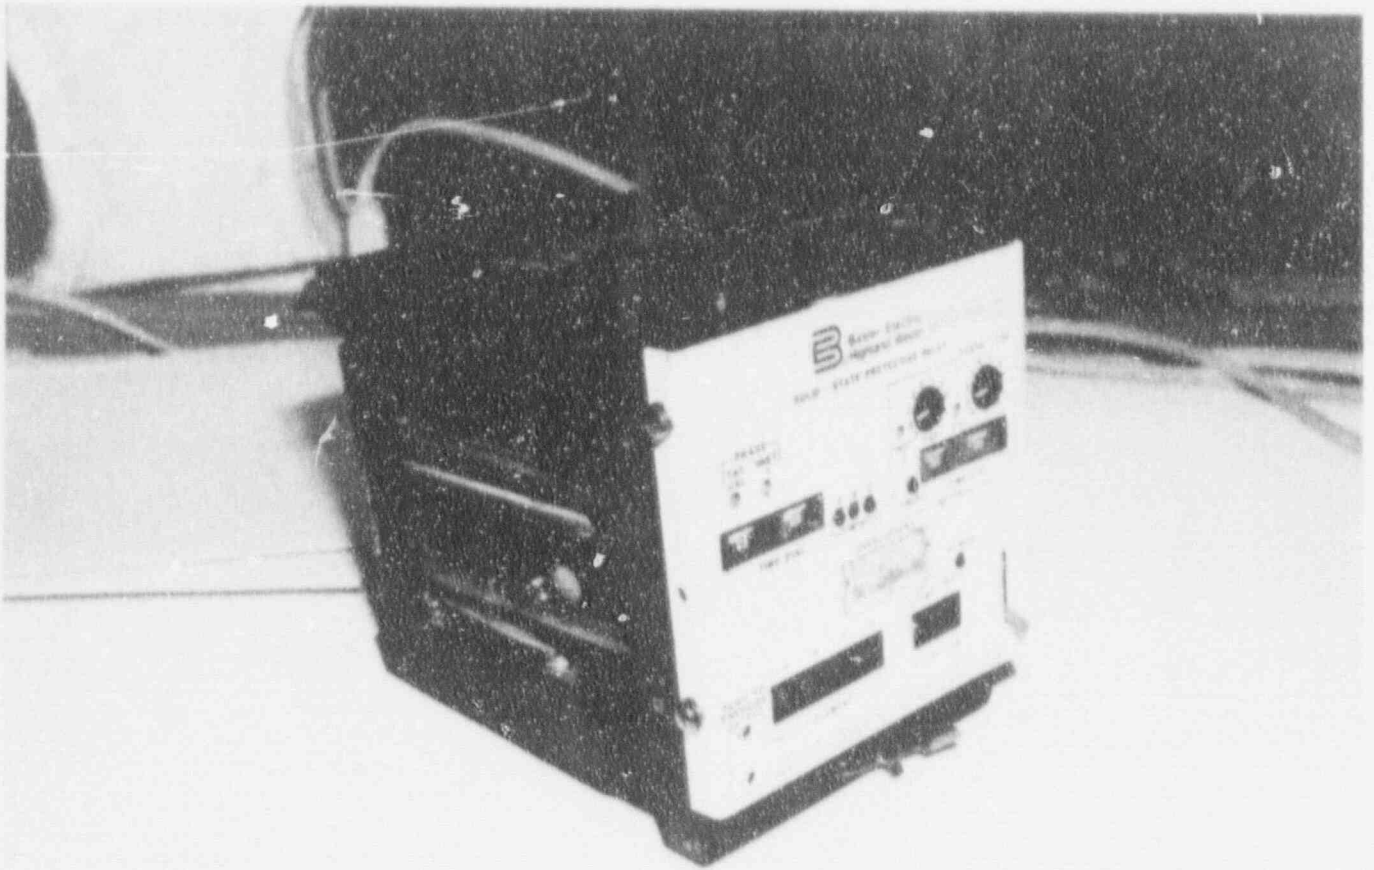
Figure 4-32. Basler Electronic Relay after Degraded Condition of Dirt Accumulation

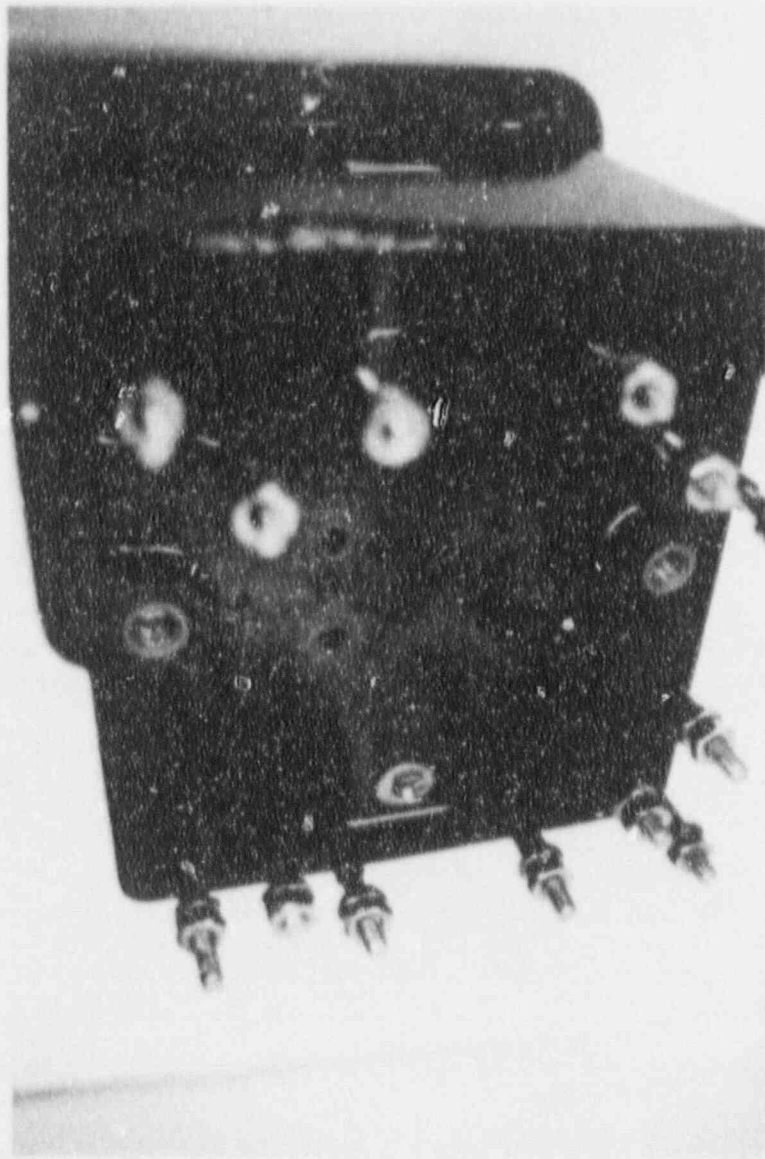
Figure 4-36. Blistered Surface on
GE HFA Auxiliary Relay in
Overheated Degraded Condition

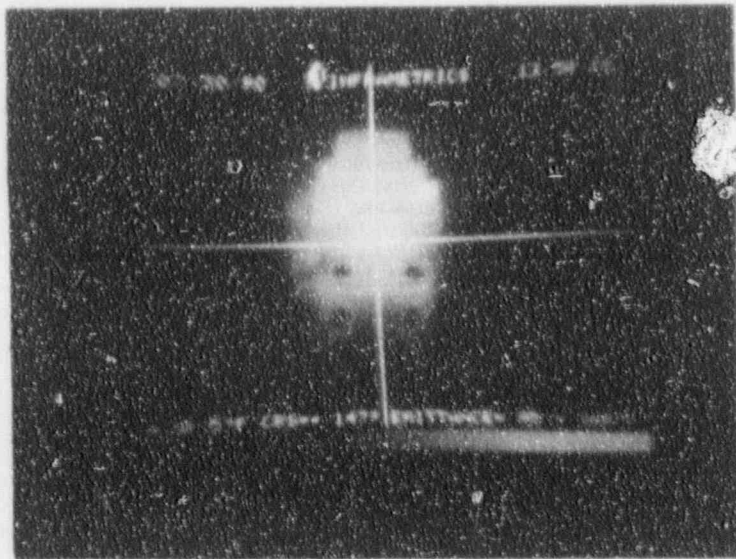
Figure 4-72. Infrared Scanning Thermograph
of Timing Relay Showing Hot Spot During
Overheated Degraded Condition
