LICENSEE EVENT REPORT (LER)

FACILITY NAME (1) CALVERT CLIFFS, UNIT 2	DOCKET NUMBER (2) 050003118	PAGE (3) 1 OF 013
---	--------------------------------	----------------------

TITLE (4)  
D/G Inoperability

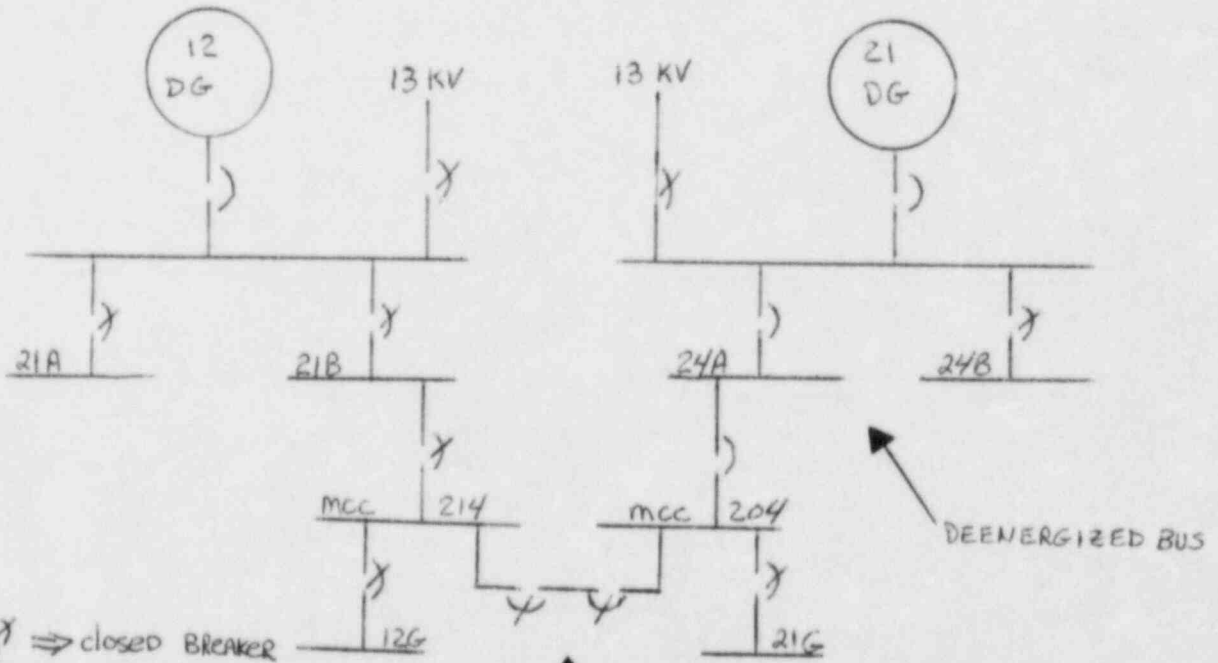
EVENT LINEUP

At 2115 on April 25, 1984, 24A 480V AC Safety bus (ED-BU) was removed from service for preventive maintenance. To maximize 21 DG (EK-DG) availability, 21 DG auxiliaries (Fuel oil transfer pump DC-9, room ventilation fan VJ-Fan, air start system air compressor LC-CMP, and various other engine auxiliaries LB-EHT, P and LA-EHT, P), normally supplied from 24A 480V AC Bus via MCC 204R (ED-BU), were kept energized by powering MCC 204R from MCC 214R (ED-BU) via a tie breaker (ED-BKR). This lineup, which is shown in the drawing (see Attachment 1), allowed 12 DG (EK-DG) to power 21 DG auxiliaries but in turn removed the independence between the two DGs. 21 DG was declared out of service, but not logged as such since T.S. 3.9.1.2 requires only one diesel to be operable in MODES 5 and 6. Had the unit been in a higher mode, less severe consequences would have occurred as the log entry concerning entry into a T.S. action statement would have prevented 12 DG from being taken out of service.

At 0625 on April 26, 1984, licensed personnel on the next shift failed to recognize the dependence of 21 DG on 12 DG and placed 12 DG out of service so preventive maintenance could be performed. Although operations personnel were aware that Unit 2 480V Bus 24A was out of service, the correlation was not made between that work and its effect on 21 DG operability. Consequently, both 12 and 21 Diesels were made inoperable.

↑  
 ABNORMAL  
 CROSS TIE  
 CONNECTION

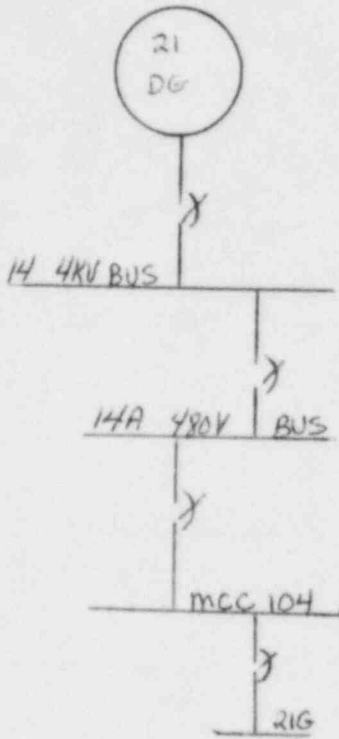
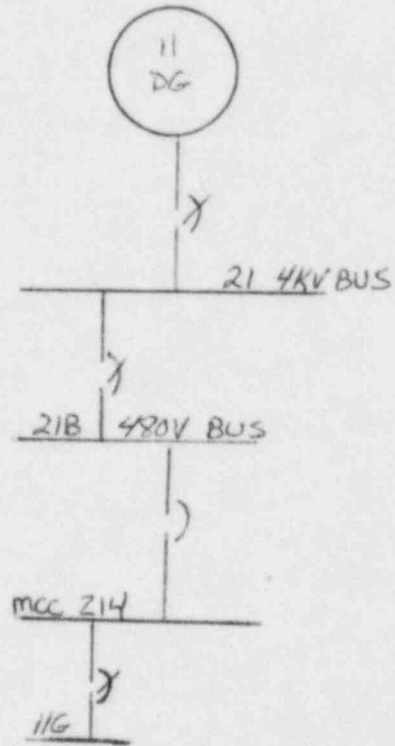
REQUIRED ELECTRICAL LINEUP  
DURING LOSS OF OFFSITE POWER

During this event, the 2 500KV offsite power circuits and the 69KV SMECO offsite power circuit remained operable. Had the 2 normal offsite power circuits been lost during the event, the 69KV SMECO power supply could have been aligned to Unit 2 to supply the safety loads required for shutdown operation. Had a total loss of off-site power occurred during the event, DG 11 would have automatically started and paralleled to Unit 1 Bus 11 (EK-DG). DG 21 would have automatically started and paralleled but would have eventually shutdown when the fuel oil day tank was depleted or on a fault condition caused by the high DG room temperature (because of the inoperable ventilation fan). Existing inspection procedures and Control Room alarms would have ensured the operators' awareness of these conditions prior to an actual diesel trip condition. By realigning 11 DG to Unit 2 4KV Bus 21 and 21 DG to Unit 1 4KV Bus 14, an independent DG would be available for each unit allowing, in this case, Unit 1 to be safely shutdown and Unit 2 to be maintained in a MODE 6 configuration.
