FAILURE ANALYSIS OF THE TYPE 304 STAINLESS STEEL 4-in.
RECIRCULATION BYPASS LINES OF THE MONTICELLO BWR POWER PLANT*

ARGONNE NATIONAL LABORATORY
9700 South Cass Avenue
Argonne, Illinois 60439
Materials Science Division

April 1976

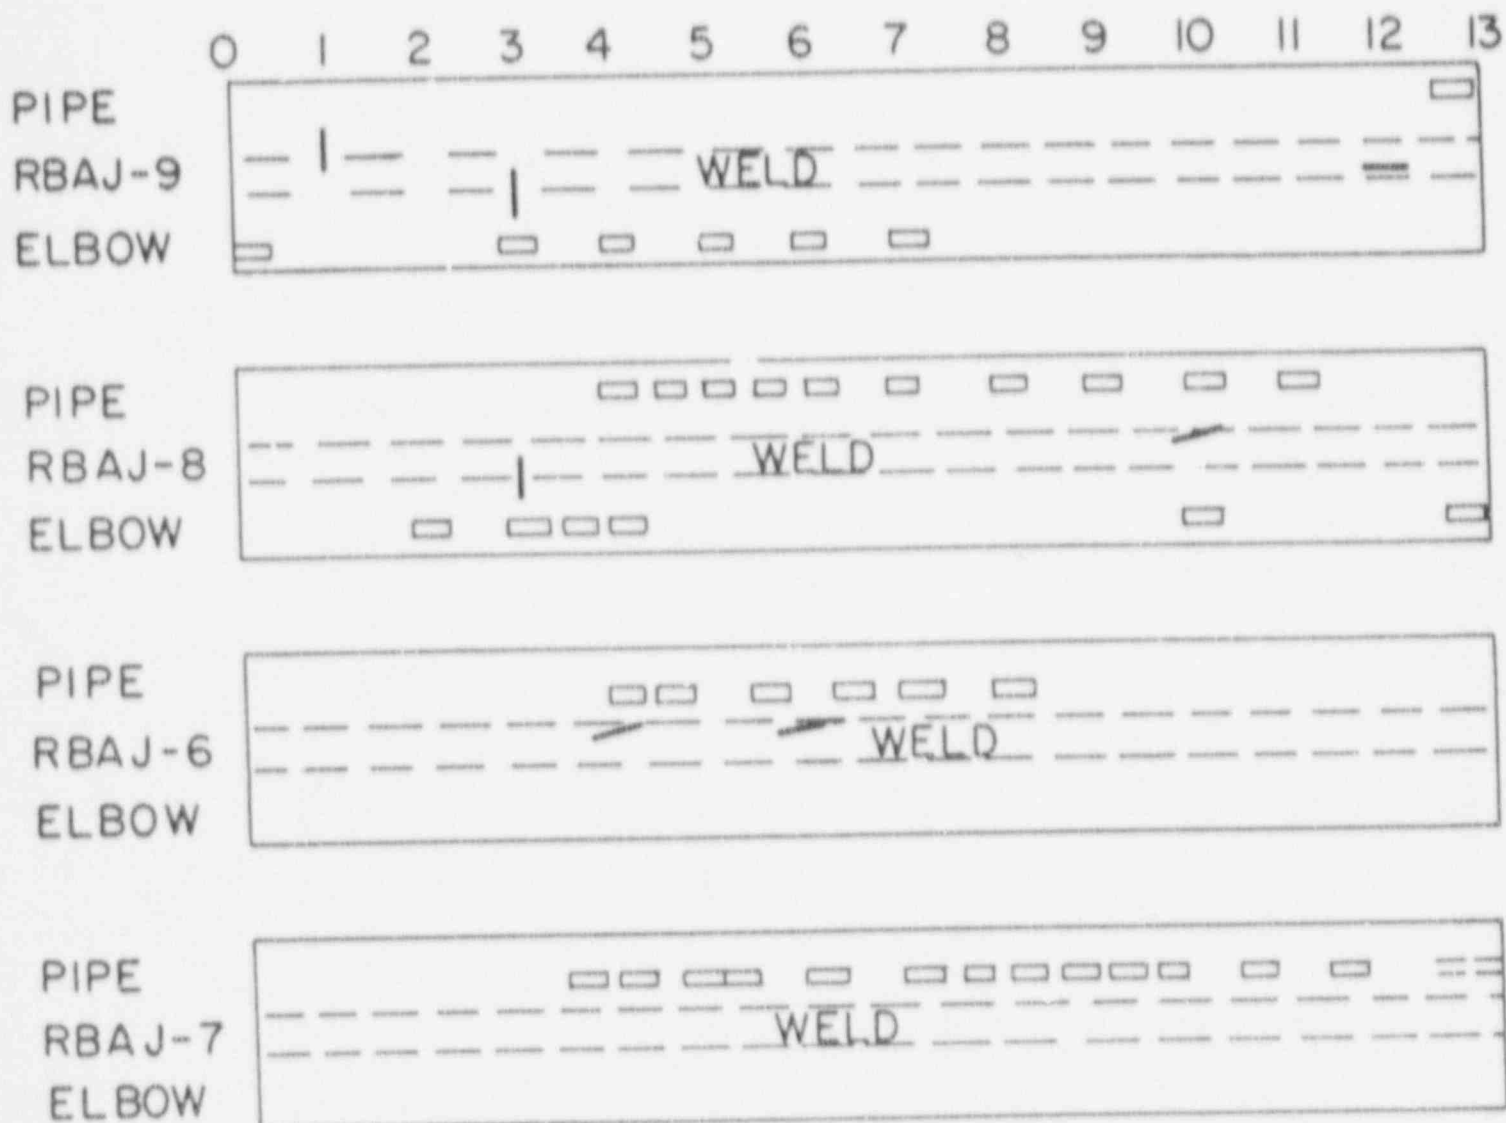
top of the figure denote the clock positions. Ultrasonic test indications are present on both the elbow and pipe sides of the weld; however, it is not possible to determine the orientation of the indications due to geometric masking of the UT signal. Radiographic indications appear on the pipe side of the weld at all the joints except RBAJ-8 and RBAJ-9. The latter two welds have radiographic indications on both sides of the joint. Dye penetrant examination of the radiographic indications located in welds RBBJ-12, RBAJ-9, RBAJ-8 and RBAJ-6 did not confirm the presence of cracking in these joints.

Fig. 4. Radiograph and ultrasonic results of welds from Loop A. The figure is an axial unfolding of the pipe with the weld shown at the center of each diagram and the clock positions numbered at the top. The view is from the pipe OD. The pipe and elbow sides of the weld are also shown.

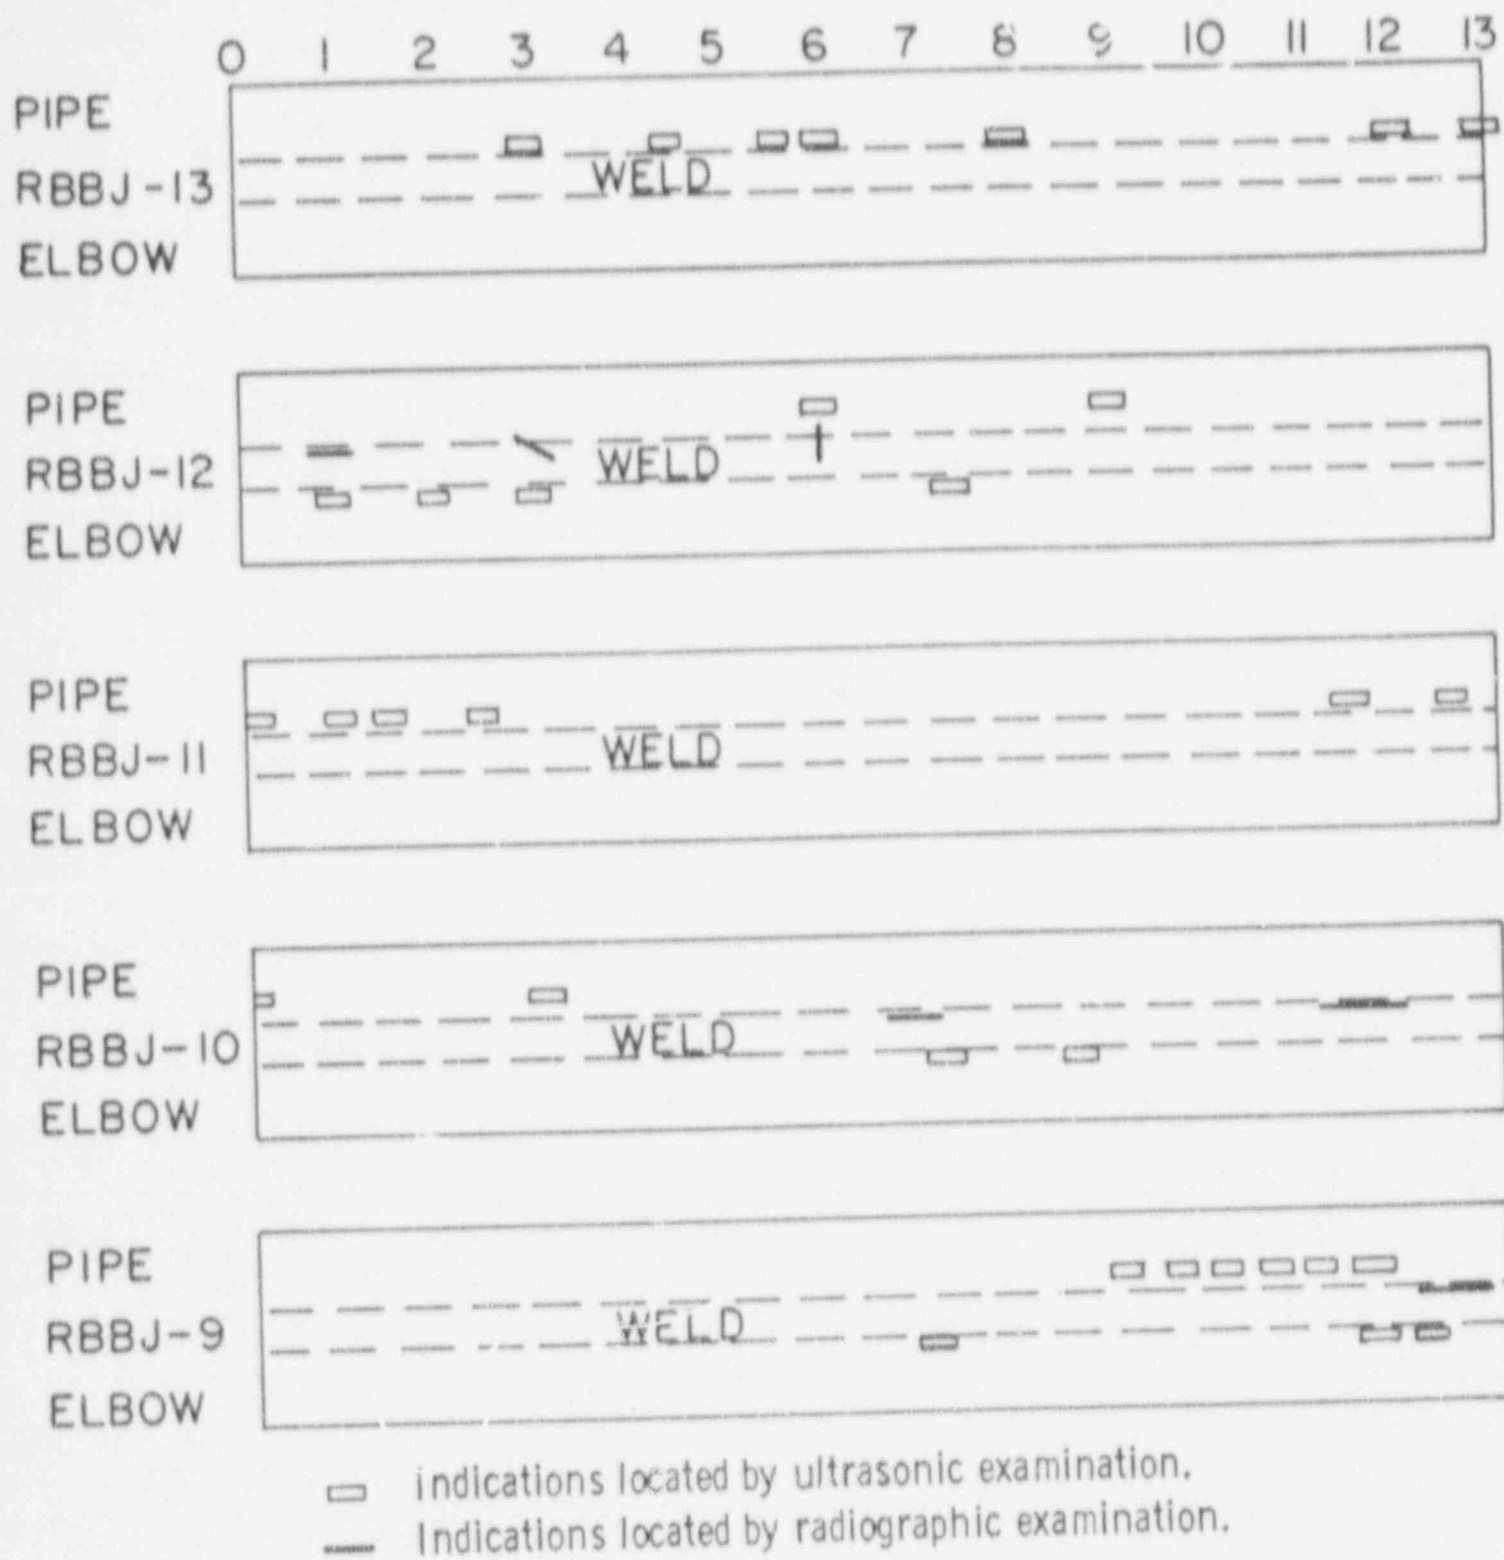
Fig. 5. Radiograph and ultrasonic results of welds from Loop B. The figure is an unfolding of the pipe with the weld shown at the center of each diagram and the clock positions numbered at the top. The pipe and elbow sides of the weld are also shown.

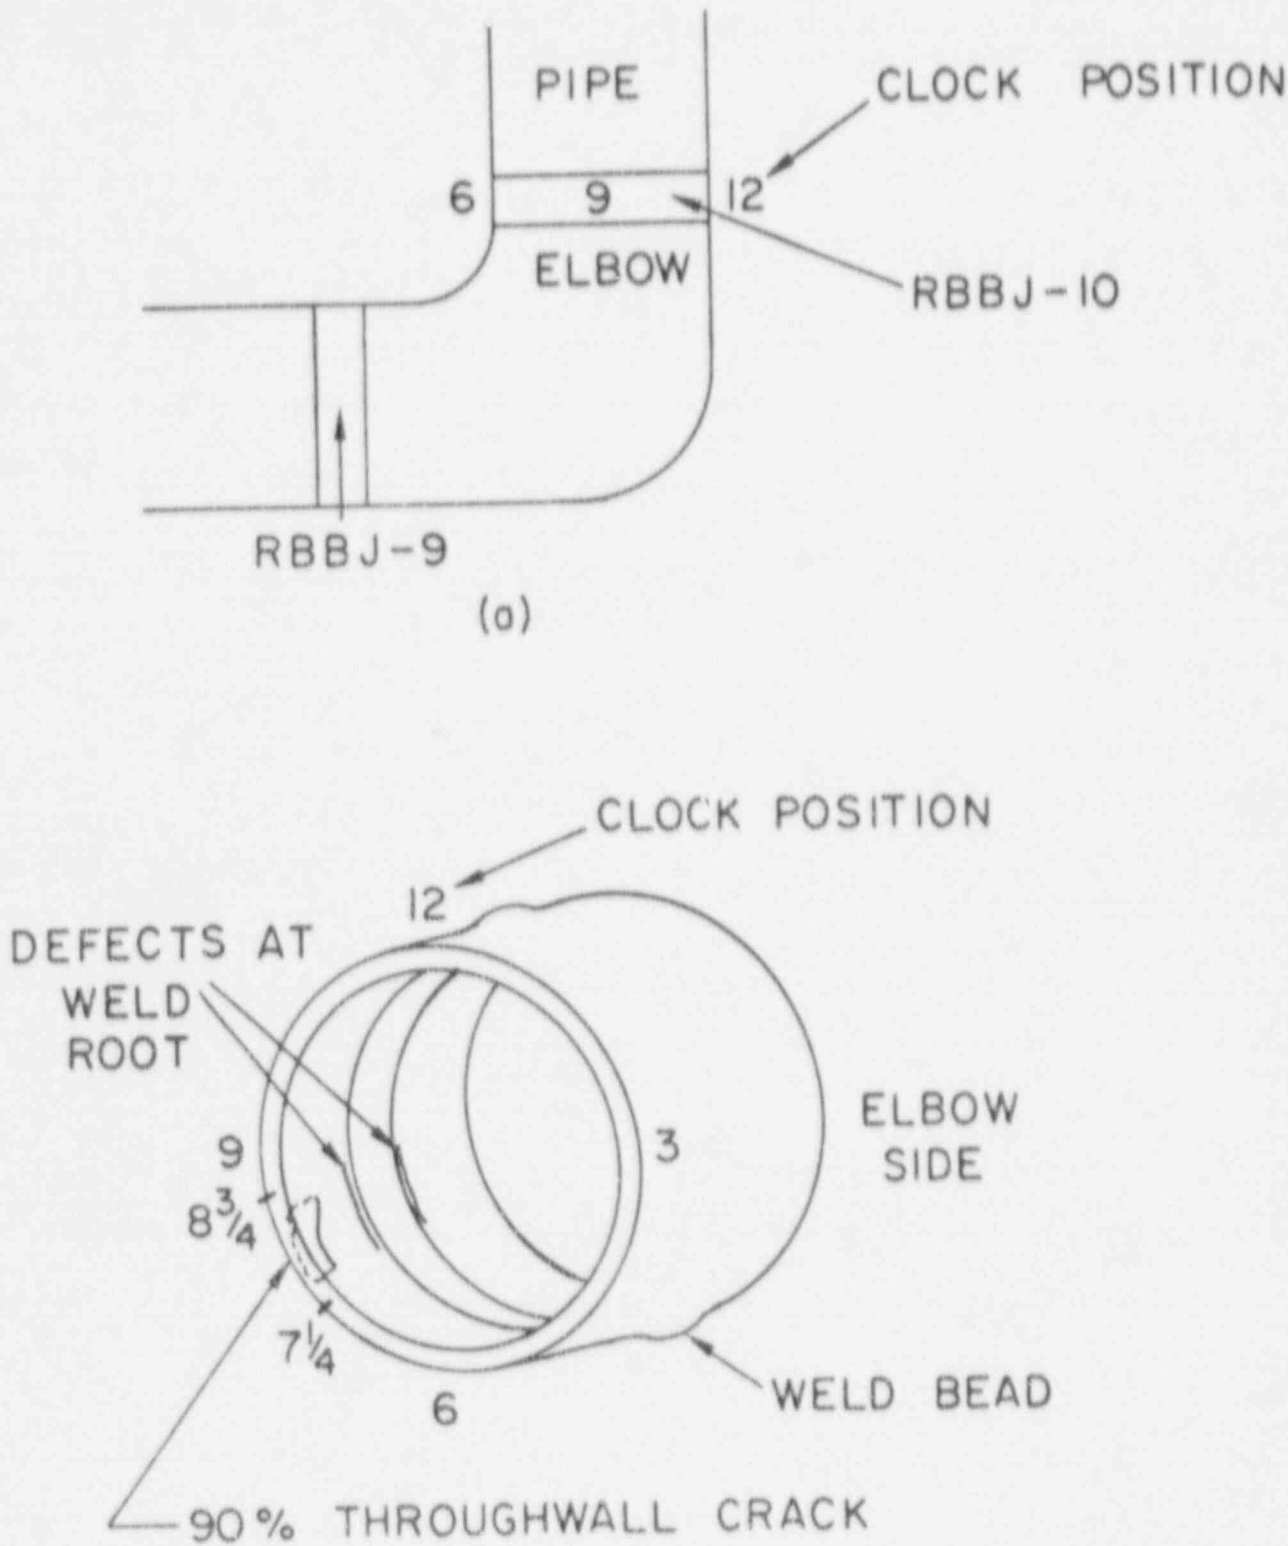
Weld RBBJ-10 was cut from the pipe using a motorized hack saw and included $\sim 1/2$ -in. of material on each side of the weld bead. The elbow geometry is shown in Fig. 6a. Figure 6b shows a three-dimensional view of the weld and the observed major crack, which extends from the 7 1/4 to the 8 3/4 clock position.

Fig. 6. (a) Schematic of Loop B with the elbow containing welds RBBJ-9 and RBBJ-10. The clock positions are shown. (b) A three-dimensional schematic showing weld RBBJ-10. The weld bead and clock positions are shown. The defects were located at the 7 1/4 to 8 3/4 clock position. One (90% throughwall) crack was observed in the HAZ, and two defects were detected at the weld root.

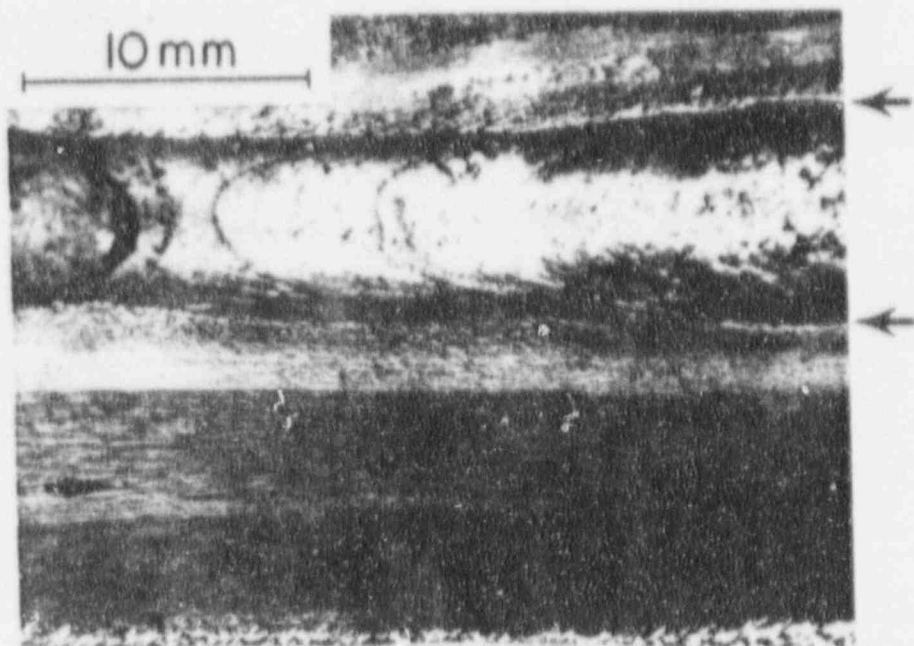
Two weld-root defects were also observed. The ID surface of the pipe is shown in Fig. 7a with the weld bead and defects. The elbow side of the weld is toward the top of the figure. A higher-magnification photograph is shown in Fig. 7b. The major crack can be seen on the pipe side of the weld bead. The major crack follows the circumference and jogs along the counterbored machine marks. The weld-root defects are visible in Fig. 7b.

Fig. 7. (a) The ID surface of weld RBBJ-10. The weld bead (B) and elbow (A) and pipe (C) sides of the weld are indicated. The clock positions are $8 \frac{3}{4}$ at the left and $7 \frac{1}{4}$ at the right. (b) A higher-magnification photo of (a). The machining marks at the surface are readily seen. The major crack and two surface defects are visible (arrows).

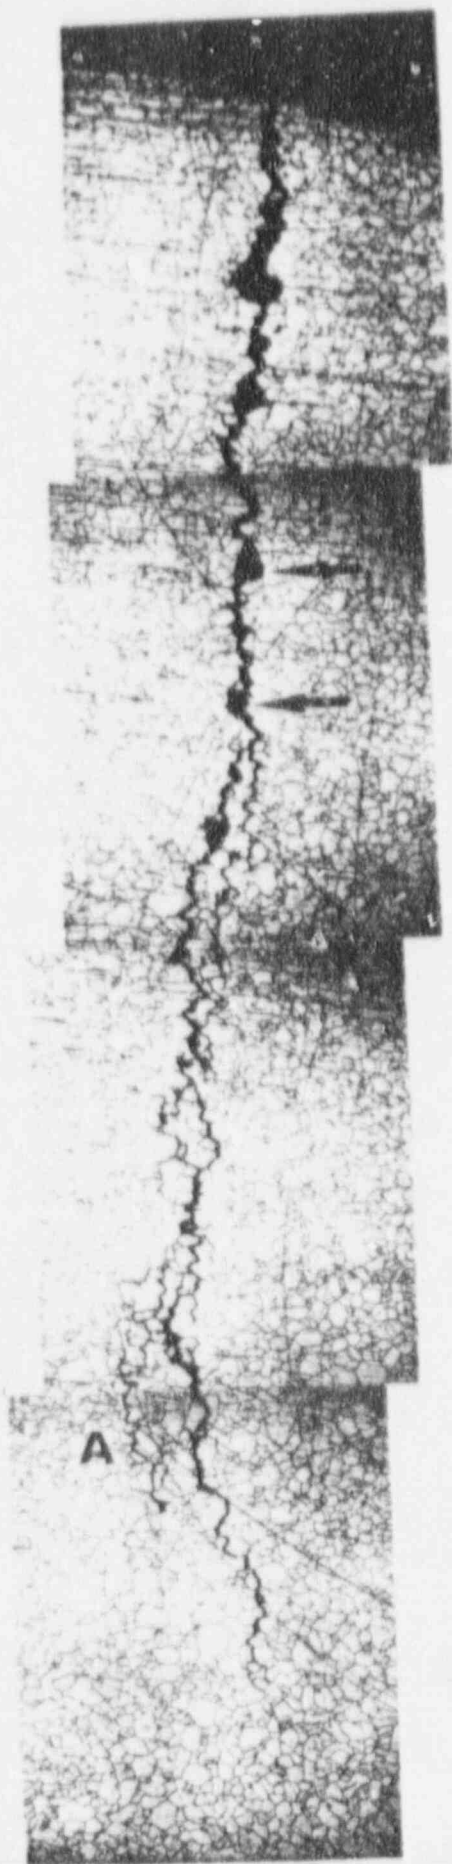
A composite cross-sectional metallographic view of the major crack is shown in Fig. 9. Sample preparation included metallographic polishing prior to etching in a 10% oxalic acid solution using a current density of 1 A/cm^2 to delineate the grain boundaries. Several interesting features in this figure are worth noting. The crack is intergranular, and dark irregular-shape areas, which may have contained precipitates or grains, are evident. Branching of the main crack is also readily seen.

Fig. 9. An enlarged view of the crack in the HAZ. An oxalic acid etch was used to delineate the grain boundaries. The dark irregular-shape areas (arrow) may have contained grains and/or precipitates. Crack branching is also observed.

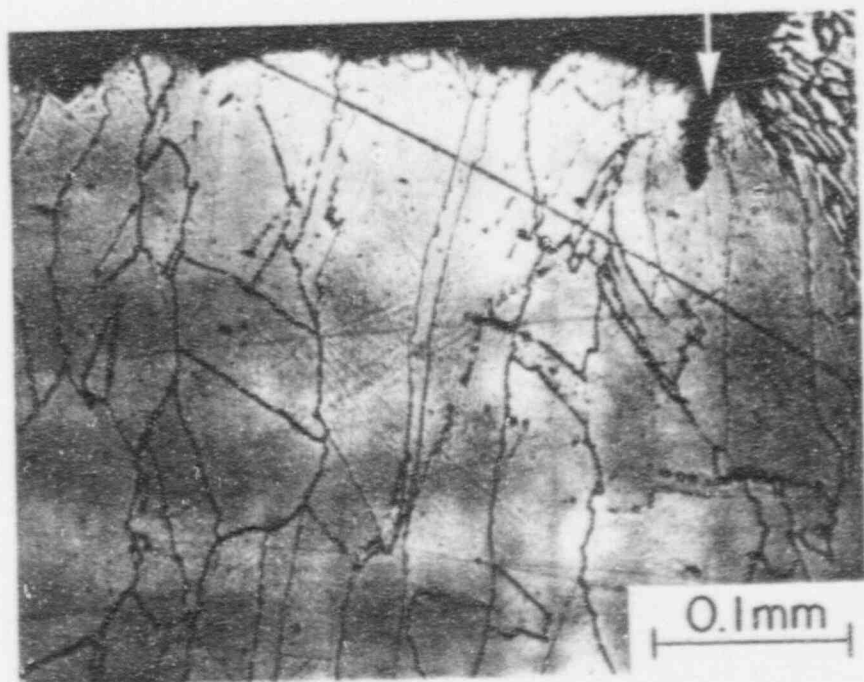
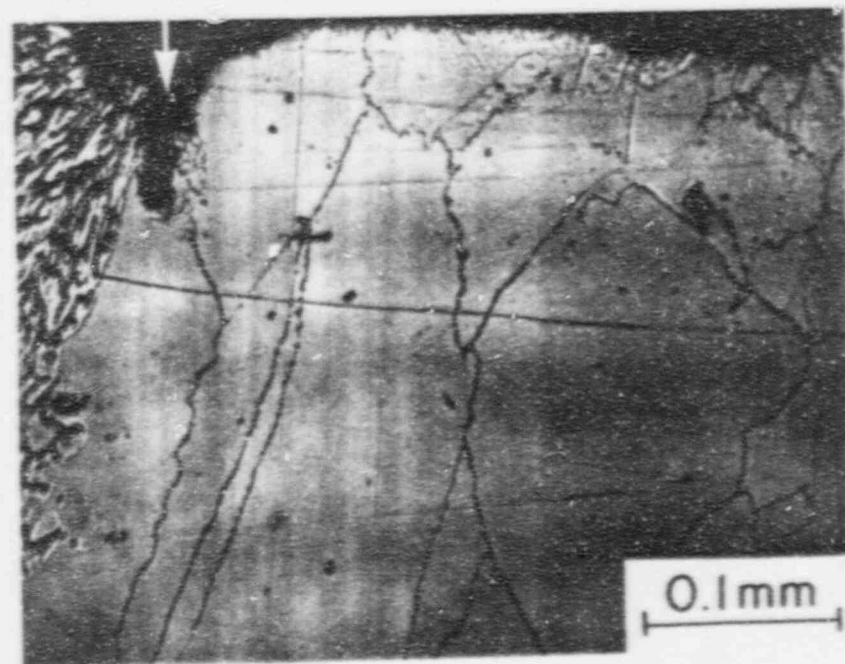
A cross-sectional view of the crack-like defects at the weld root is shown in Fig. 10. These typical weld-root defects, which have blunt tips, occur on both sides of the weld. The grain size of the base material on the pipe side differs from that of the elbow side because of the mechanical working and heat treatment received by the elbow during the forming (hot bending) process. The grain size in the bulk of the elbow material is larger than at the ID surface. This difference (Fig. 11) is partially due to the forming process and the heat provided during welding. Figure 11b, which is a magnified view of Fig. 11a,

Fig. 10. The defects at the weld root are shown at the pipe side (A) and elbow side (B) of the weld. These crack-like defects are shallow (0.004") and transgranular and have blunted tips. This type of defect in this location has not contributed to the (BWR) piping failures investigated at ANL. The grain size differences are attributed to the thermal history of the elbow.

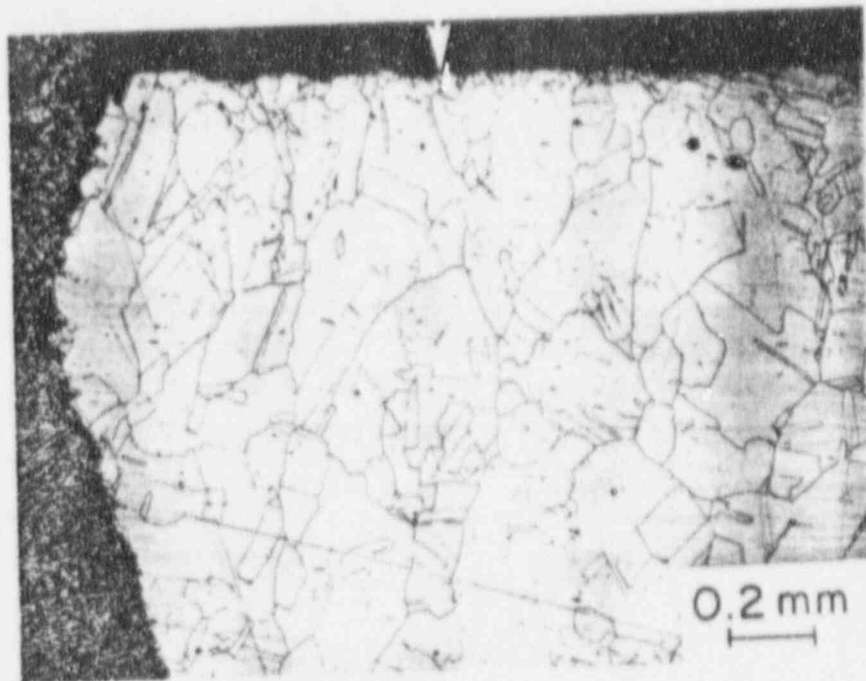
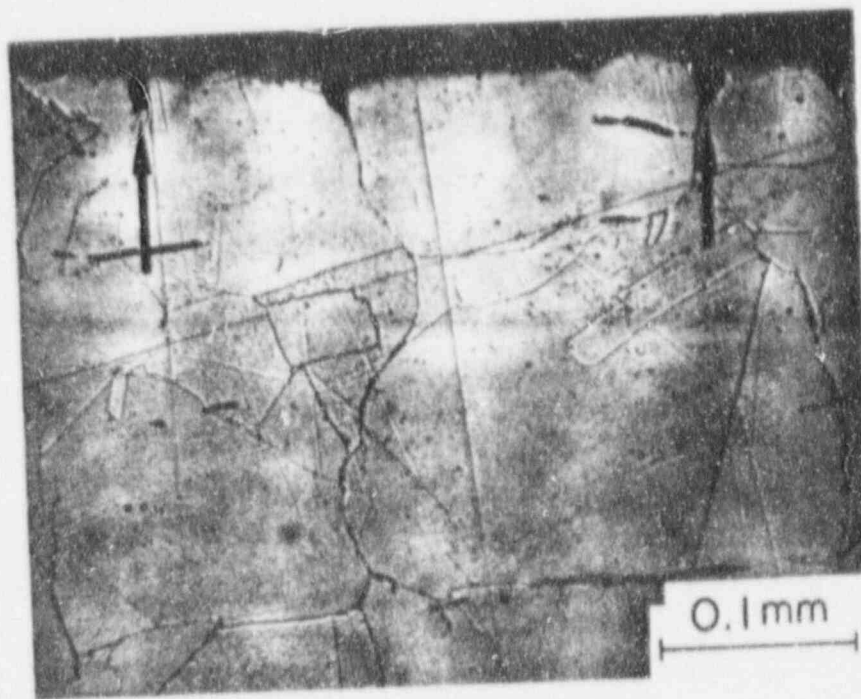
Fig. 11. Grain structure of the elbow material. (a) Small grains (due to recrystallization) are at the ID surface (arrow). Large grains follow the weld fusion line. (b) A magnified view of the ID surface. The notching (arrow) that has occurred is seen at the grain boundaries as well as at the center of grains.

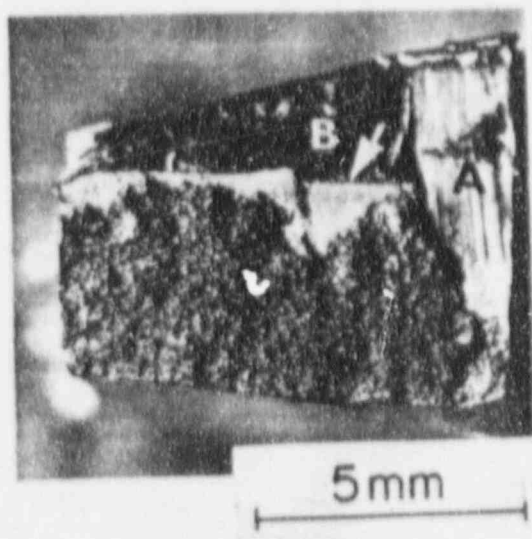
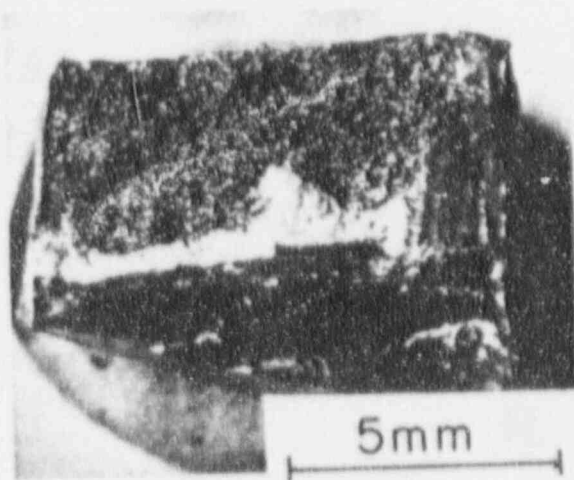
Fig. 13. The mating pieces of the fracture surface are shown. The regions labeled A and B were saw cut prior to separating the two pieces. Ductile tearing (arrow) appears as high-contrast areas on the photograph.

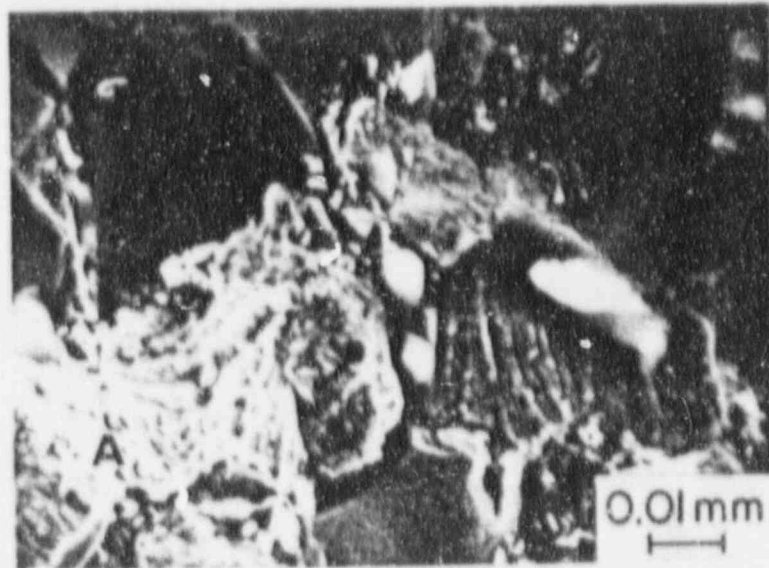
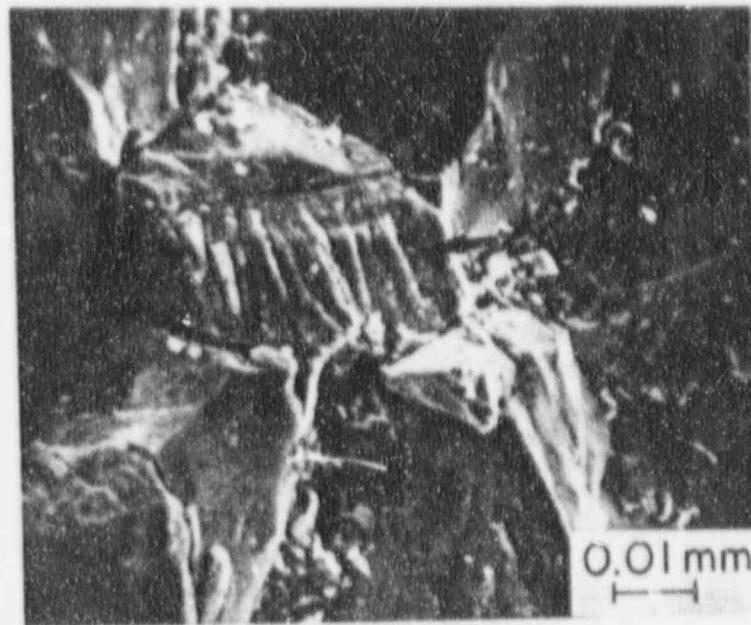
Fig. 14. The fracture surface as seen with the SEM. Photograph (a) was taken after exposure of the surface to the NS-1 solution for 100 h. Photograph (b) is the same region after 219 h in the solution. "Tongue" behavior (arrow) can be seen. These two photographs show the effects of the NS-1 solution on removing the surface oxide (A).

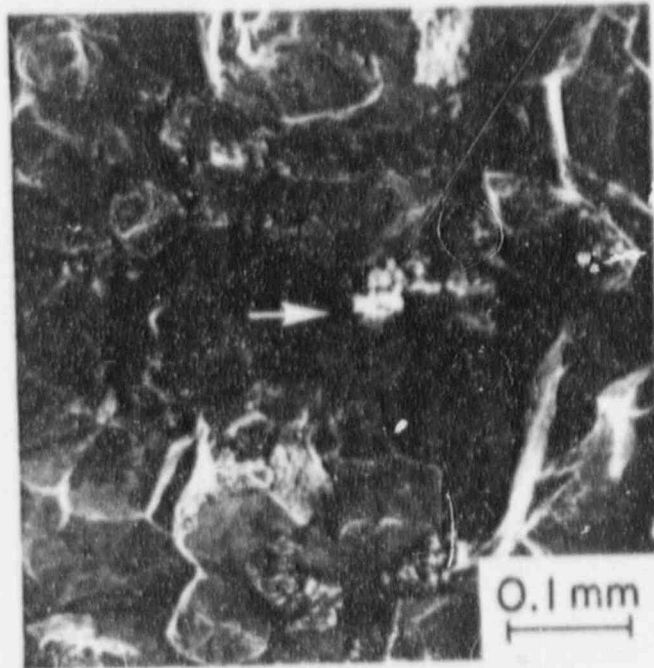
Fig. 15. An SEM photograph showing the fracture surface. The high-contrast regions are oxides that have become charged (arrow). Precipitates are also seen at the grain boundaries.

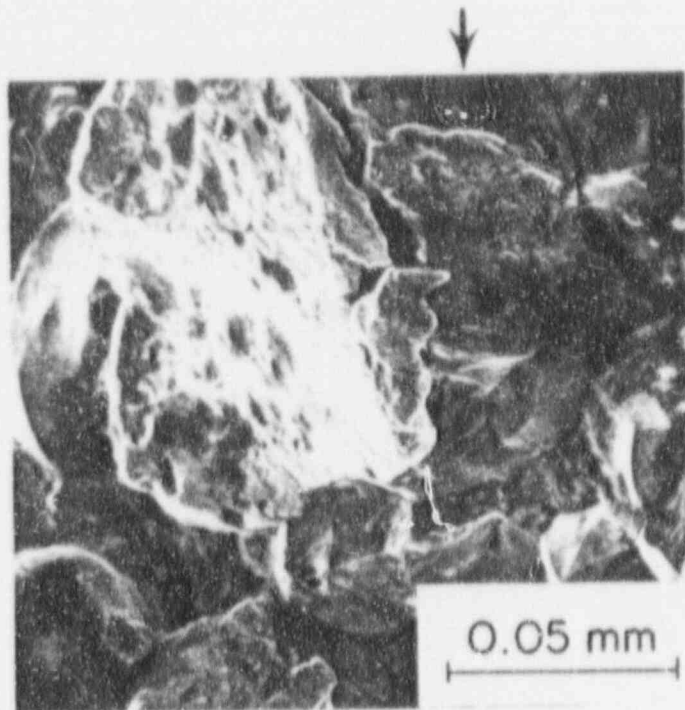
Fig. 16. Photograph showing slip (arrow).

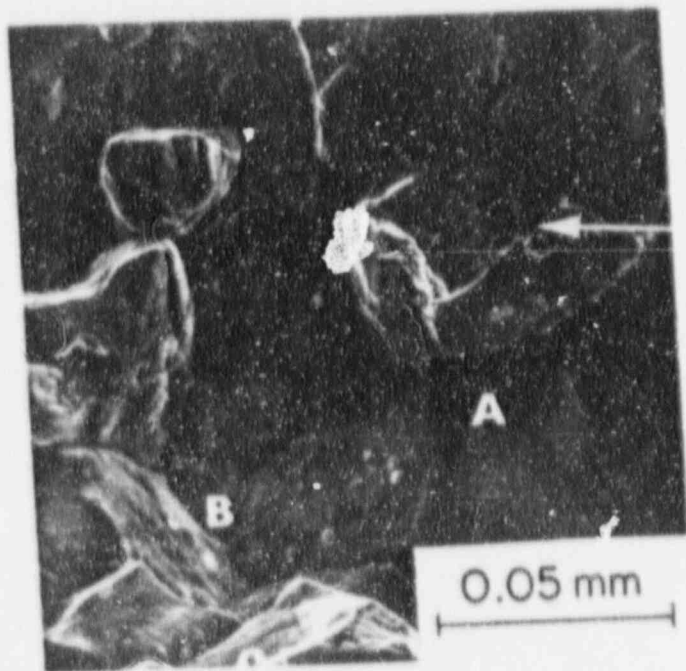
Fig. 17. Photograph showing slip (arrow), grain-boundary separation (A), and crack arrest (B).

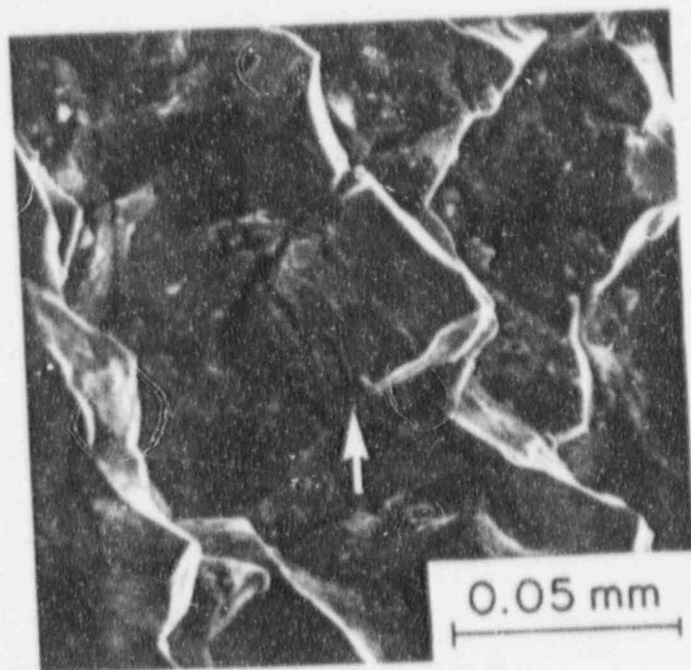
Fig. 18. Photograph showing transgranular fracture (arrow) at an isolated grain on the fracture surface.

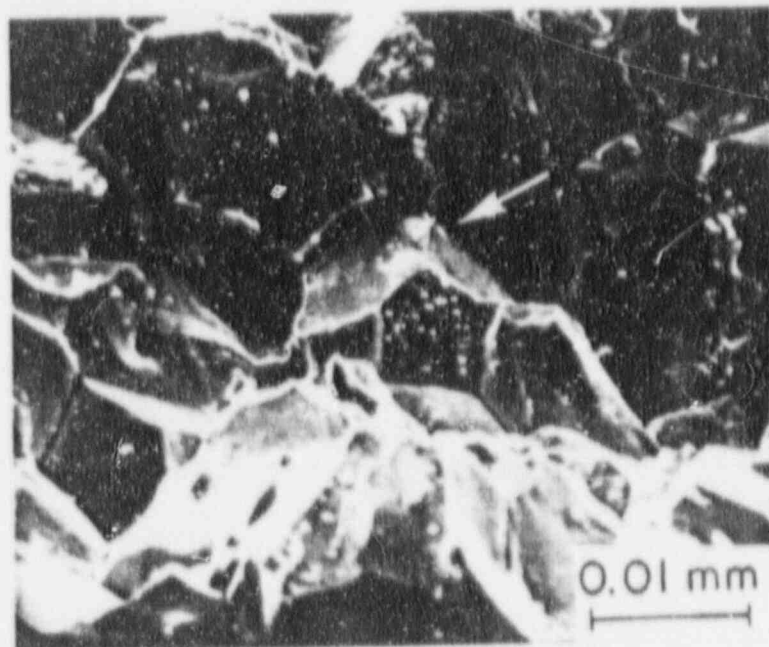
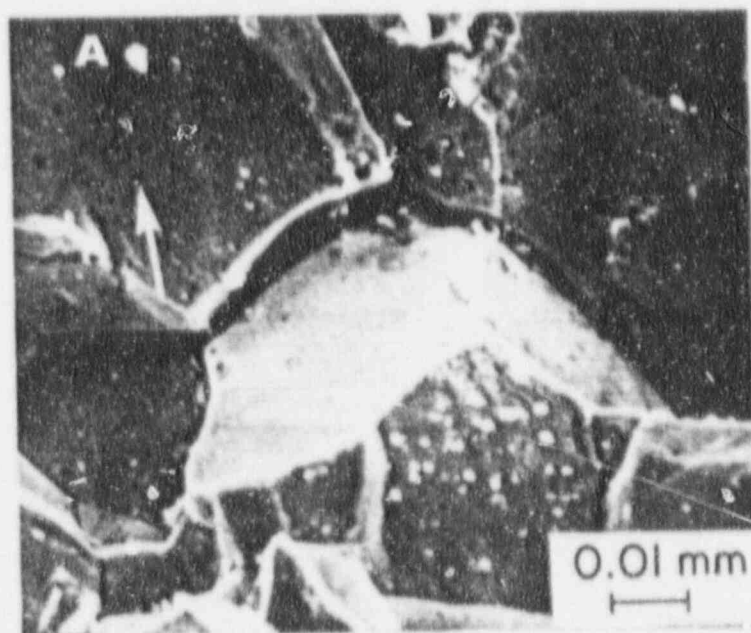
Fig. 20. (a) Crack branching, grain-boundary separation, and precipitates are shown (arrow). (b) Enlargement of (a). Dark circular areas, where precipitates have been (arrow), are seen. X-ray fluorescence was performed on precipitates bright area labelled A and the bulk grains.

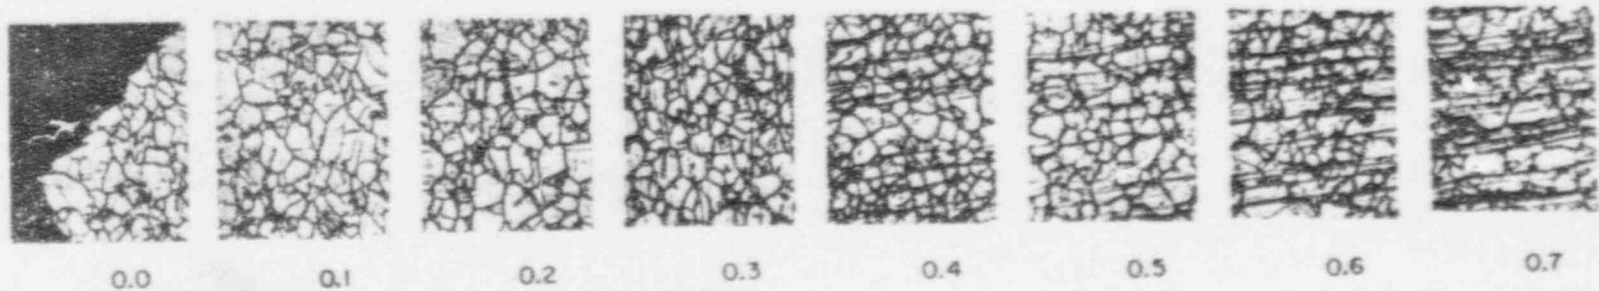
The influence of sensitization on crack initiation and propagation is not firmly established. A sensitization test showed that the major crack was not in an area of maximum sensitization; this crack was 0.32 in. from the weld, and the maximum sensitization was 0.5 in. from the weld. Transmission-electron-microscope (TEM) examination showed that precipitates are present in the grain boundaries in the vicinity of the major crack. It is not known how these precipitates affect the grain-boundary energy and/or influence crack propagation.

Fig. 27. Sensitization test of an area that includes the HAZ. The samples were immersed in oxalic acid for a given length of time so that grain-boundary etching could occur. The weld fusion line is shown in (a), and each succeeding photograph [(b)-(h)] is of an area 0.1-in. farther from the weld. The heaviest sensitization is seen at a distance of 0.4-0.5 in. from the weld. The horizontal lines are drawing lines produced during pipe fabrication.

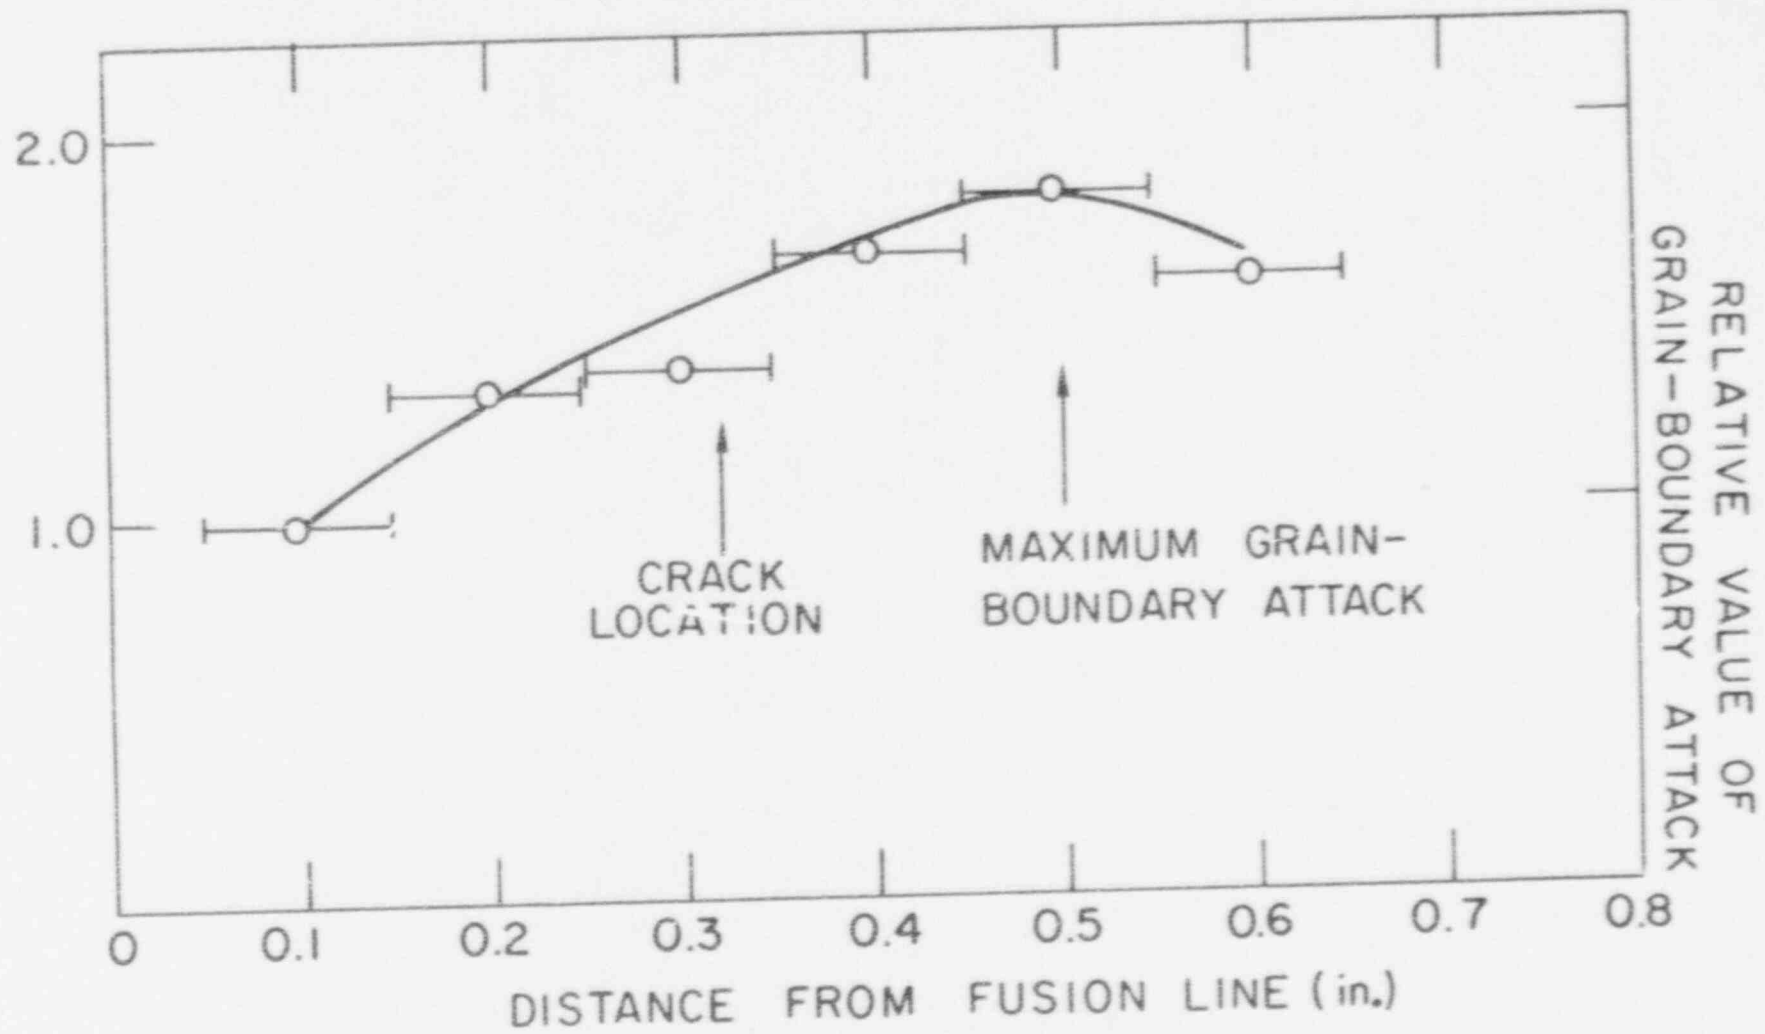
Fig. 28. Relative sensitization vs distance from the fusion line. Sensitization is obtained by using the QUANTIMET scheme of measuring the relative area (dark area/light area) of etched grain boundary from Fig. 27. The maximum in sensitization occurs at 0.5 in., whereas the crack occurs 0.3 in. from the weld fusion line.

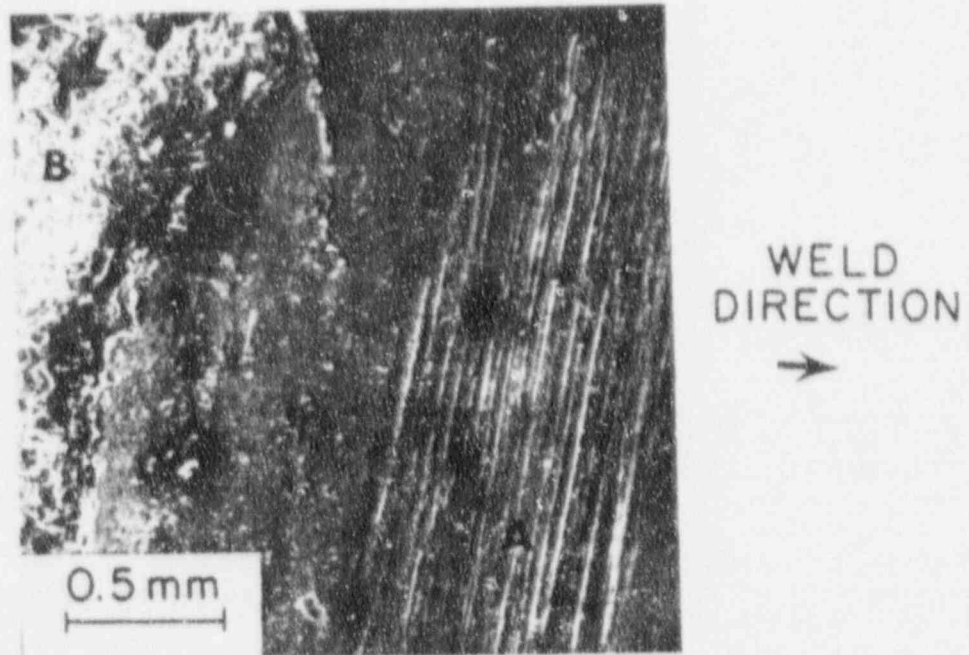
Fig. 31. The ID surface of RBBJ-10. The machining marks (A) and fracture surface (B) are seen. The crack probably originated in a region where machine marks exist; however, the crack edge (arrow) in this figure is outside the machined region.

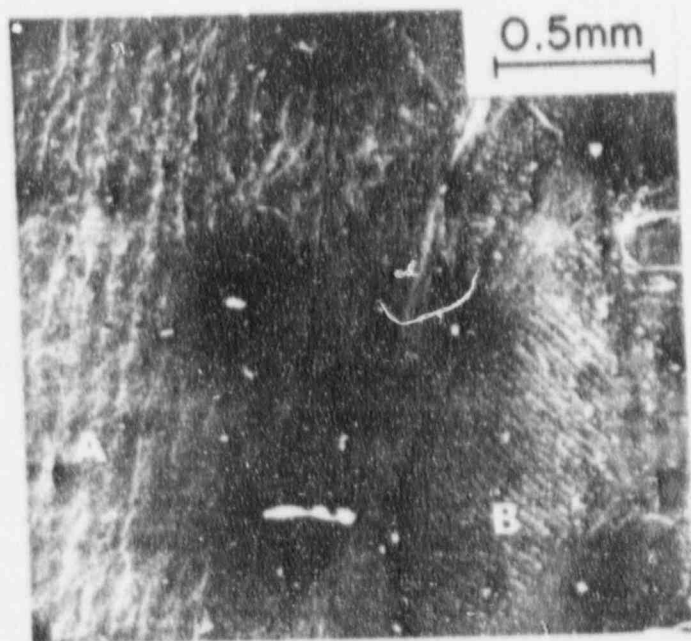
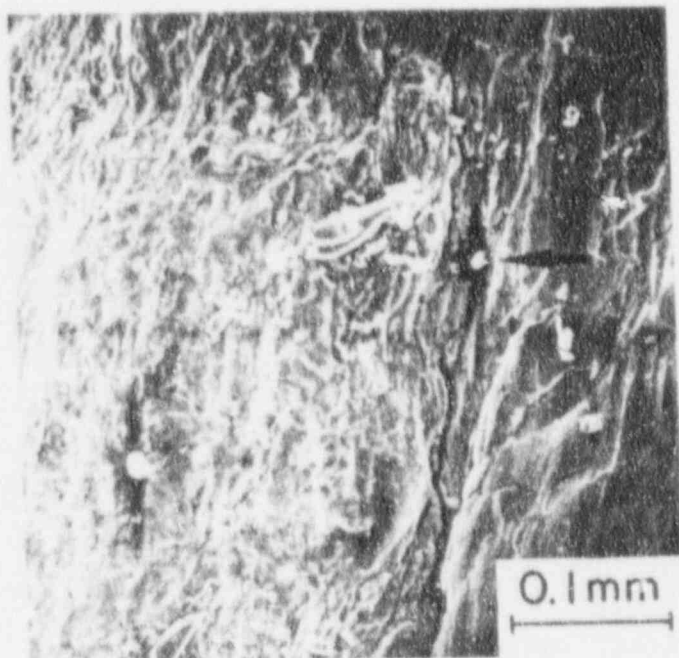
Fig. 32. (a) The machining marks (A) and defect at the weld root are shown (arrow). The weld is at the right. Solidification marks (B) are also shown. (b) The defect at the weld root is shown magnified. The weld is at the right side of the figure. Precipitates at the grain boundaries are shown (arrow). The defect follows the weld root and is both transgranular and intergranular.
