## PHILADELPHIA ELECTRIC COMPANY

SUBJECT: Licensee Event Report  
Limerick Generating Station - Unit 1

Reference: Docket No. 50-352  
 Report Number: 1-91-009  
 Revision Number: 00  
 Event Date: April 12, 1991  
 Report Date: May 13, 1991  
 Facility: Limerick Generating Station  
 P.O. Box A, Sanatoga, PA 19464

TITLE (4) Reactor SCRAM resulting from a Spurious Loss of the DC Electrical Power Supply to the Main Turbine Electrohydraulic Control System.

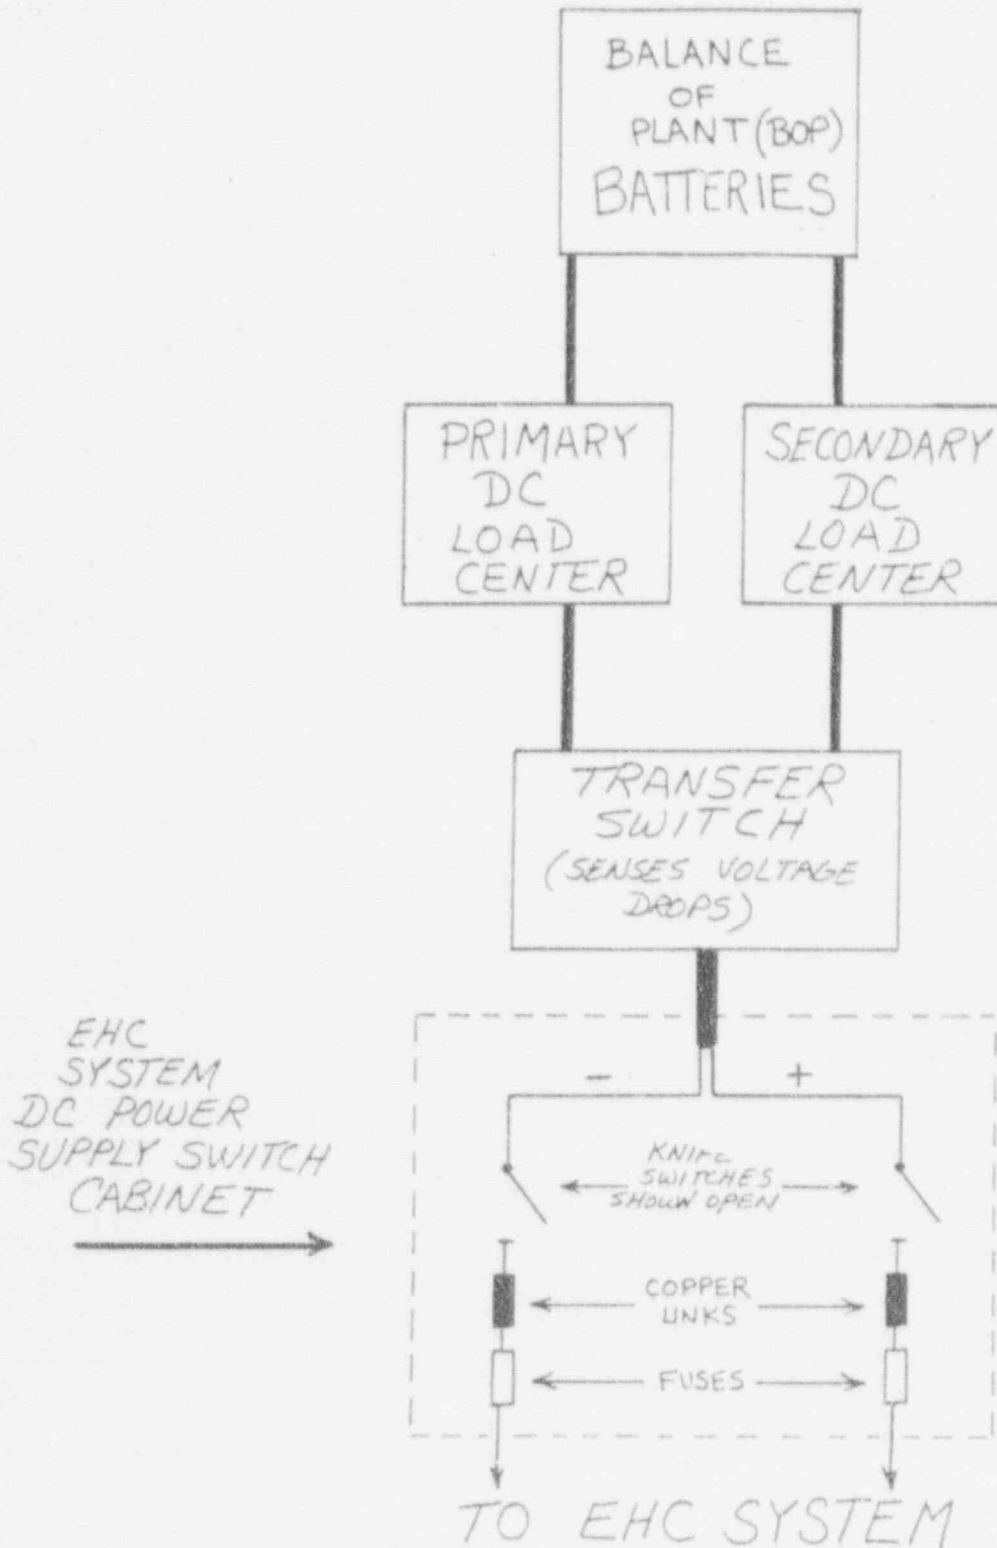
# DIAGRAM 1

The cause of the loss of the 125 volt DC electrical power supply to the EHC system, which initiated the Main Turbine trip, was due to a loosely fitting copper link found in the General Electric (GE) Company supplied DC power supply cabinet (See Diagram 1). The copper links were installed during original construction of the Unit 1 EHC system. The EHC system 125 volt DC electrical power supply lines have the capability to be double fused. There was no need or requirement to double fuse these DC power lines, and hence, copper links were installed in place of the secondary fuses. Troubleshooting by the EHC System Engineer (SE) following the Unit 1 SCRAM actuation revealed that one of the copper links was loose, and showed signs of pitting, which is indicative of arcing in the circuit. Additionally, loss of the DC power supply to the EHC system through this loose copper link was repeatable during troubleshooting activities when vibration was initiated in the area of the switch cabinet. Loss of 125 volt DC power to the EHC system will initiate a Main Turbine trip signal if the undervoltage condition is present for 0.2 seconds or longer per design. During troubleshooting, the EHC SE determined that the actual undervoltage condition existed for 0.5 seconds. Therefore, the Main Turbine trip initiated as designed on the loss of 125 volt DC power to the EHC system. This event is the first occurrence of a loose copper link or fuse and it has been concluded to be an isolated occurrence.

1. The four (4) copper links installed in the 125 volt DC electrical power supply switch cabinets for the Unit 1 and Unit 2 EHC systems were removed and replaced by lugged hardwire connectors to ensure reliability of both EHC systems.

2. An evaluation of known copper links installed in similar electrical switch cabinets for other Unit 1 and Unit 2 systems as listed in the Limerick Generating Station (LGS) fuse index will be performed. This evaluation is expected to be completed by December 1, 1991, and appropriate actions will be implemented as necessary.
