PHILADELPHIA ELECTRIC COMPANY

SUBJECT: Licensee Event Report
Peach Bottom Atomic Power Station - Units 2 and 3

This LER concerns Primary Containment Isolation System isolation due to a failure of the No. 2 Startup Emergency Feed cable and a Unit 2 & 3 shutdown for cable replacement.

TITLE (4): Primary Containment Isolation System Isolation Due to a Failure of the No. 2 Startup Emergency Feed Cable and a Unit 2 and 3 Shutdown for Cable Replacement

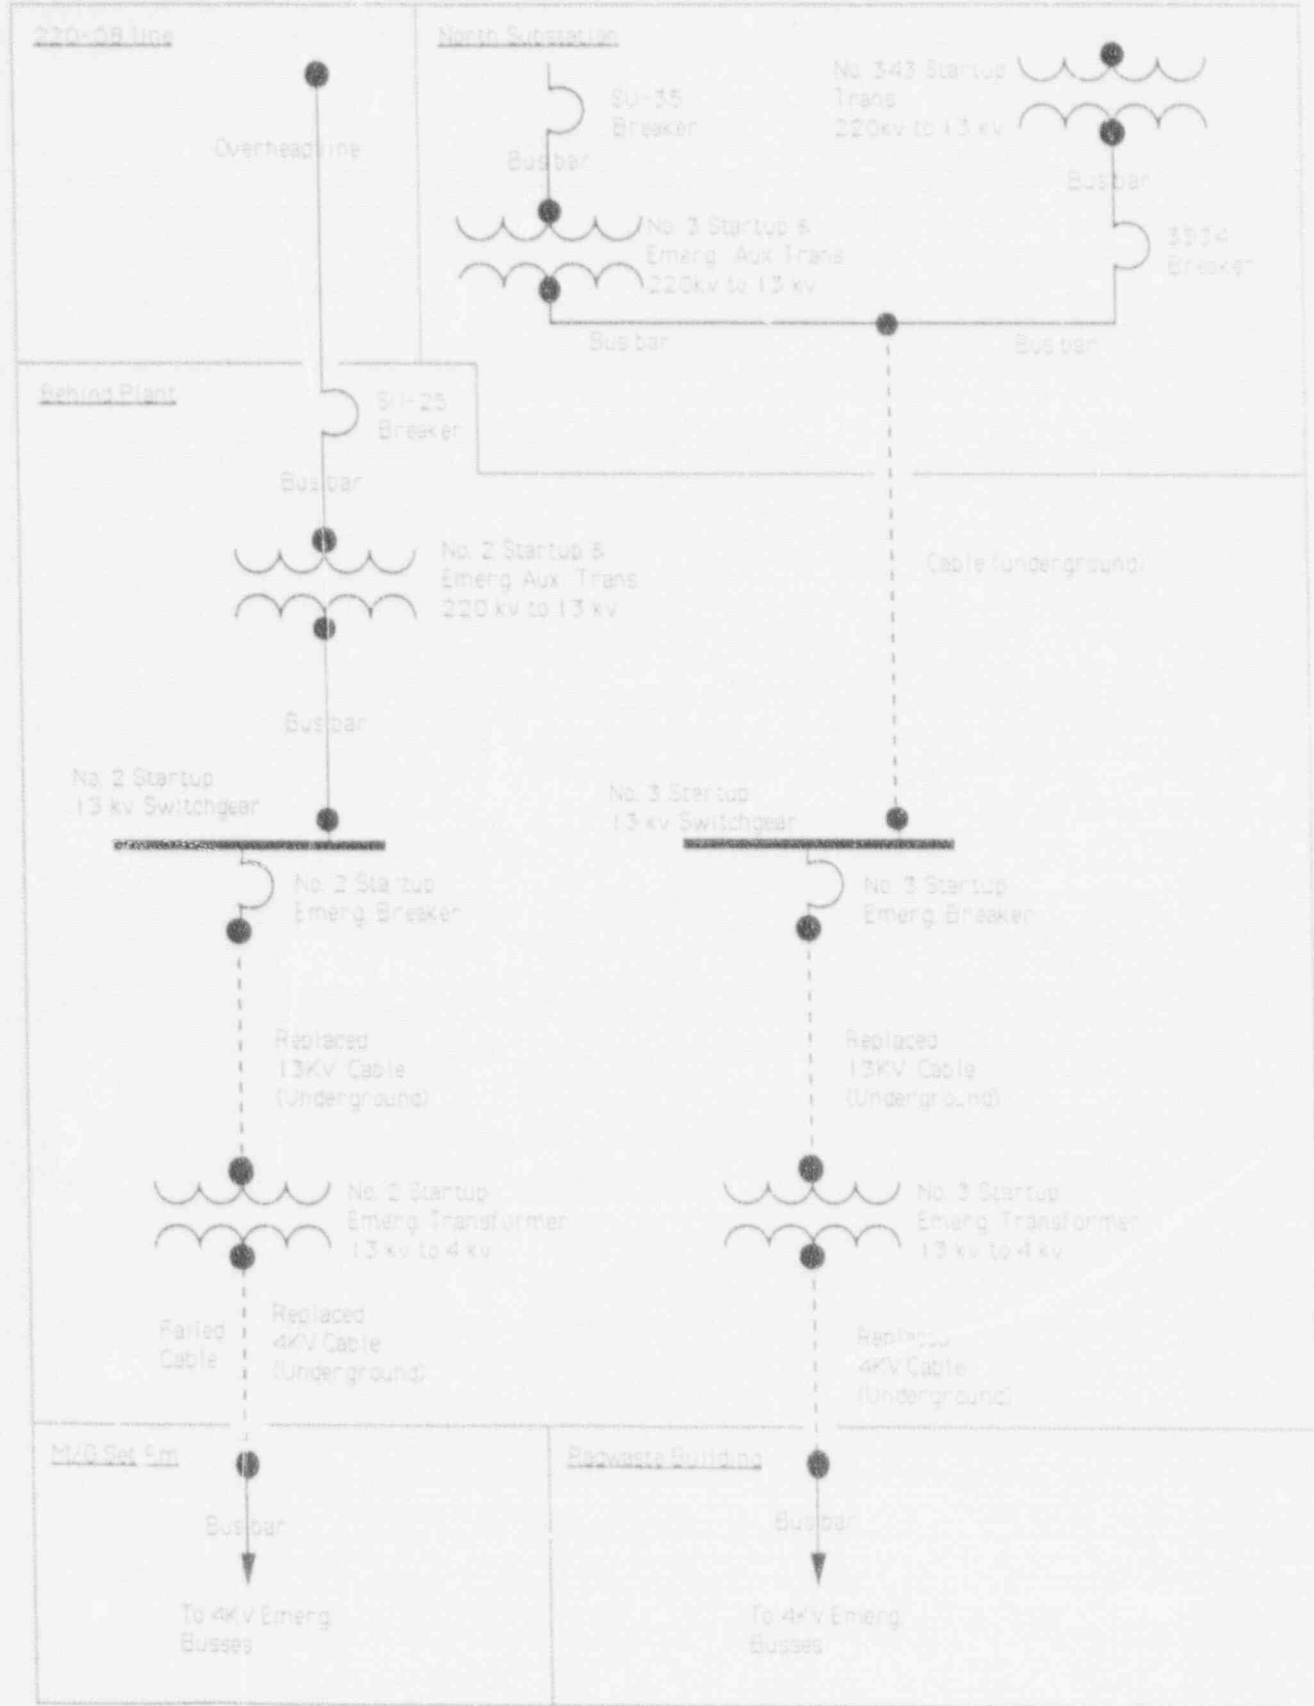
No. 2 Startup Emergency Feed cables (See Attached Drawing) were inspected which identified that one of the twenty-seven cables on the secondary side of the No. 2 Startup Emergency Transformer was damaged and one cable had indication of degradation. The decision was made to repair the one damaged cable with a splice and abandon the degraded cable in place as an interim repair. It was planned to pull new cables at the first opportunity. The repaired cable was tested satisfactorily and the Unit 2 Emergency Startup Feed was returned to service at 0250 hours on 4/26/91.

The No. 2 4KV cables were inspected and accelerated insulation degradation was identified which is known as "Treeing". "Treeing" results when normally occurring voids and impurities from the manufacturing process degrades the cable insulation when energized at low current conditions and exposed to a damp environment.

The event was initiated when the No. 2 Startup Emergency Feed cable failure caused the opening of the No. 2 Startup Emergency Breaker. The accelerated insulation degradation identified is known as "Treeing". "Treeing" results when normally occurring voids and impurities from the manufacturing process degrades the cable insulation when energized at low current conditions and exposed to a damp environment.

System isolations were reset on both units immediately following the event. The 13 KV and 4 KV cables on both sources from the Startup Emergency Breaker down to the 4 KV Emergency Busses have been replaced with a new type cable. The manufacturing process and the cable additives have been improved which significantly reduces the new cables vulnerability to "Treeing". The new cables and connections have been tested as specified by Engineering. The 4 KV Emergency Busses have been returned to their normal Startup Emergency Feeds.
