LIMERICK GENERATING STATION

SUBJECT: Licensee Event Report  
Limerick Generating Station - Units 1 and 2

LICENSEE EVENT REPORT (LER)

TITLE (4) This LER reports the inadvertant isolation of the Refuel Floor Secondary Containment & initiation of the 'B' Standby Gas Treatment system due to a suspected tubing or valve leak.

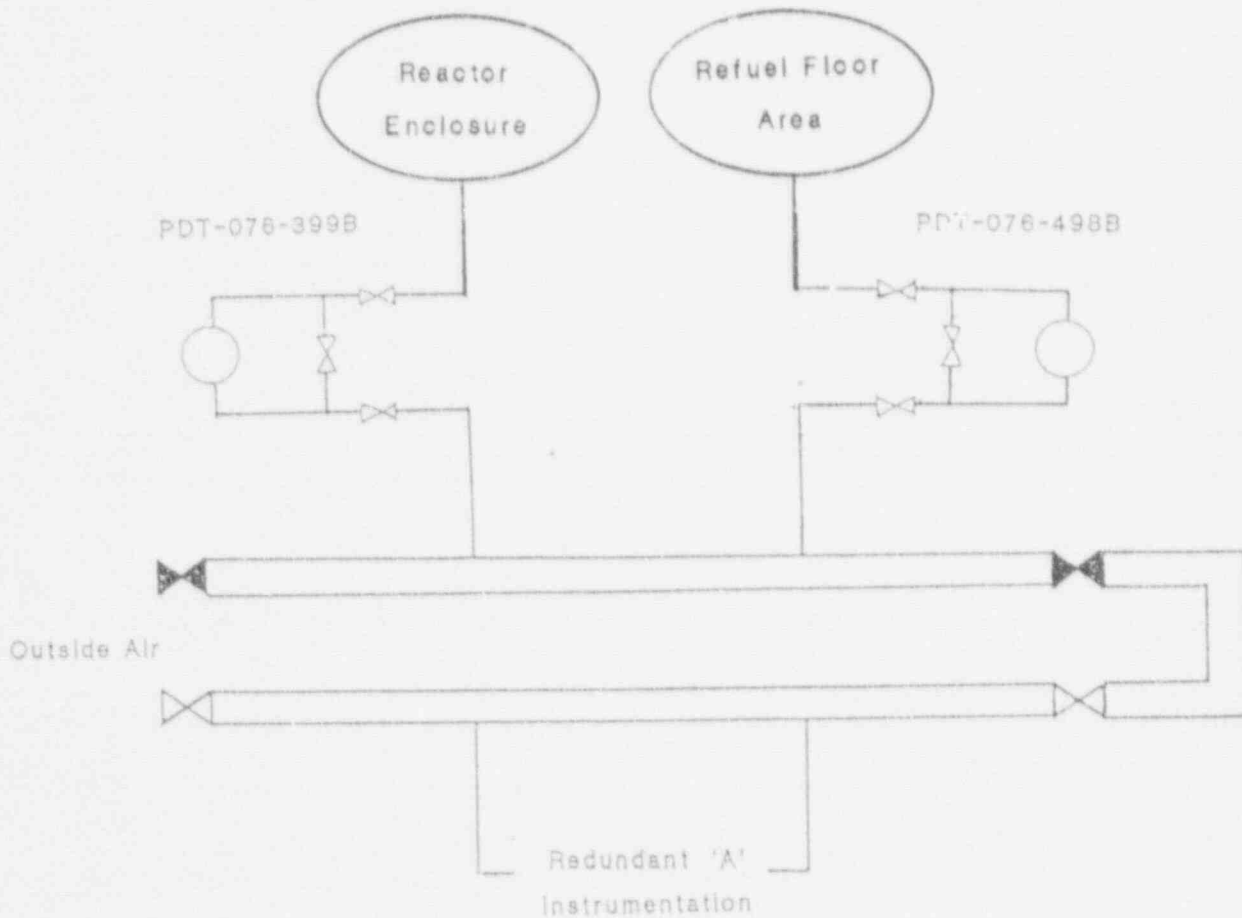
Figure 1

The cause of this event was the generation of a false low negative differential pressure signal as a result of a suspected small leak in the isolated outside air sensing line, or the manifold equalizing valve for PDT-076-399B allowing indicated negative differential pressure to approach zero.

Since the 'B' outside air sensing line header was isolated in accordance with ST-2-076-401-1 (see Figure 1), a small leak in the instrument tube fittings could, over time, allow the 'B' outside air sensing line header pressure to vent and equalize such that the differential pressure across the transmitter approached zero. This is due to PDT-076-399B being physically located in the Unit 1 Reactor Enclosure. Therefore, the negative differential pressure decayed and reached -0.1 inches wg causing the 'B' isolation signal to be generated. The same scenario would occur if the manifold equalizing valve for PDT-076-399B had a small leak.

As a result of plant conditions, a leak check of tubing and valves could not be initially performed by I&C personnel. However, on May 16, 1991, I&C personnel were able to perform a leak check of tubing and valves and then performed procedure ST-2-076-401-1 while observing the output of PDT-076-399B for a slowly degrading differential pressure condition. No leaks were identified and the pressure transient could not be reproduced. Further investigation is required to confirm the cause of this event and to identify and repair any leaking fittings. Upon completion of this investigation a supplement will be provided to clearly define causes and present any additional corrective actions as necessary.
