PLANT HATCH - UNIT 2
NRC DOCKET 50-366
OPERATING LICENSE NPF-5
IGSCC FLAW EVALUATIONS AND WELD OVERLAY DESIGN
UNIT 2 SPRING 1991 MAINTENANCE/REFUELING OUTAGE

PLANT HATCH - UNIT 2
NRC DCKET 50-366
OPERATING LICENSE NPF-5

FEEDWATER WELD FLAW EVALUATION AND REPAIR

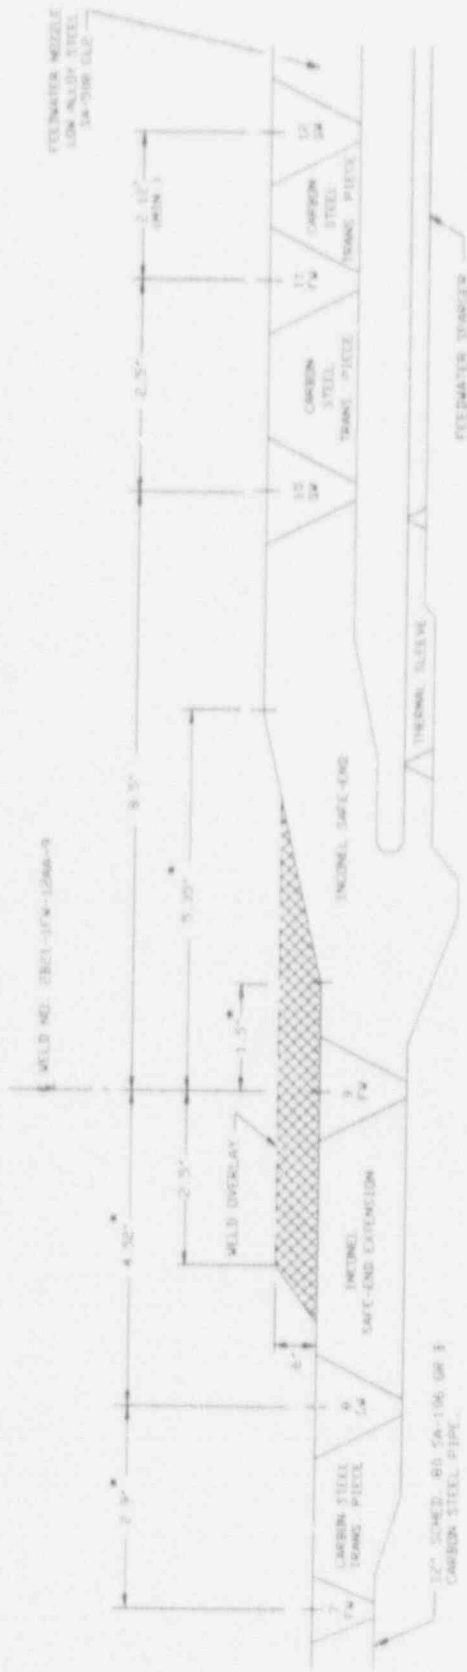
FIGURE 1

Of the twelve welds examined, feedwater weld 2B21-1FW-12AA-9 (see Figure 1) was determined to have reportable and unacceptable indications. The subject weld material is Inconel 182 and joins an Inconel 600 safe-end extension to an Inconel 600 safe-end. This weldment contains three identified flaws that are axially oriented.

These indications originate near or in the root of the weld and terminate in the weld material on the safe-end extension side. Quantification as to whether the crack originated in the base material near the root of the weld or in the root of the weld is not readily obtainable, since the precise location of the root is ultrasonically indeterminate in the area of the indications.

Using a combination of EPRI NDE Center qualified sizing techniques, the indications were evaluated and sized. The indications are all contained in approximately 2 inches of the circumference (25" to 27" CW from TDC) and have a thru-wall dimension of approximately 50% to 75%, with a length of less than 0.5".

These flaws did not present a significant structural concern, even if through the original component wall, since they are axially oriented. However, repair was considered to be necessary based upon ASME Section XI and guidance in NUREG-0313, Revision 2. NUREG-0313 Paragraph 4.4.2 notes that a component with axial flaws will generally benefit from weld overlay. Further, because of the observed depth of the flaws (75% max), GPC elected to make a standard weld overlay repair.

Figure 2 of the SIA report (Enclosure 2) represents the repair design utilized for this location. The design basis for this design is the NUREG-0313 Rev. 2 "Standard Weld Overlay" which is based upon an assumed 360 degree "thru-wall" circumferential flaw. This assumption is very conservative for the observed flaws.
