Report No.: SIR-91-028
Revision No. 0
Project No. GPCO-19Q
May, 1991

EVALUATION AND REPAIR OF
FLAW INDICATIONS IN THE FEEDWATER
"A" SAFE-END TO EXTENSION WELD
AT HATCH UNIT 2

Georgia Power Company

Structural Integrity Associates, Inc.

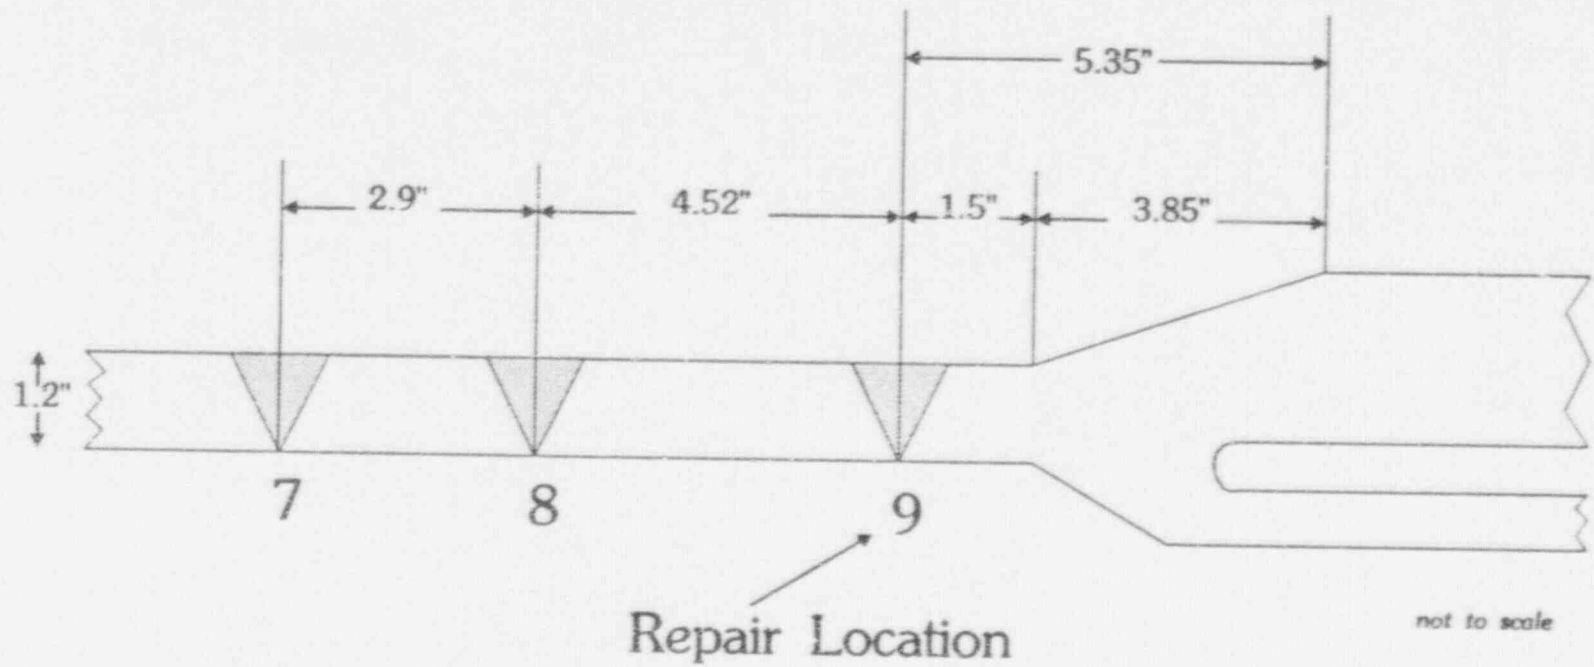
Figure 1. Geometry of Repair Location

Weld 2B21-1FW-12AA-9 contains three identified flaws which are axially oriented and essentially confined to the Inconel 182 weld material [3]. The flaws are all contained in approximately 2 inches of circumference. The girth weld material is Inconel 182 weld metal, and the base material on either side of the weld is Inconel 600.

The identified flaws are located in the safe-end to extension piece weld (weld 9 in Figure 1). This weld is remote from the feedwater nozzle, and joins two Inconel 600 components. The weld itself was fabricated with Inconel 182 material. No low alloy steel is affected by the repair. Figure 1 illustrates the geometry of the location.

The repair is not located in the region of the thermal sleeve annulus, but in the pipe safe-end region where the inside surface is in contact with normal feedwater flow.

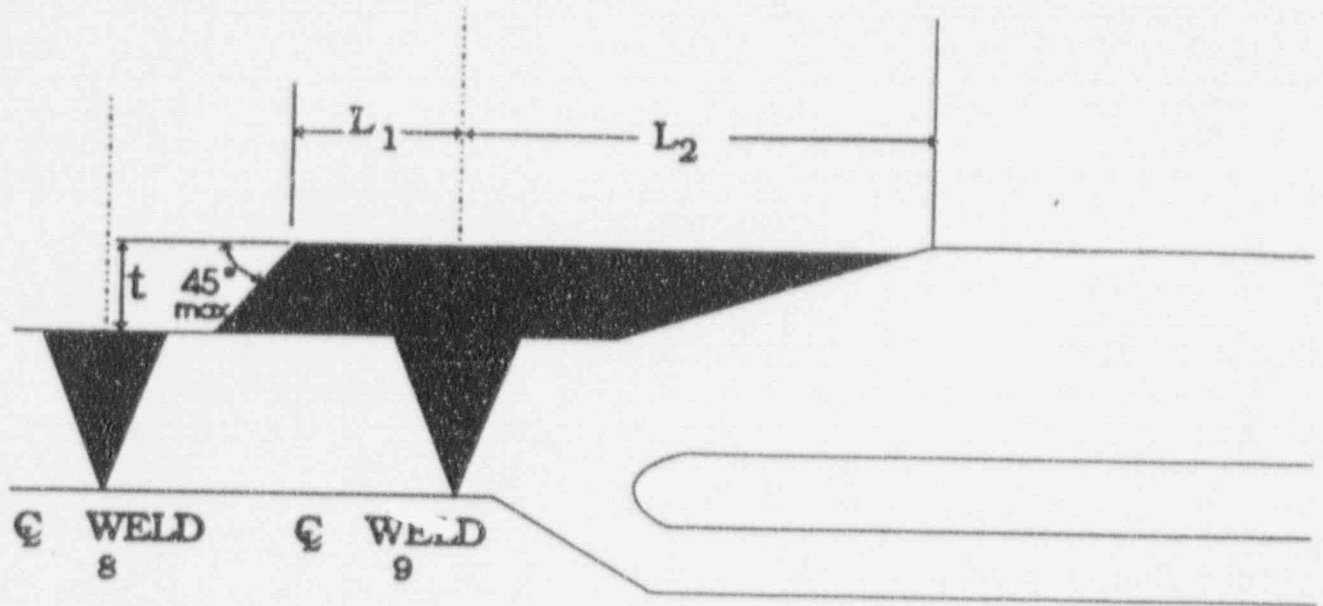
Figure 2 Weld Overlay Repair Design

The design basis for this repair is the NUREG-0313, Revision 2 "Standard Weld Overlay" which is based upon an assumed 360° through-wall circumferential flaw [1]. This assumption is very conservative for the observed flaws. The weld overlay repair design is presented in Figure 2.

The design thickness for the weld overlay repair is 0.4 inches for structural adequacy. This thickness is adequate to provide a standard weld overlay repair for a 360° through-wall circumferentially oriented flaw. In addition, allowance was included to account for the worst case assumption of continued flaw growth into the repair. The allowance was determined by assuming continued growth at the rate defined by:

The design thickness required to meet the Standard Weld Overlay requirements for this location is 0.4 inches. The allowance for continued flaw growth is 0.2 inches. This allowance may be considered to be sacrificial material to guarantee that the structural portion of the repair (0.4 inches) is not degraded in the unlikely event that the observed flaws continue to propagate into the applied weld material.

The overlay length is blended into the safe-end taper on that side of the repair as noted in Figure 2. On the pup piece side, the overlay is designed to extend to a full thickness length of at

Because of the thermal sleeve junction on the inside surface and because of the flaws themselves, the welding was sequenced such that all passes began at the safe-end taper, and proceeded toward the feedwater piping end of the repair (in other words, the welding progressed upstream relative to feedwater flow). This sequence minimized the resulting stresses in the region of the thermal sleeve junction. On the safe-end side of the repair, the weld overlay was blended into the transition region, to minimize stress concentration in the region.

Structural Integrity Associates has reviewed the as-built data [7] for the subject repair, and has determined that the design basis for the repair has been met by the repair. The required structural reinforcement thickness of 0.4 inches is met at all measured locations. The allowance for continued flaw propagation (0.2 inches) is met in the vicinity of the observed flaws in particular, and the average of all thickness measurements exceeds the design thickness of 0.6 inches (which includes both structural material of 0.4 inches and growth allowance of 0.2 inches). Two locations have reported thicknesses of slightly less than the 0.6 inches value (0.57 inches and 0.58 inches), but this is not significant and in no way invalidates the repair. These locations are remote from the observed flaw location.

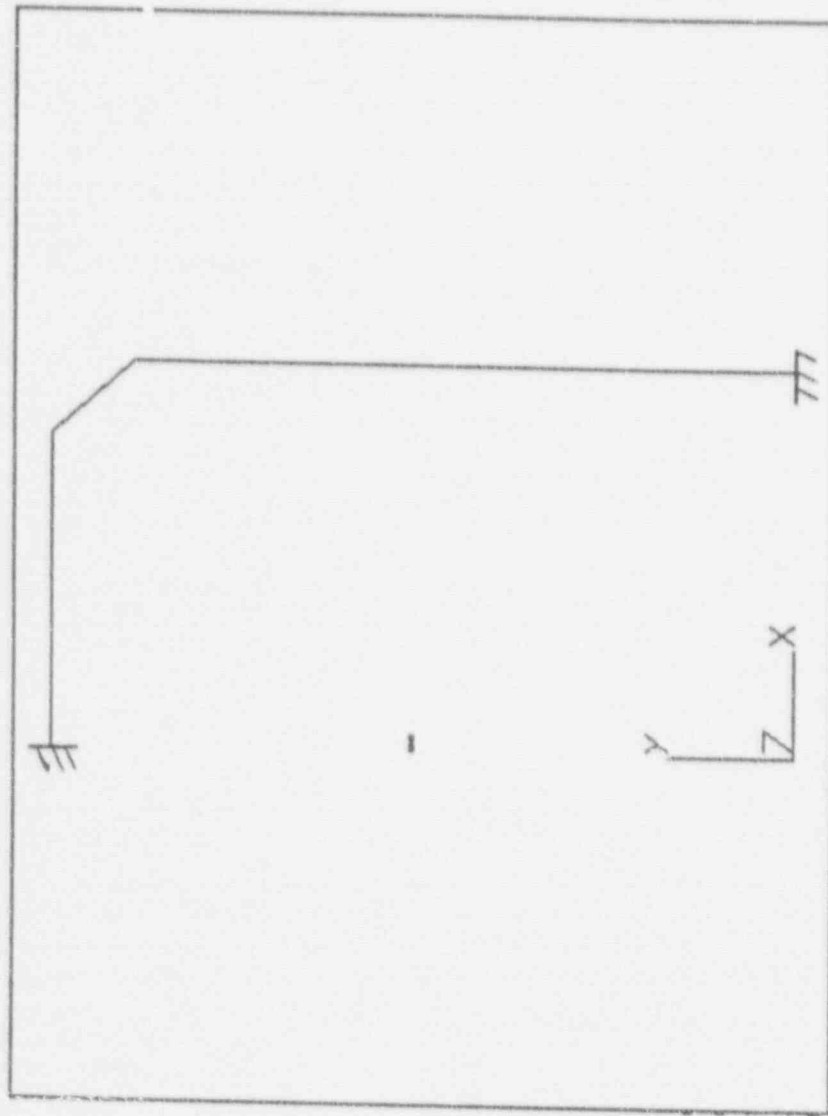
Figure 3. Finite Element Piping Model for Evaluation of Shrinkage Stresses

The reported axial shrinkage due to the repair is an average of 0.078 inches. The only welds potentially affected by this shrinkage are in-line with the repair, so any imposed stress on these welds will be axial rather than bending. (The bending stresses are dominant in the recirculation system repairs.) Most of the minor shrinkage experienced during the feedwater repair will be accommodated by flexure of the relatively flexible feedwater riser piping, so no significant stress is expected in any of the Inconel or Inconel to carbon steel welds adjacent to the repair location.

A simple finite element piping analysis of the feedwater riser and safe-end region was performed to confirm this conclusion. The finite element model is shown in Figure 3. The resulting stresses at each of the Inconel weld joints in this line are shown in Table 2. These stresses are not expected to have a significant effect on these welds.
