BELLEFONTE NUCLEAR PLANT UNITS 1 AND 2 - REVISED RESPONSE TO DEVIATIONS 50-438/83-10-01, 50-439/10-01, PORTIONS OF THE FIRE PROTECTION SYSTEMS DO NOT CONFORM TO THE DESIGN CRITERIA OF THE APPLICABLE NFPA CODE - 50-438/83-10-03, 50-439/10-03, EXTERIOR FIRE PROTECTION WATER SYSTEM WAS NOT INSTALLED UNDER A QA/QC PROGRAM - 50-438/83-10-05, 50-439/83-10-05, IMPROPER FIRE DAMPER INSTALLATION

BELLEFONTE NUCLEAR PLANTS UNITS 1 AND 2  
REVISED RESPONSE TO DEVIATION 50-438/83-10-01, 50-439/83-10-01  
PORTIONS OF THE FIRE PROTECTION SYSTEMS DO NOT CONFORM TO  
THE DESIGN CRITERIA OF THE APPLICABLE NFPA CODE

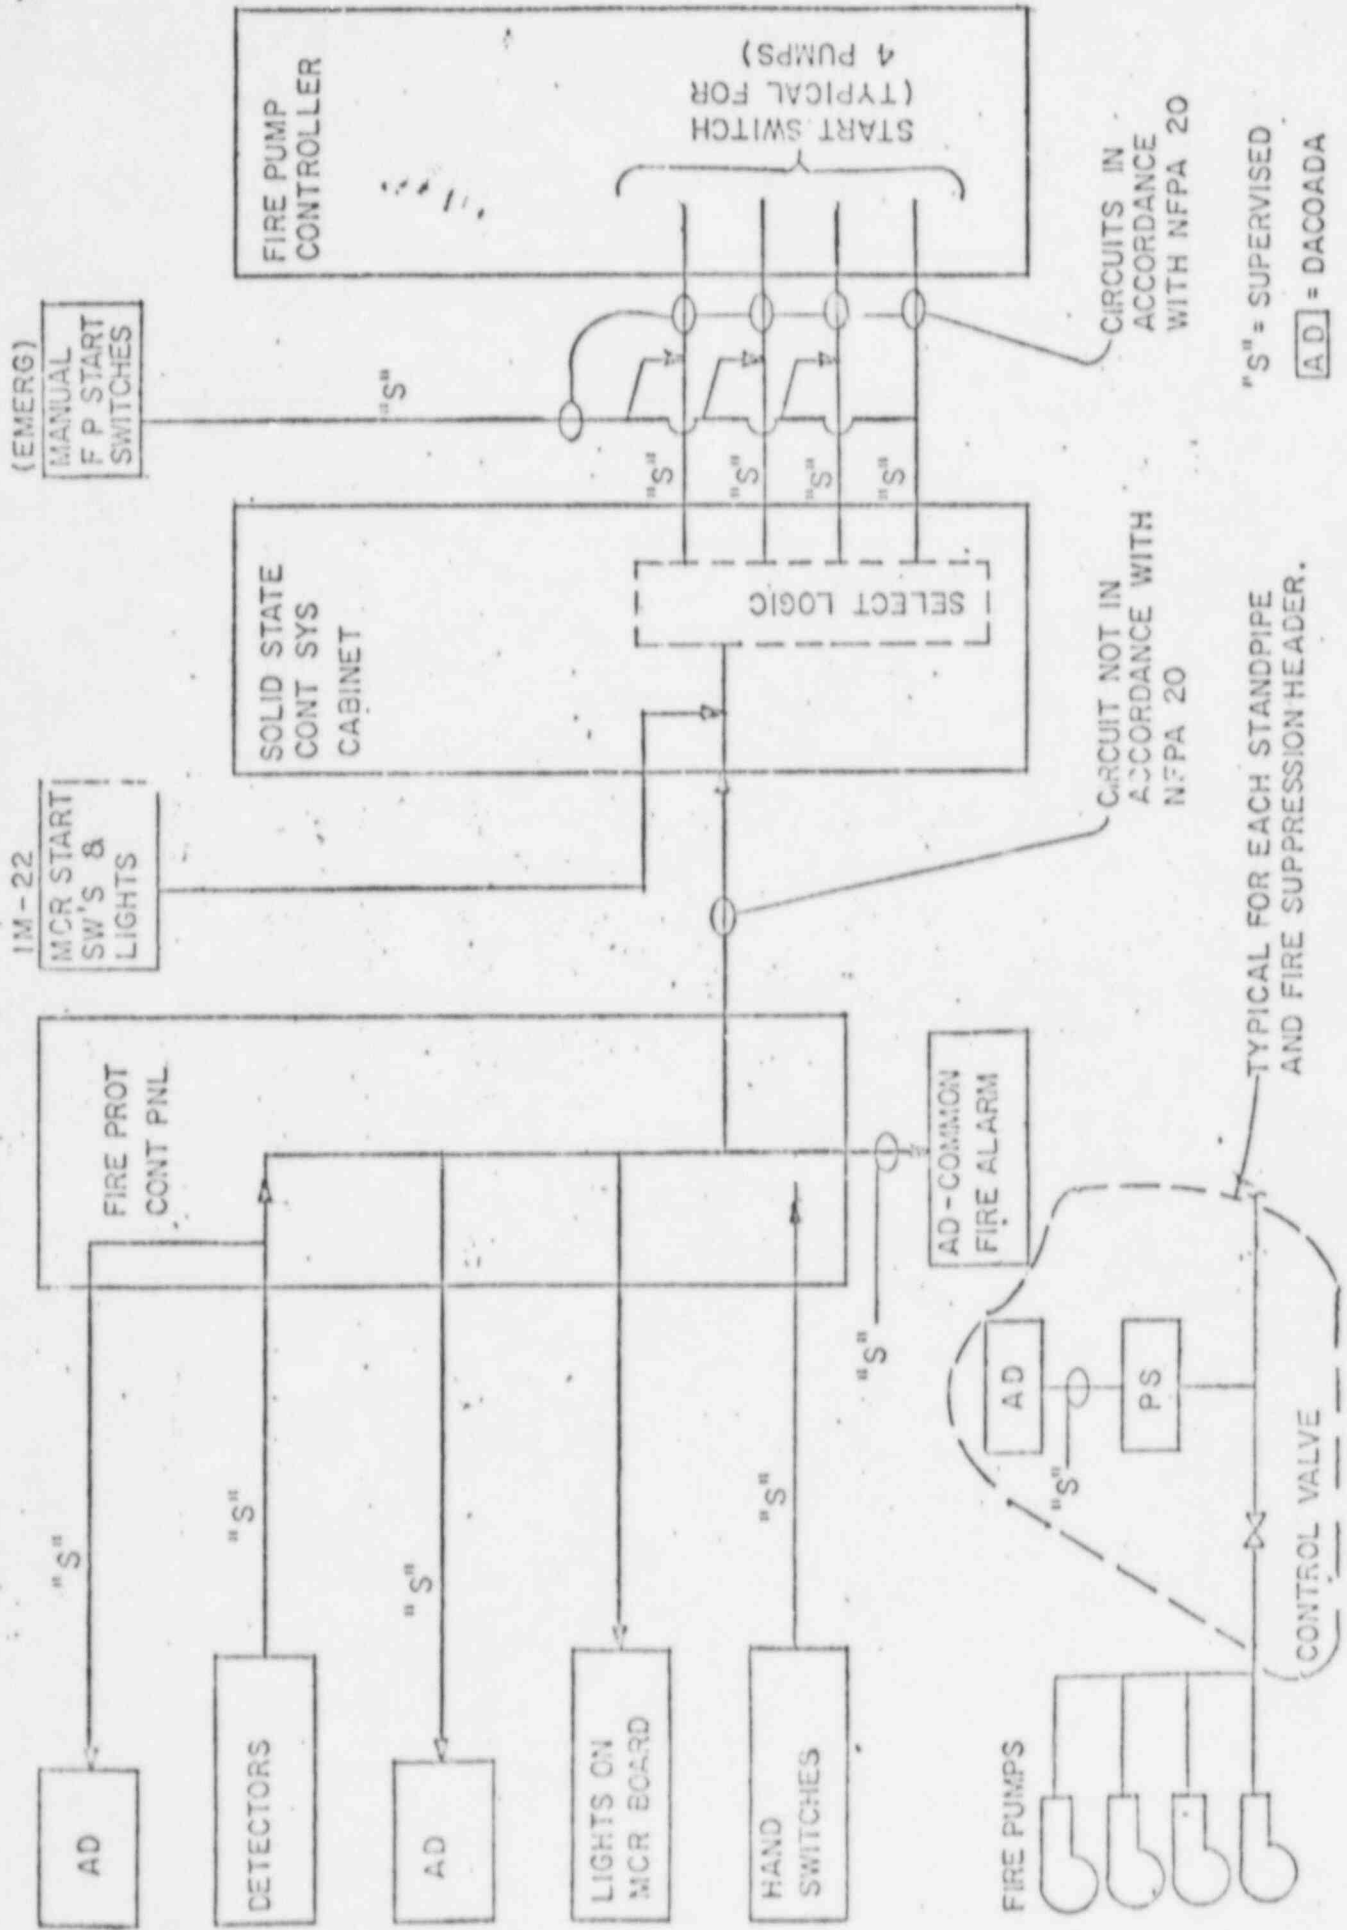
FIGURE 1

The following Fire Pump Start Block Diagram (Figure 1) with accompanying explanatory notes illustrates the fire pump start circuitry inputs.

1. In event of either a detector actuation or manual fire pump start initiation, there is an alarm on DACOADA (supervised) for the individual condition and a common alarm (supervised).

2. There is a pressure-switch indication downstream of each valve (supervised) which can be compared with the alarm in item 1 to ensure pumps have started and valve has opened. (Exceptions are standpipes which do not have valves).

3. If pumps start, there will be indication on main control room board (MCR) IM-22. If not started, operator can attempt to start them from: (1) MCR (nonsupervised circuit), (2) manual fire pump start switch downstream of solid state control system (SSCS) (supervised), or (3) at the fire pump controller.

4. In summary, there are supervised circuits to alarm the operator that the pumps should be started and status (most of which is supervised) to show that they have started. If they did not start, there is both nonsupervised start circuits in MCR and supervised start circuits at the SSCS cabinet.

5. There are 20,000-gallon tanks on top of the turbine building which would gravity-feed most areas which would automatically fill from the four electric pumps.
