SUSQUEHANNA UNIT 1 REACTOR MODE SWITCH FUNCTIONAL TESTING AND WEAR CHARACTERISTICS EVALUATION

FIRL Final Report
F-A5898

Pennsylvania Power and Light Company
2 North Ninth Street
Allentown, Pennsylvania 18101

February 10, 1984

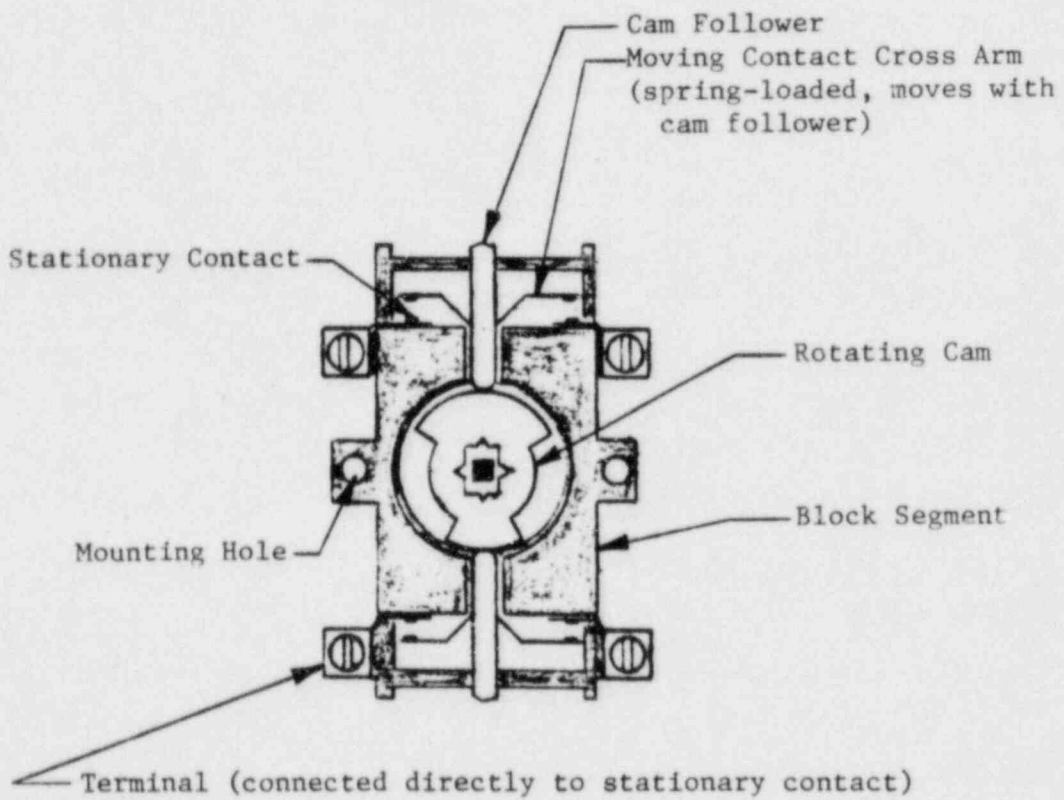
Figure 2. Contact Block (shown with contact cover removed and all contacts open)

not firmly fixed in place and were free to move approximately 1/16 in with respect to the moving contacts [see Figure 2]. The stationary contact is directly coupled to the wiring terminal. Therefore, depending on the position of the lead wires, the stationary contact could be pushed toward or away from the moving contact with the switch open. In the closed position, the play in the stationary contact was always overcome by the moving contact, assuring closure of the contacts.) Both Gould and GE stated that they believed the switch mounting used by FIRL to be the cause of the extraneous contact closures. For this and all previous tests, the switch had been firmly held in a horizontal position on a laboratory table. The manufacturer and supplier insisted that Specimen No. 5898-003 be tested in a manner which simulates the actual in-service condition (i.e., mounted in a panel angled at 42 degrees with an isolation can and wiring harness installed). PP&L agreed to this test change, and FIRL constructed the mounting fixture. (It should be noted that FIRL at no time considered the misoperation of the switch to be attributable to the test method.) Prior to testing FIRL Specimen No. 5898-003 in the test fixture, the switch was again modified by Gould/GE. An improved torsion bar assembly was installed and an "e"-ring was removed after PP&L approval was obtained for the modification. The new torsion bar had smaller tolerances with respect to the detent mechanism aperture and removed much of the play in the switch. The "e"-ring is a clip that was used to hold the torsion bar in the lock assembly. When the torsion bar was changed from a short stub that only connected to the beginning of the plastic cam shaft to a shaft that extended the entire length of the switch, the "e"-ring became unnecessary. After modifying the switch, functional testing was performed with the switch mounted in the test fixture. During this procedure, it was found that the isolation can, which GE brought for the test, did not fit because a lateral support member was located incorrectly and there were no countersunk holes in the front of the isolation can. PP&L, GE, and Gould agreed to test the switch without the isolation can. All wiring was approved by PP&L and GE prior to commencing the functional test. During this functional test, Switch No. 5898-003 again failed to meet the acceptance criteria when the switch was in position 3. Again, contacts (15, 16) and (7, 8) closed in position 3. An

At the time of the above functional tests, the following modifications were proposed by Gould and GE to resolve the anomalies: fixing the external contacts with epoxy, milling the cam surfaces (more accurate than punching), shortening the switch by removal of blank contact blocks, and epoxying the cams to the shaft. When the replacement mode switch was received (FIRL Specimen No. 5898-004), Gould stated that only the first two proposed solutions had been implemented. In addition, the switch was already wired and installed in an isolation can when it arrived at FIRL. The wiring included stress reliefs that fixed the wires to the inside of the isolation can. Complete functional and mechanical cycling tests were performed on Specimen No. 5898-004.

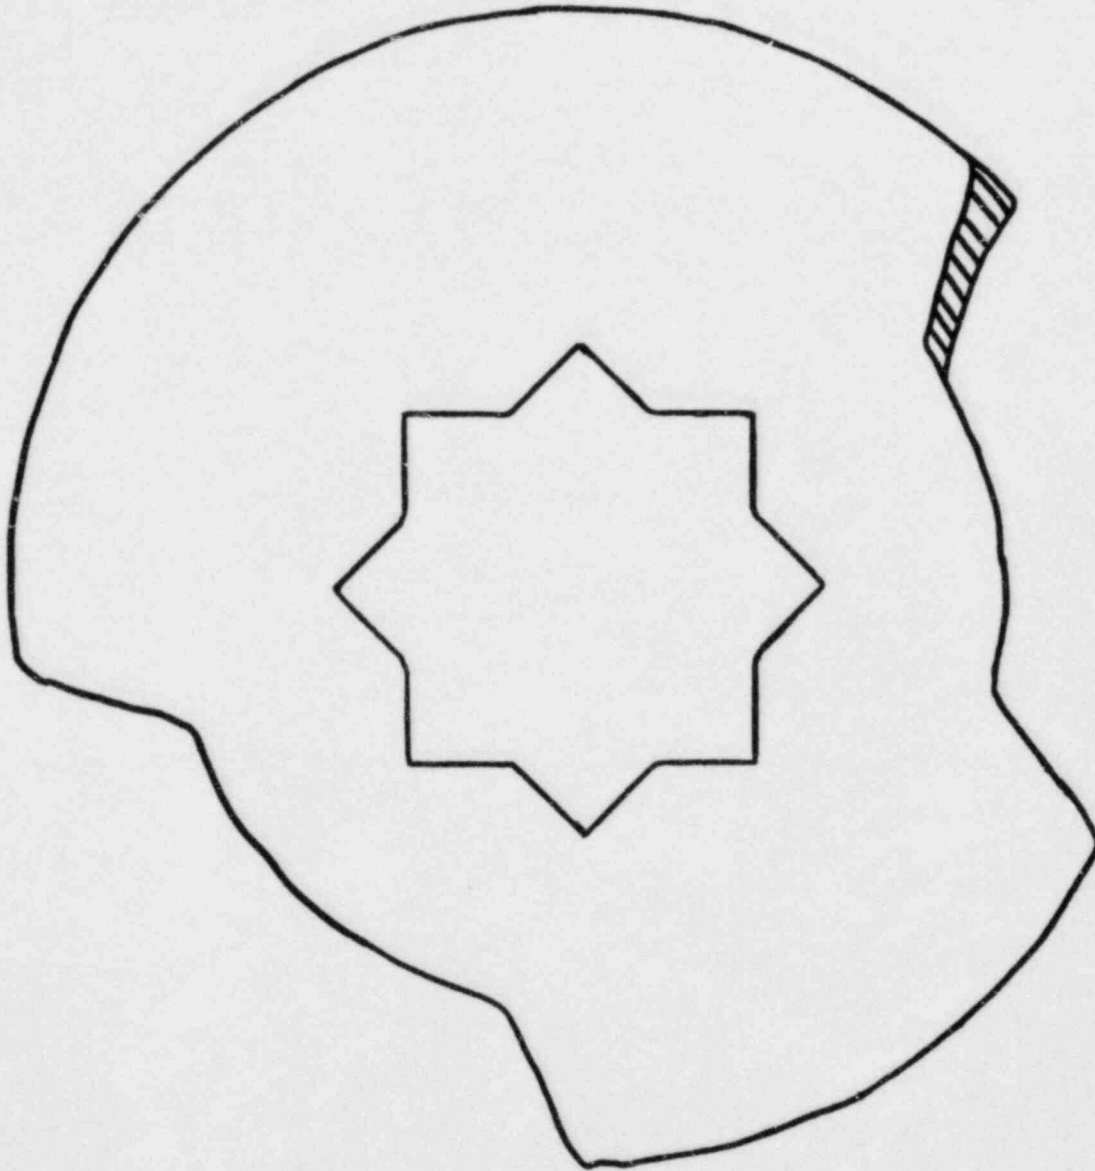
Figure 5. Comparison of Red Cam [(29, 30), (31, 32)] and Spare Red Cam

at disassembly. The used green cams were very close in size and shape to the spare green cam as viewed with the optical comparator. However, the spare red cam was different from the red cams used in the switch. As illustrated in the optical comparator tracing (Figure 5), three of the four slopes match well. The fourth slope on the used red cam is steeper and its corresponding upper dwell is longer than the spare red cam. Some minor wear was evident on cycled switch cams. The wear occurred on the high spots of the rough slope surfaces and on the cam edges.
