U.S. NUCLEAR REGULATORY COMMISSION
OFFICE OF INSPECTION AND ENFORCEMENT

IE Bulletin No. 78-05

MALFUNCTIONING OF CIRCUIT BREAKER AUXILIARY CONTACT MECHANISM -
GENERAL ELECTRIC MODEL CR105X

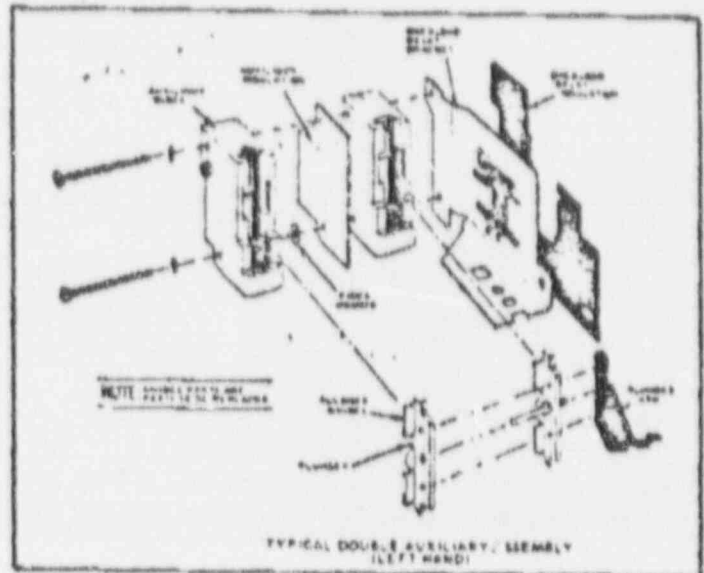
FIGURE 2

The Sacramento Municipal Utility District recently reported a problem encountered with the operation of the GE Model CR105X auxiliary contact mechanism installed in a 480 volt circuit breaker. Investigation into the cause for the inability to shutdown a booster supply fan (SF-A-7) in the control room emergency air conditioning system revealed that an auxiliary contact (GE Model CR105X) had failed in the closed position, preventing the fan's power supply circuit breaker from opening. The specific cause for failure was binding of the plunger arm due to burrs and nicks on its surface.

CHANGING PLUNGER ARM & INSULATION (SEE FIG. 2)

1. Slide plunger assembly out of auxiliary contact block, by lifting up and out.
2. Select the new plunger arm that is bent the same way as the one installed.

3. Loosen screw on plunger to release metal arm but (DO NOT REMOVE SCREW FROM PHENOLIC PLUNGER (OR PLUNGERS)).
4. Mount new plunger arm on plunger. Fasten arm to plunger with screw (or plunger post if installing double aux. blocks).

5. Apply thin coat of aeroshell grease along plunger guides.
6. Reinstall plunger assembly in contact block.
7. Reassemble overload to mounting bracket. Remove overload insulation and install new. (NOTE: Overload insulation must be removed and replaced with new insulation supplied with kit.)

8. Remount complete assembly on contactor base.
9. Reconnect any wires previously removed.
10. Reassemble magnet assembly to contact base (on reversers or multispeeds be sure to interlock this assembly with mechanical interlock arm. Check for free movement of armature assemblies and mechanical interlocks).

11. Observe that auxiliary contact plunger assemblies are operating properly.
