MIDLAND PROJECT
QUALITY ASSURANCE
DEPARTMENT

NONCONFORMANCE REPORT

16 NCR NO.	C-02299-V	
17 DATE ISSUED	4-3-84	18 REV 0
19	PAGE 1 OF 12 ^{HAS} 40954 _{20 SUTS-184}

5 ITEM DESCRIPTION
CONCRETE PLACEMENT SWI (609) a'

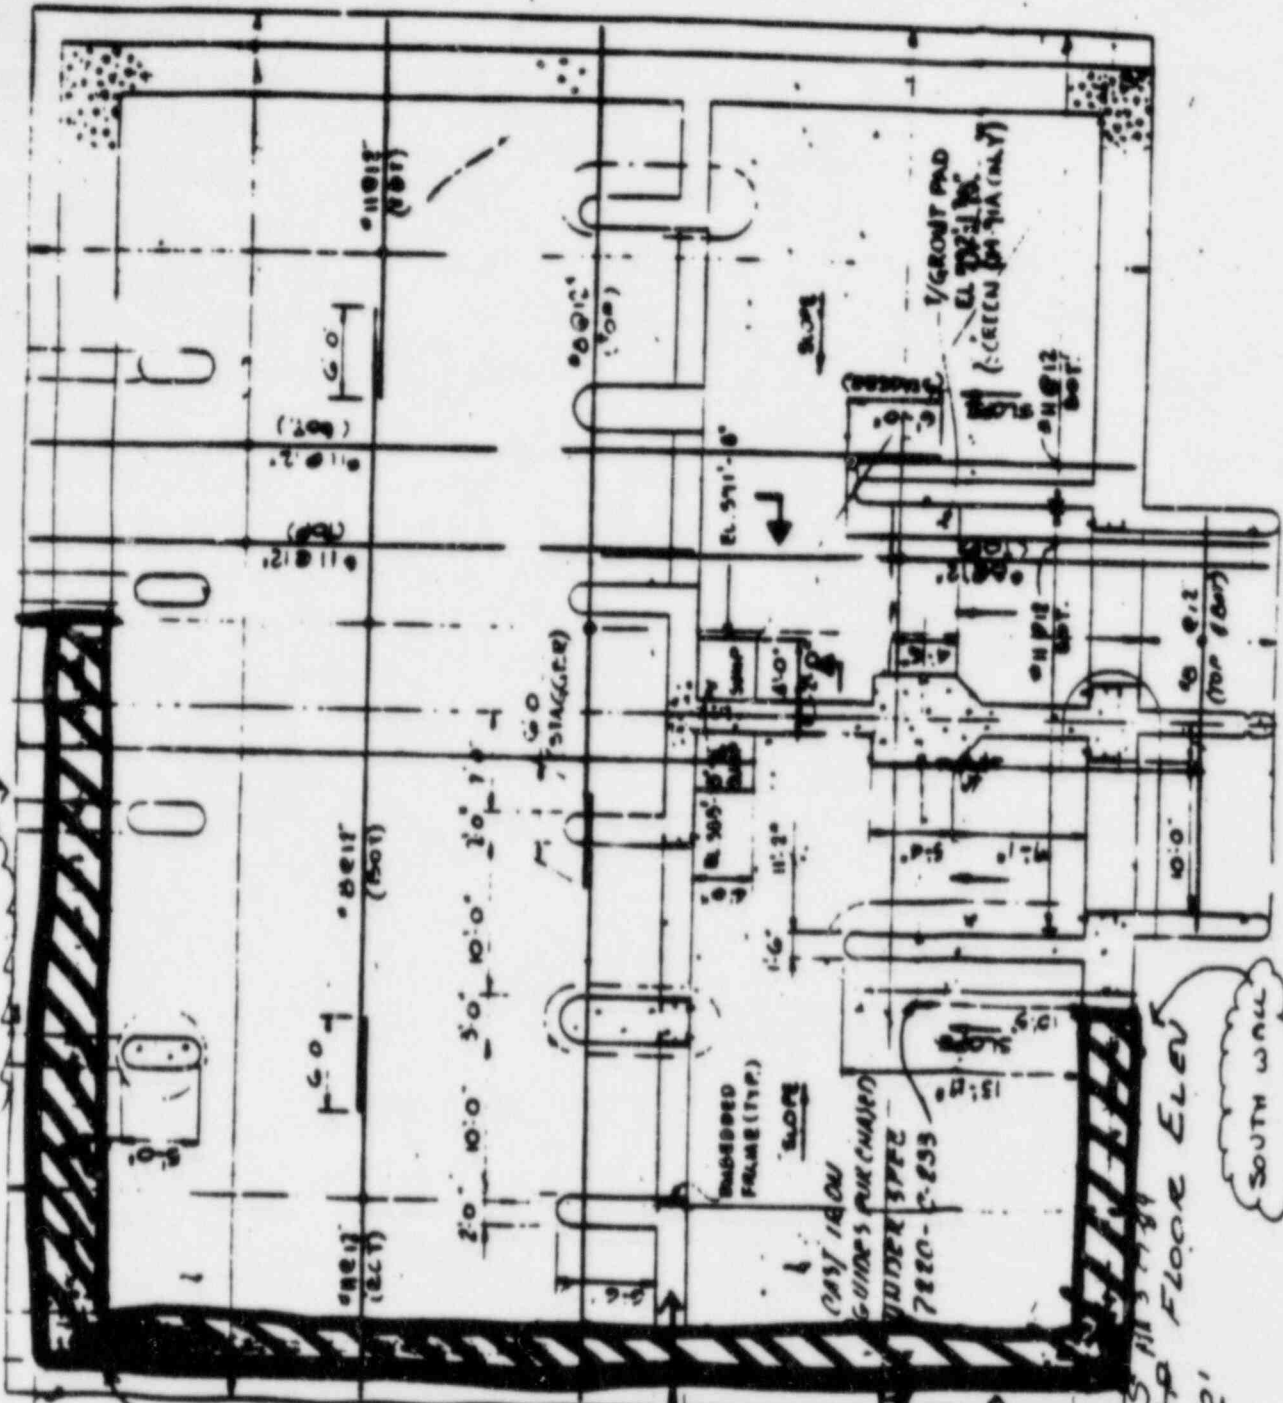
1 ITEM LOCATION S.W.P.S., EL. 592' to 609', SEE ATTACHED SKETCH ON PAGE 12.

13 NONCONFORMANCE CONTRARY TO THIS, CONCRETE PLACEMENT SWI (609) a' CONTAINS THE FOLLOWING:
 A) A GROUT LEAK ALONG THE HORIZONTAL CONSTRUCTION JOINT AT EL. 609'
 B) CRACKS EXUDING WATER
 C) ~~ROSTING TIE WIRE ALL 4/14/84~~
 D) VOIDS
 E) GROUT REPAIRS - NOT TIGHTLY BONDED, HOLLOW SOUNDING OR SHOWING EVIDENCE OF MOISTURE
 F) PLYWOOD
 G) UNSOUND CONCRETE
 H) ~~CRACKS IN CONCRETE FORMS DISKS ALL 4/14/84~~

- I.) RUSTING DROP-IN ANCHORS
- J.) VERTICAL JOINT TO ADJACENT POUR ON SOUTH WALL - POORLY BONDED AND LEAKING WATER
- K.) IMPROPERLY BONDED VERTICAL CONSTRUCTION JOINT TO EAST/WEST WALL DIVIDING AREA 800E & 800F.
