NORTHEAST UTILITIES

Re: 10CFR50.73(a)(2)(i)
March 24, 1992
MP-92-315

Reference: Facility Operating License No. NPF-49
Docket No. 50-423
Licensee Event Report 91-022-01

This letter forwards supplemental Licensee Event Report 91-022-01, in accordance with LER 91-022-00. LER 91-022-00 was submitted pursuant to 10CFR50.73(a)(2)(i), any operation or condition prohibited by the plant's Technical Specifications.

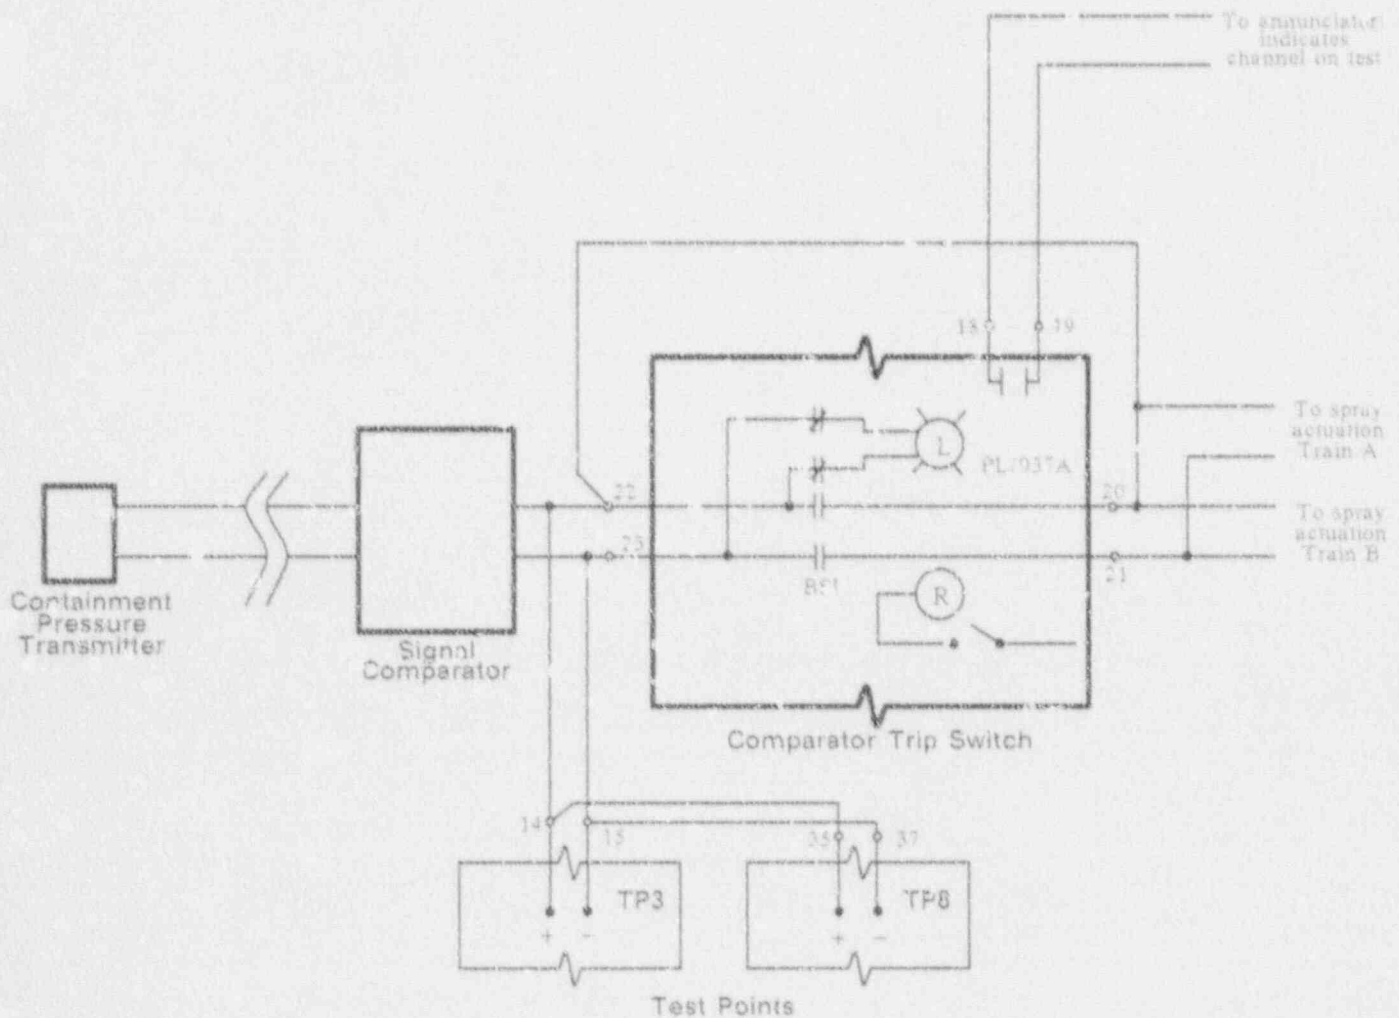
CDA Protection Channel Figure (Partial)

On August 20, 1991, at 0800 hours, while shutdown in Mode 5 (Cold Shutdown), at 95 degrees Fahrenheit and atmospheric pressure, Instrumentation & Controls (I&C) Department personnel reviewing the test methodology during the performance of the monthly analog operational check discovered that closure of the comparator trip switch auxiliary (BSI) contact, which enables transmission of the Containment Depressurization Actuation (CDA) signal, was not being verified. During the investigation of the event, it was determined that the refueling channel calibration procedures for the four CDA signal pressure channels were not in full compliance with the requirements of the Technical Specifications. The Technical Specifications require that overlap testing be performed as part of a channel calibration. The refueling channel calibration procedures did not verify closure of the BSI contact. This contact is in series to allow processing of a CDA signal from the Westinghouse 7300 instrument racks, to the Solid State Protection System (see the attached figure).

A channel calibration is performed on all four containment pressure instruments at least once every 18 months (i.e., at refueling) pursuant to the requirements of Technical Specification 4.3.2.1. However, the applicable procedures did not contain sufficient overlap to verify continuity between: a) the containment pressure instrument input to the comparator trip switch test card; the Westinghouse 7300 instrument racks and b) the output of the comparator trip switch test card (to the Solid State Protection System).

The primary cause of the event is management deficiency. The vendor protection channel testing procedures, which were submitted to plant management prior to initial startup, were not distributed to the I&C Department procedure writers for incorporation into the applicable procedures.

The energized to actuate design of the CDA circuit does not provide annunciators which directly monitor contact status. The typical protection channel design places the channel in trip during testing and utilizes annunciators to provide indication of off-normal contact status. Actuation is provided by deenergizing the SSPS input relay. The CDA protection channel design (which is energized to actuate) requires that the channel be bypassed during testing. An annunciator and bistable light provide indication of the off-normal channel condition, but does not directly monitor the status of the BSI contact. To verify contact continuity of the BSI, a voltmeter must be placed across the contacts to verify continuity.

There are four utilized contacts on the comparator trip switch test card: two (normally open) contacts are used to light the associated bistable when the switch is in test. One (normally closed) contact is used to provide a channel in test annunciation. The (normally closed) BSI contact is used in line with the SSPS input relays to block an actuation signal while in test. Since they employ different sets of auxiliary contacts (from the same switch), neither the bistable light nor the "channel in test" annunciator provide positive indication of the position of the comparator trip switch BSI contact.

The monthly analog channel operational test procedures were modified to include guidance on continuity verification of the CDA comparator trip switch BSI contact for the four protection channels. These procedures were changed vice the channel calibration procedures since they are performed on a more conservative frequency. The modified surveillance procedures were satisfactorily performed. The review of other protection channel instrument loops did not identify similar deficiencies. A review of other I&C department procedures versus the vendor operating instructions has been performed to determine if similar conditions exist. Discrepancies were identified in the step sequence of some procedures. These discrepancies do not violate any of the Plant Technical Specifications or Final Safety Analysis Report (FSAR) requirements, and will be resolved via the internal commitment tracking program.
