JOHN MERTENS

Mr. J. M. Martin
Regional Administrator
U. S. Nuclear Regulatory Commission
Office of Inspection and Enforcement
Region V
1450 Maria Lane, Suite 210
Walnut Creek, California 94596-5368

July 20, 1983

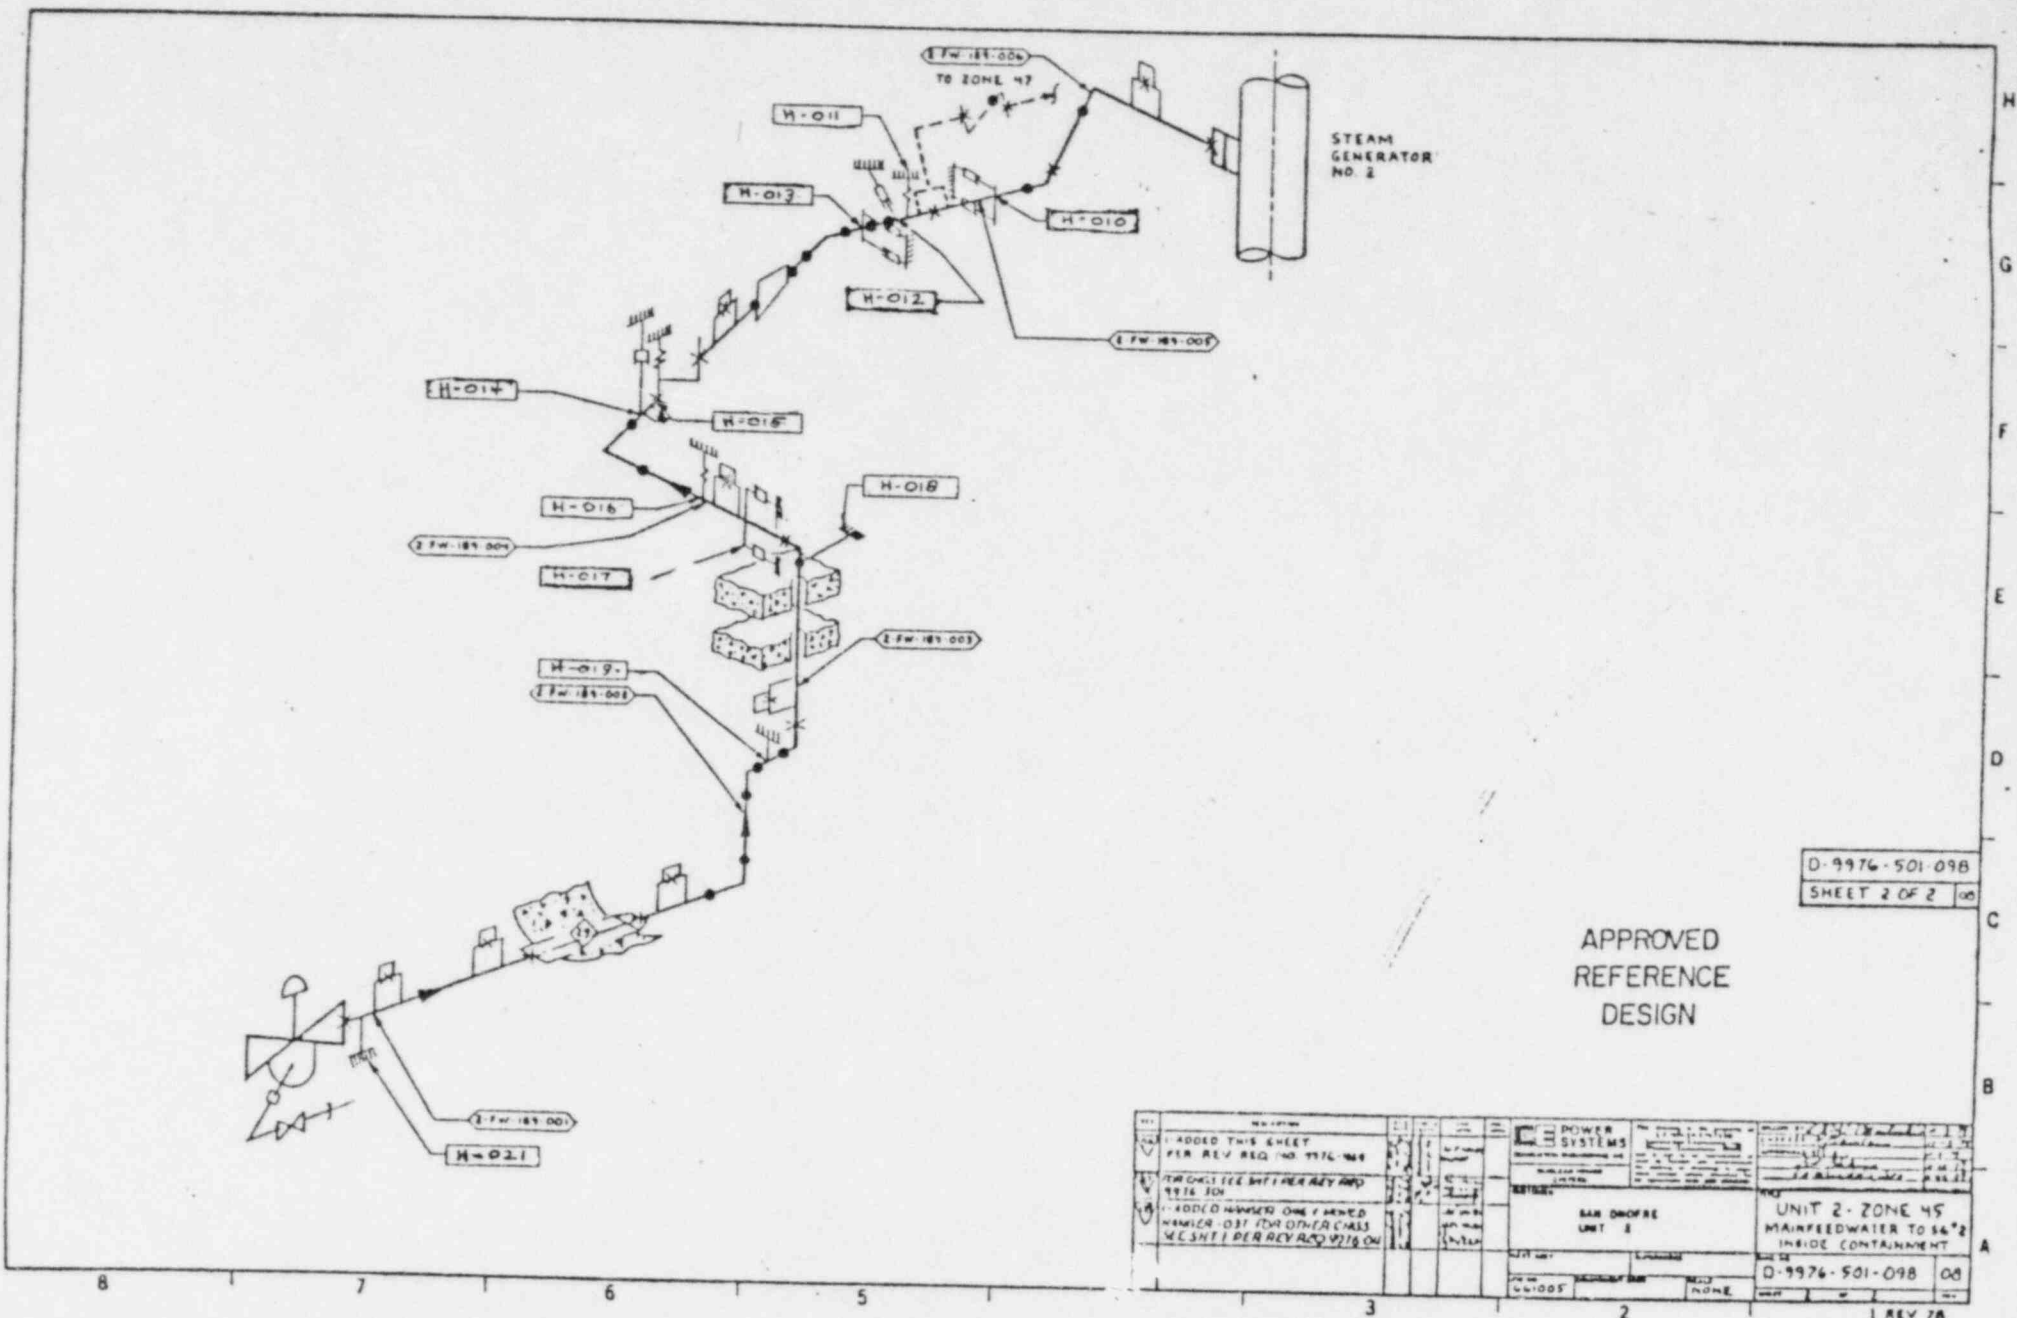
FIGURE 2

On December 9, 1982, while performing the feedwater piping thermal expansion test at the 50% power plateau, a mechanical snubber at location S2-189-H013 (see Figure 2) was found damaged. The initial engineering investigation (Attachment 4) concluded that the remaining mechanical snubbers, five additional for a total of six in question, at locations S2-189-H013, S2-189-H010, and S2-189-H017 were probably also damaged. Eventually, the original damaged snubber and four others were replaced. The sixth, on support S2-189-H010, was manually stroked with satisfactory results and was not replaced.
