# NORTHEAST UTILITIES

Reference: Facility Operating License No. DPR-65  
Docket No. 50-336  
Licensee Event Report 92-006-00

LICENSEE EVENT REPORT (LER)

TITLE (4)  
Containment Isolation Valves-Design Deficiency

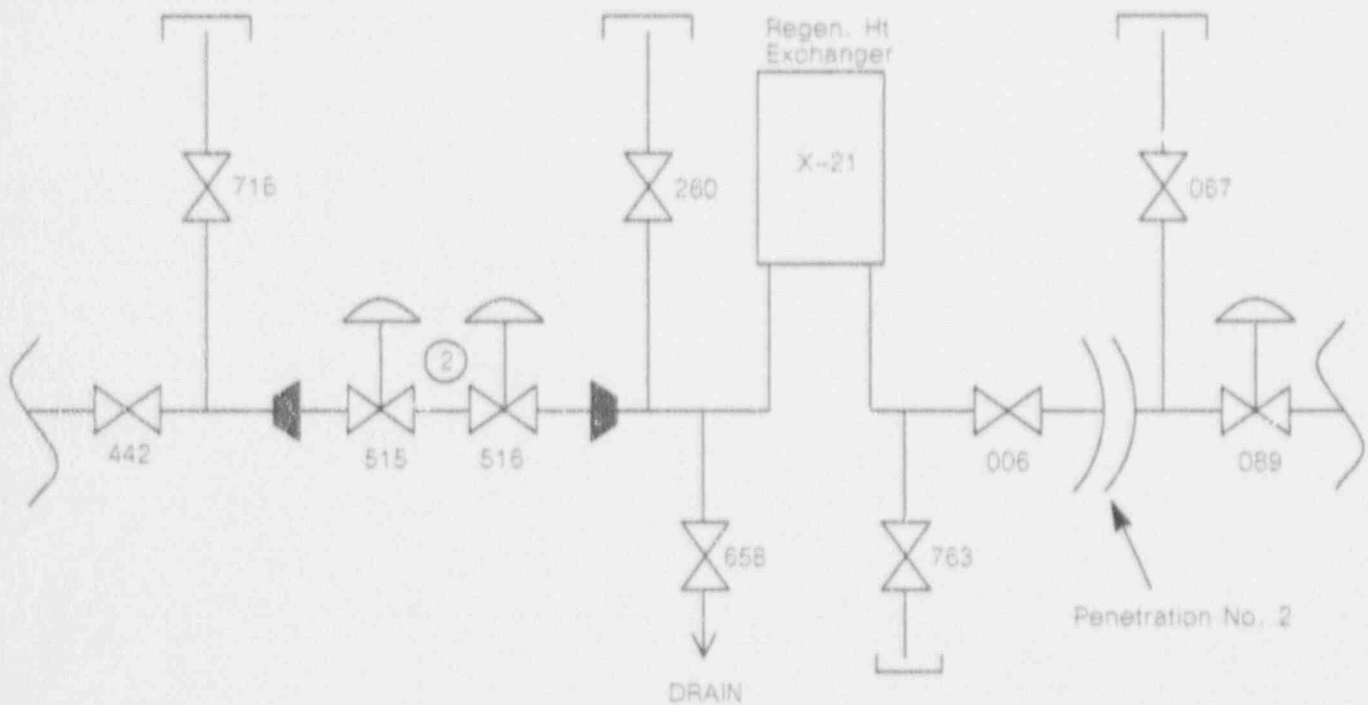
FIGURE 1

While at 100% power on March 2, 1992 at 1645 hours, a design deficiency was discovered for letdown isolation valves 2-CH-089 and 2-CH-516. An internal engineering evaluation postulated a failure of the 24VDC bus in Engineered Safeguards Actuation System (ESAS) Actuation Cabinet RC02C, which would prevent its output relays from energizing and automatically closing the valves. 10CFR50 Appendix A, Criterion 54 requires that the design of piping systems penetrating the containment be provided with leak detection and redundant isolation capabilities.

The root cause for the event is believed to be a design error by the Architect Engineer during the initial layout of the plant. Additional reviews show that no other containment penetration has this condition.

Additional assurance that loss of the Z2 actuation cabinet would not result in the loss of isolation capability is provided by the fact that valve 2-CH-515 also provides isolation capability for this penetration. Valve 2-CH-515 is located just upstream of 2-CH-516 inside containment and is identical to 2-CH-516. Both these valves are identical in operation, internal configuration, and material. Both are seismic Class I, QA Category 1E 1500# ASA rated globe valves. Both these valves fail closed and are normally held open by air pressure. However, 2-CH-515 is powered by the Z1 125VDC facility and receives Z1 SIAS actuation to close. SIAS closure signals are concurrently generated with a CIAS signal (both signals are generated from the same parameters). In the event of a CIAS with a concurrent loss of the Z2 facility, 2-CH-515 would automatically close on the SIAS signal and would provide automatic isolation.

MP2 LETDOWN PIPING AND VALVE ARRANGEMENT

Valve 2-CH-515 will be added to the LLRT program and any necessary changes to the Final Safety Analysis Report (FSAR) and Technical Specifications will be made.
