Reference: Facility Operating License No. NPF-49  
Docket No. 50-423  
Licensee Event Report 91-028-01

FACILITY NAME (1) Millstone Nuclear Power Station Unit 3	DOCKET NUMBER (2) 0   5   0   0   0   4   2   3	PAGE (3) 1 OF 0   7
---	--	------------------------

TITLE (4)  
Improper Power Range Trip Rate Decay Time Trip Setpoint Due to Improper Work Practices

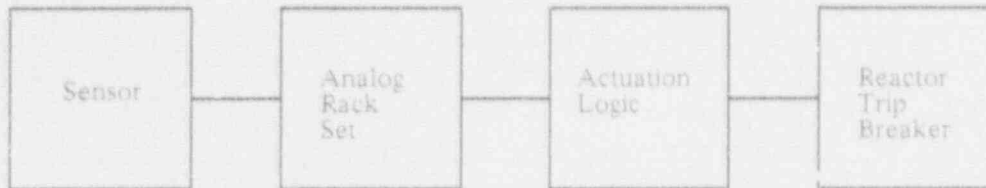
While investigating this event, it was found that the power range response time test did not encompass the entire power range circuit. Technical Specification 3.3.1 states that for the Power Range, Neutron Flux, the Response Time should be less than or equal to 0.5 seconds as measured from the detector output or the input of the first electronic component in the channel.

The Time Response Surveillance procedure incorrectly specified using the output of the summing and level amplifier as the test point location. The author of the Time Response Surveillance requested assistance from the Nuclear Instrumentation System (NIS) expert to identify the test method and test point location. The system expert knew nothing about Response Time Testing requirements and, therefore, provided the surveillance author with the Reactor Power test point. This test point is commonly used throughout the NIS surveillances that do not require a specific test point location since it is the first place to read Reactor Power. The procedure review process did not discover this error.

Response time testing incorporates the components shown in the following block diagram:

Additionally, the NIS Time Response Surveillances have been revised to measure the time response starting at the input to the first electronic component. The Response Time of each NIS Power Range Channel has been completed using the revised method and the old response time tests have been reviewed to verify that all Acceptance Criteria have been met. A full test to Westinghouse specifications of the functional circuit has been performed. I&C has developed a comprehensive review policy that designated what a reviewer looks for when performing a Technical Specification review, Final Safety Analysis Report review, Vendor procedure review, Overlap Testing review, and a Setpoint review. Also, an "Evaluation of Retest Requirements for PDCR Closeout" form has been developed by I&C.

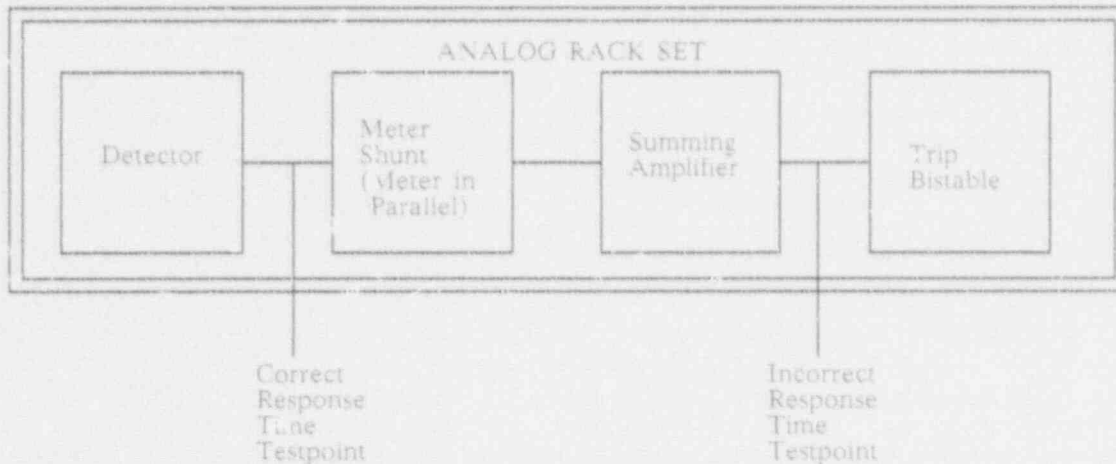
The component that was not fully incorporated in the Time Response testing was the Analog Rack Set. The Analog Rack Set incorporates the subcomponents shown in the following block diagram:

The root cause of the incorrect test point used to record the response time of the NIS power range event is technical error. The procedure did not use the first electronic component in the Power Range drawer as specified by Technical Specification. The review process did not discover this error.
