Hope Creek Generating Station

HOPE CREEK GENERATING STATION
DOCKET NO. 50-354
UNIT NO. 1
LICENSEE EVENT REPORT 92-004

LICENSEE EVENT REPORT																				
FACILITY NAME (1) HOPE CREEK GENERATING STATION										DOCKET NUMBER (2) 0 5 0 0 0 3 5 4				PAGE (3) 1 OF 5						
TITLE (4): Engineered Safety System Actuation: Channel "B" Emergency Core Cooling System actuation during design change implementation due to design deficiency and personnel errors.																				
EVENT DATE (5)			LER NUMBER (6)				REPORT DATE (7)			OTHER FACILITIES INVOLVED (8)										
MONTH	DAY	YEAR	YEAR	*	NUMBER	*	REV	MONTH	DAY	YEAR	FACILITY NAME(S)		DOCKET NUMBER(S)							
0	3	0	8	9	2	9	2	-	0	0	4	-	0	0	0	4	0	6	9	2
OPERATING (9) MODE		THIS REPORT IS SUBMITTED PURSUANT TO THE REQUIREMENTS OF 10CFR: (CHECK ONE OR MORE BELOW) (11)																		
4		20.402(b)		20.405(c)		XX		50.73(a)(2)(iv)		73.71(b)										
POWER LEVEL %		20.405(a)(1)(i)		50.36(c)(1)				50.73(a)(2)(v)		73.71(c)										
0 0 0		20.405(a)(1)(ii)		50.36(c)(2)				50.73(a)(2)(vii)		OTHER (Specify in Abstract below and in Text)

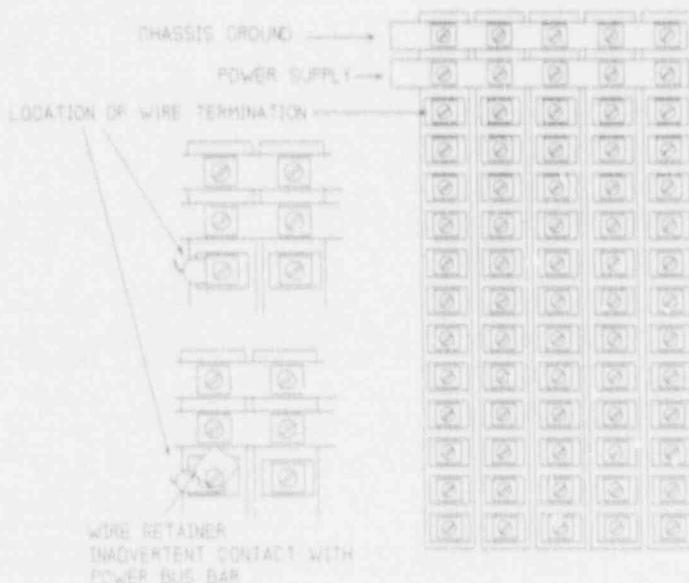
ROSEMOUNT TRIP UNIT CONNECTIONS

The Rosemount trip units monitor plant parameters and provide trip signals for ECCS equipment when predetermined action levels are exceeded. The system is configured with up to 12 trip units located in a rack with a common 24 vdc power supply and ground via bus bars which run the length of the cabinet rear. There are an additional 14 terminals on the rear of the rack for each trip unit for field wiring and interconnections. The location of the rack and the close proximity of the termination posts render modifications to the rear panel difficult. For this reason, and the previous ESF actuation which occurred during DCP implementation on 6/19/91 (see LER 91-014-00), it had been decided to complete the DCP during a shutdown.

As the leads were being landed to the rear of a Rosemount trip unit a wire retaining ring attached to the screw inadvertently rotated such that it came in contact with the power bus bar. When the bus bar was momentarily grounded a temporary loss of power to the channel "B" ECCS trip units in the cabinet occurred and when power to the trip units returned, selected trip units actuated.

The cause of this occurrence is a previously identified design deficiency associated with the ECCS relay cabinet, inadequate precautions in the work package and inadequate pre job briefing between the technicians and the NSS to ensure the risks associated with the work, and measures to prevent a spurious initiation were thoroughly understood. A design change was being implemented at the time of this occurrence to correct the design deficiency. A corrective action, from a previous event, to complete the DCP during an outage was satisfied; however, planning did not take full advantage of the outage conditions to disable the logic or inhibit pump operation as the system was not required for shutdown condition.

1. The portion of the design change being implemented at the time of this event was completed and tested satisfactorily.

The full design change is scheduled for completion during the stations 4th refueling outage.
2. Maintenance Department Management will review this event with all Controls Department supervisors and technicians involved in the continuing implementation of the design change. Lessons learned from this event will be discussed in departmental continuing training.
3. Planning department will ensure all work orders, for the remainder of the DCP, contain steps to disable equipment to preclude a similar event.
4. The pre job briefing guidelines will be reviewed with Operations and Maintenance department personnel.
