James A. FitzPatrick
Nuclear Power Plant
P.O. Box 41
Lycoming, New York 13093
315 342-3840

SUBJECT: DOCKET NO. 50-333
LICENSEE EVENT REPORT: 91-021-00 - RHRSW/ESW Pump
Room Fire Dampers

TITLE (4) **Residual Heat Removal, Emergency Diesel Generators, and Fire Pumps Potentially Made Inoperable Due to Inadequate Modification Installation Activities**

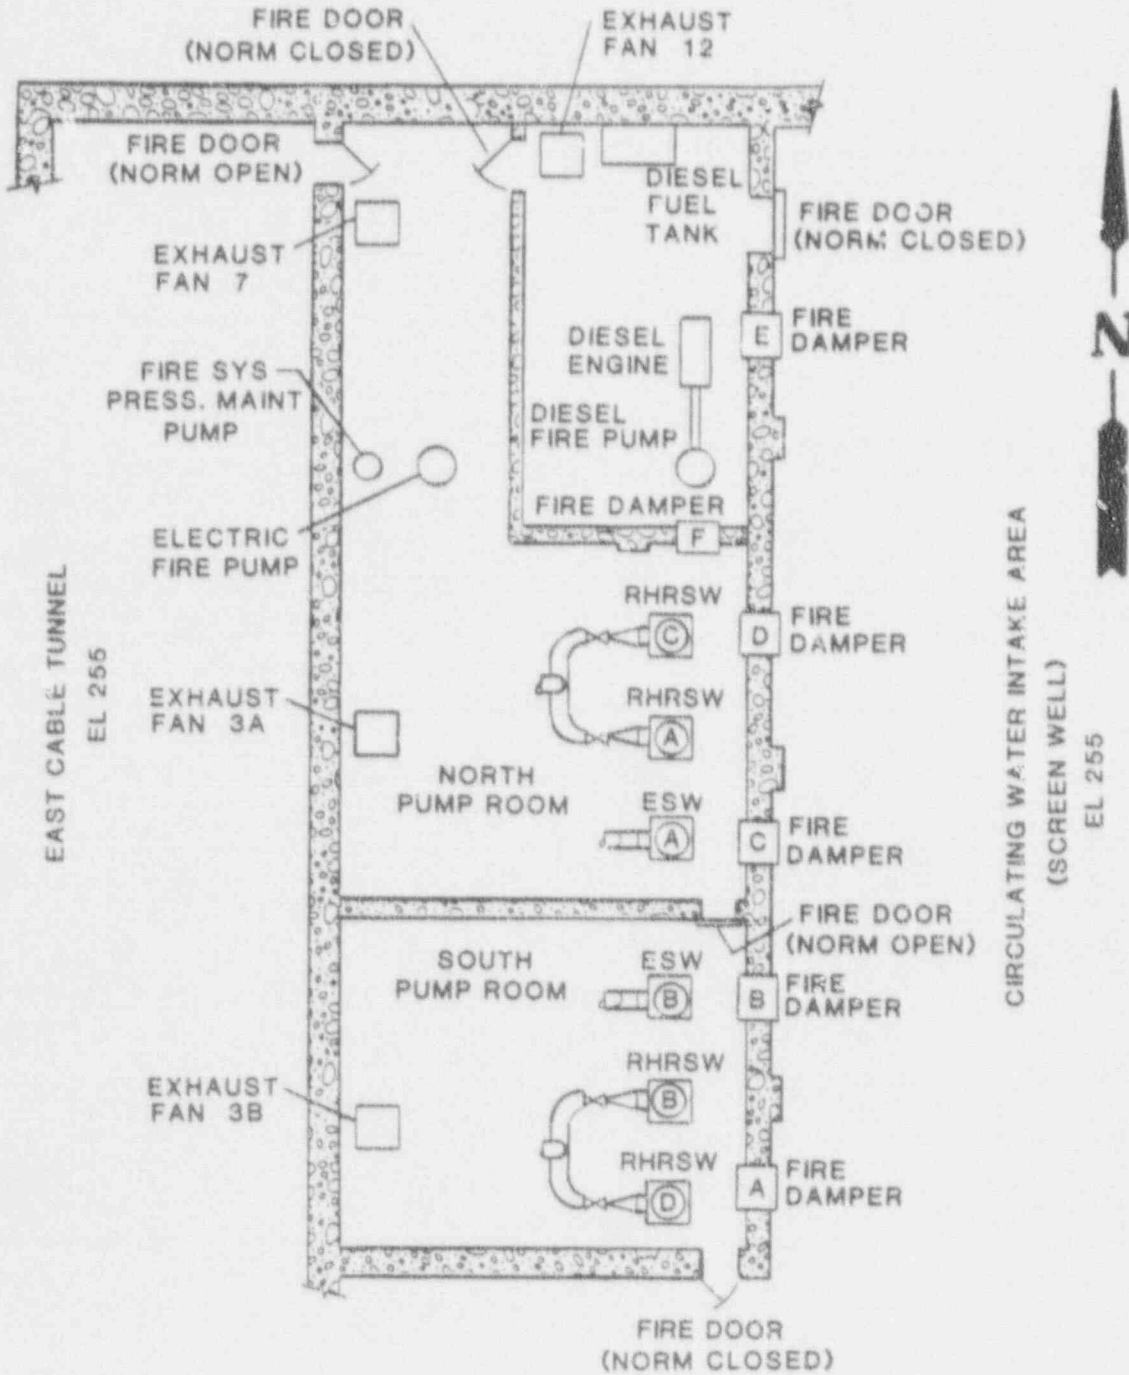
RHRSW / ESW & FIRE PUMP ROOMS

The electric motor driven fire pump is located in the north safety-related pump room as indicated on the sketch on the last page of the LER. This room is supplied with an additional exhaust fan designated as Fan 7 on the sketch. This room has the advantage of direct access to air intake from the east cable tunnel. However, because the cable tunnel supply fan is designed to supply on the order of 4,000 CFM total flow (some of which is diverted to the EDG switchgear rooms) while the safety-related pump room exhaust fans 73FN-3A&B are rated on the order of 12,000 CFM. Accordingly, fire damper closure in the north safety-related pump room has the potential to render the electric fire pump inoperable.

The diesel fire pump is located in a separate room which shares two walls in common with the north pump room as shown on the sketch. The dampers supplying the diesel fire pump room from the north safety-related pump room and the screenwell were also closed during this event and would also be closed by the postulated fire in the intake structure (screenwell) scenario. This room is cooled by a separate fan designated as Fan 12 on the sketch. Although the engine has a water jacket cooling system, the engine combustion air intake comes from within the room. Accordingly, the dampers must be open for proper operation.
