SUBJECT: EVALUATION OF THE LANDSMAN CONCERNS FOR MIDLAND

SUBJECT: EVALUATION OF LANDSMAN'S CONCERNS REGARDING
DIESEL GENERATOR BUILDING AT MIDLAND

Midland NPP Diesel Generator Building Review

Structural Evaluation of the Diesel Generator Building

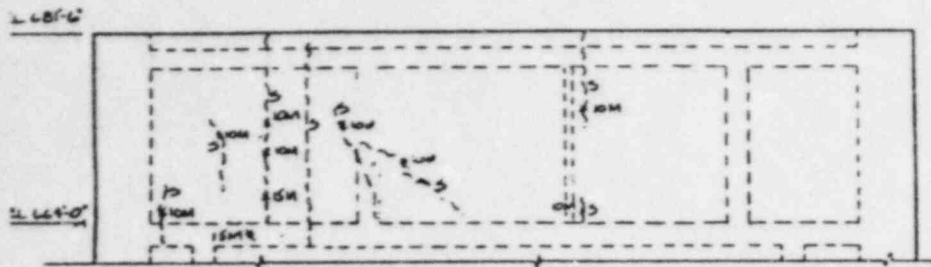
EAST WALL - EAST SIDE
LOOKING WEST

2. Para. 92: The major cracks in the east wall of the DGB developed subsequent to the release of the duct banks from the building. The number of cracks prior to the release of the duct banks are shown in Attachment #2 of the original testimony of H. N. Singh. This attachment shows only 10 cracks on the east wall, but today there are 16 cracks on the wall.

4. Para. 93: The settlement of the D.G.B. during the surcharge has created many cracks, (Singh's original testimony Q-9). On the east wall, the number of cracks increased from 10 to 16. Therefore, the surcharge did reduce the structural integrity of the D.G.B. The Applicant has not considered the settlement in his structural analyses (Singh testified before ASLD on 10 Dec 1982 to this aspect), and has not been able to demonstrate the adequacy of the D.G.B.

25. Para. 154: It is clear from the east wall that all the cracks which are inclined and have developed after the release of the duct banks are shear cracks. These cracks have bent towards south, indicating shear stress due to excessive settlement at the southeast corner.

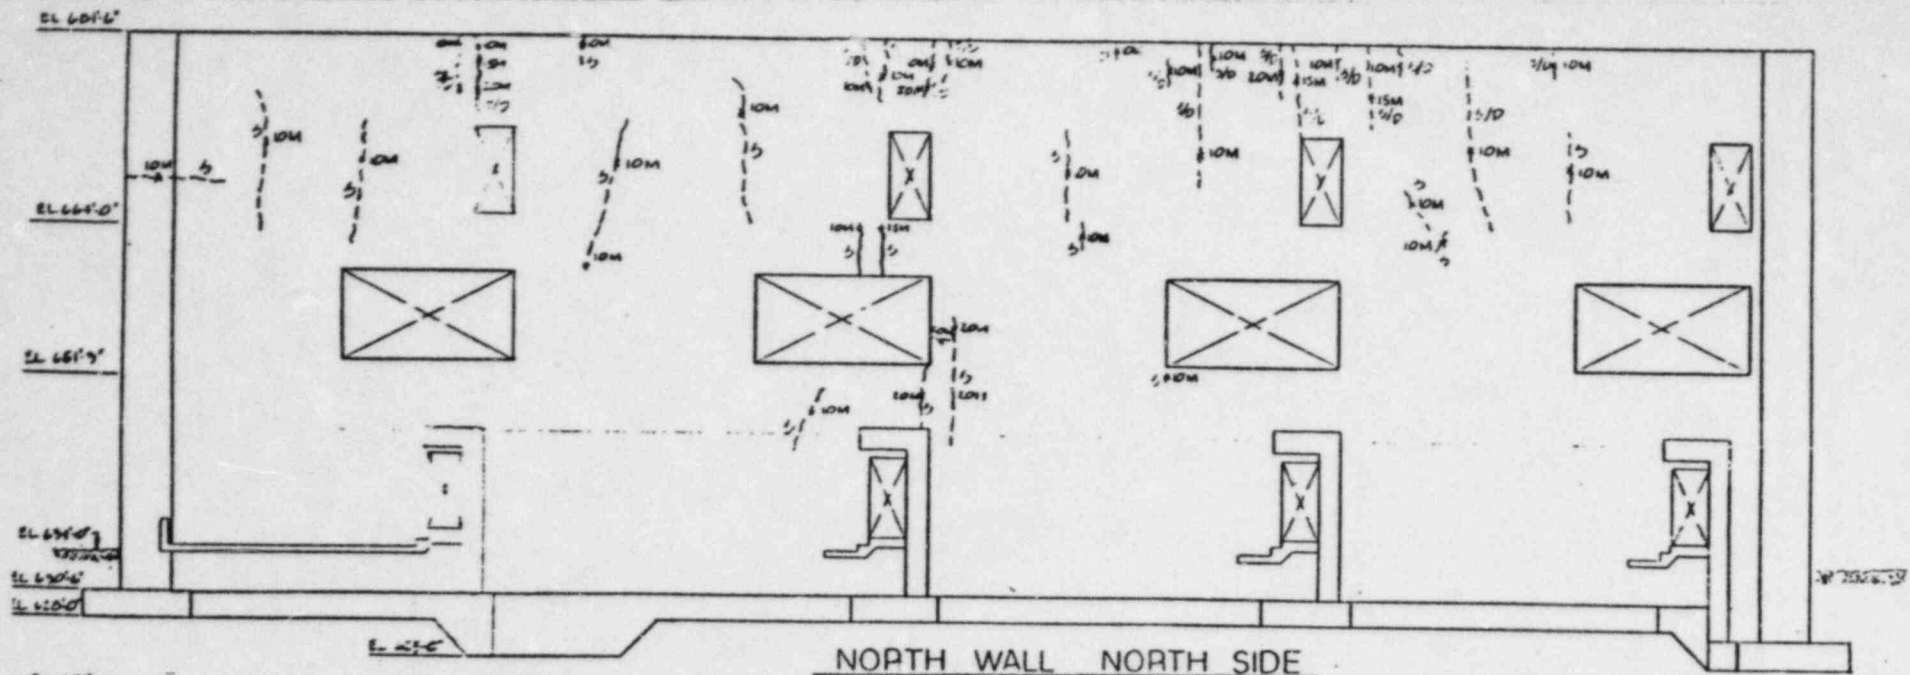
NORTH WALL NORTH SIDE

33	On north side above El 634. ③	8/78 to 1/79 (presurcharge)	*Cracks shown in 12/78 Map	No cracks shown on 9/79 Map	Cracks shown in 7/81 Mapping and slight extension of 12/78 mapped cracks.	
35	On north side below El 650 ②	8/78 to 1/79 (presurcharge)	*Crack shown in 12/78 Map	No cracks shown on 9/79 Map	Cracks shown in 7/81 Mapping	
37	On north side above El 634 ③	1/79 to 8/79 (Surcharge Period)	Fig 14-2 Mapping not applicable as it pre-dates this period of settlement	*No cracks shown on 9/79 Map	Cracks shown in 7/81 mapping and slightly extend 12/78 mapped cracks.	
39	On south side above El 634 ④	1/79 to 8/79 (Surcharge Period)	Fig. 14-2 Mapping not applicable.	*Crack shown in 9/79 map and is identified as structural displacement crack.	Same crack observed in 9/79 is again recorded in 7/81.
