SUBJECT: POTENTIAL CORE SHROUD CRACKING AT BOILING WATER REACTORS

NRC INFORMATION NOTICE 93-79: CORE SHROUD CRACKING AT BELTLINE REGION WELDS
IN BOILING-WATER REACTORS

CORE SHROUD CRACKING
PRELIMINARY SAFETY ASSESSMENT

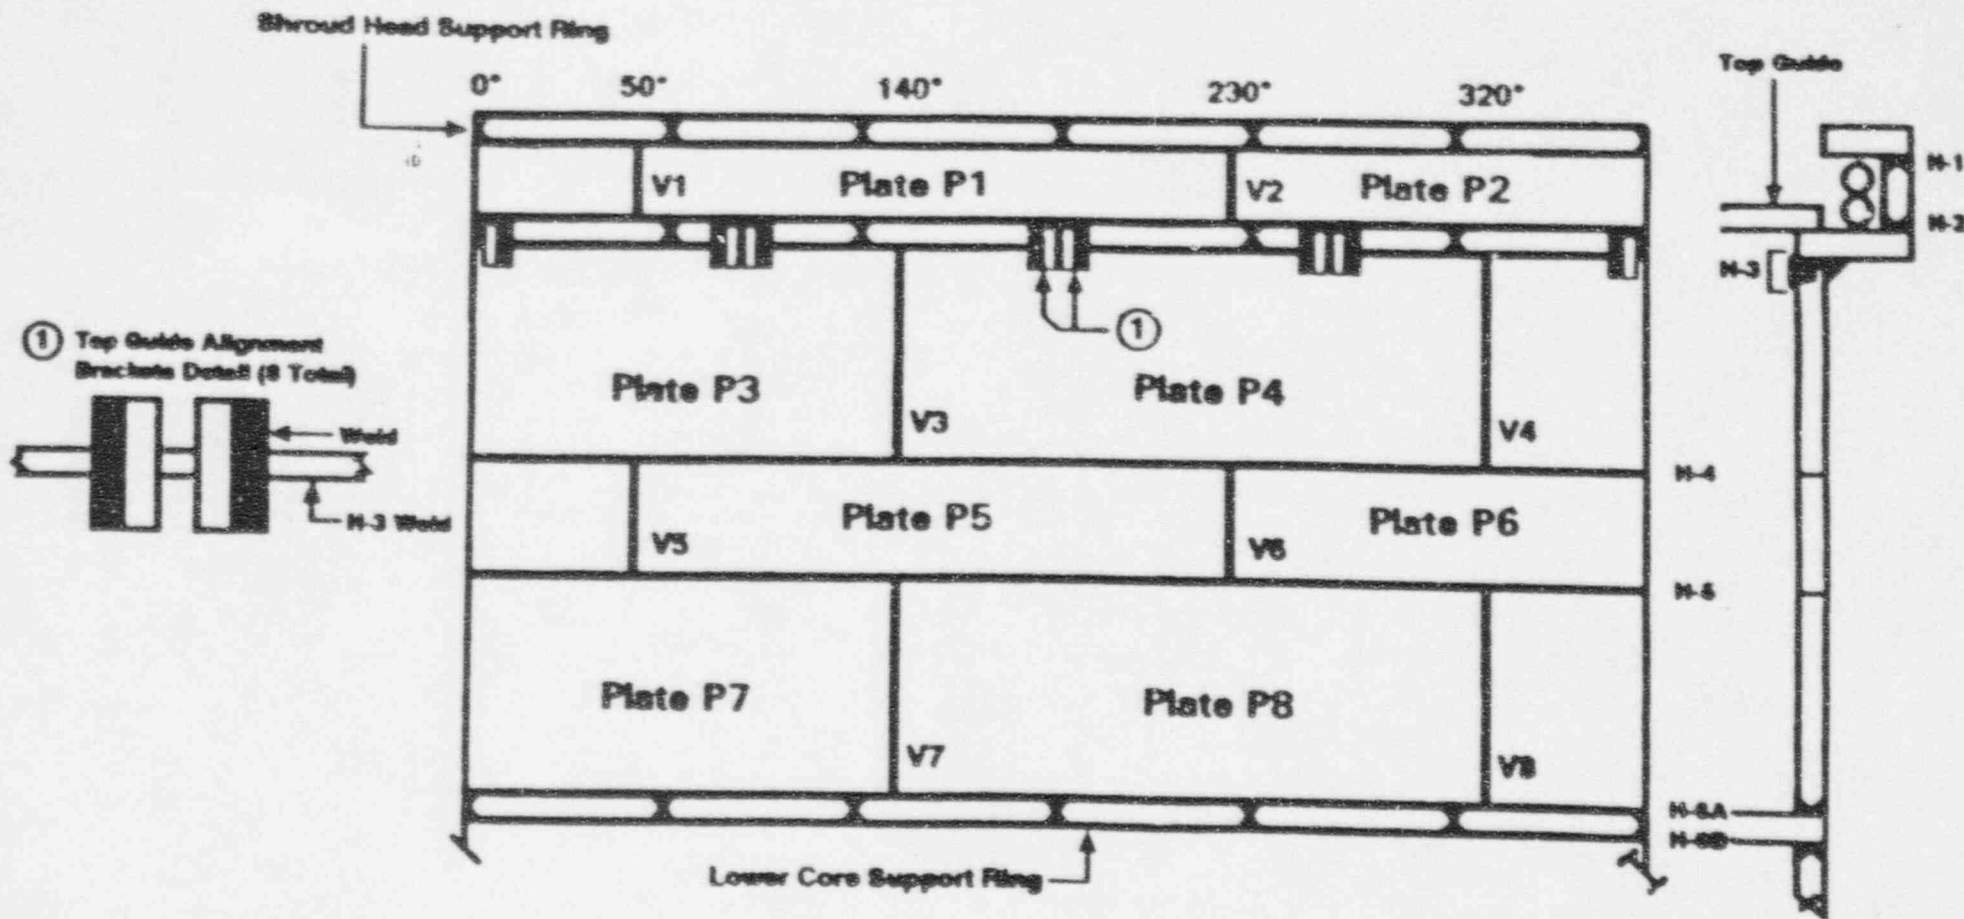
Figure 1. Weld and Plate Locations in the Beltline Region of the Brunswick Unit 1 Core Shroud (From CP&L)

Additional VT inspections revealed more axial cracks at the inside surface of weld H-4 as well as cracks at welds H-1, H-2, and H-5 of the shroud. One of the additional cracks, a circumferential crack at weld H-5, appears to be approximately 76.2 centimeters [30 inches] in length. The majority of the cracks are located in the HAZ of the welds, although one crack was discovered in the central region of shroud plate P-6. The crack in P-6, however, may be associated with a possible weld repair of a surface defect in the plate after its fabrication at the mill.

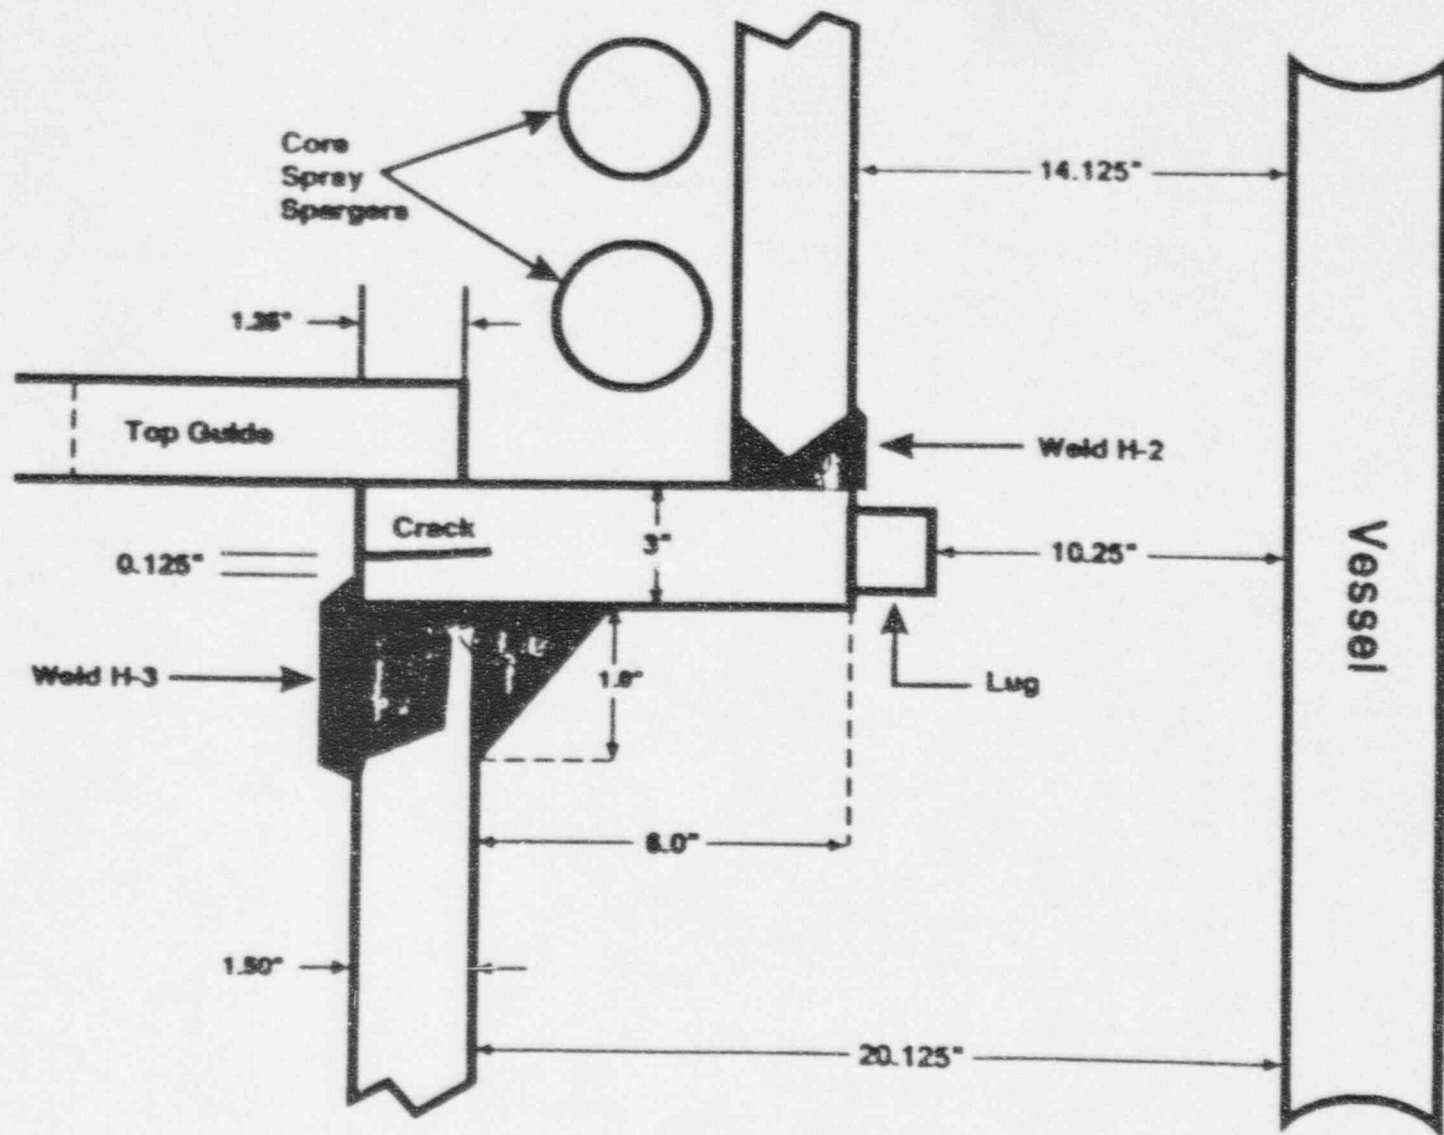
Figure 2. Details of Weld Locations H-2 and H-3 in the Brunswick Unit 1 Core Shroud (From CP&L)

The results from the boat samples indicated intergranular stress-corrosion cracking (IGSCC) as the mechanism. Preliminary results suggest that the crack in the HAZ of weld H-3 may be 3.8 centimeters [1.5 inches] or more in depth. The location of this crack is shown in Figure 2.

CP&L plans to repair the Brunswick Unit 1 core shroud before the plant is brought back into service. CP&L intends to restore the strength of the shroud by adding stiffening braces around the top portion of the shroud. However, the licensee will continue to examine and evaluate the cracks in the core shroud.

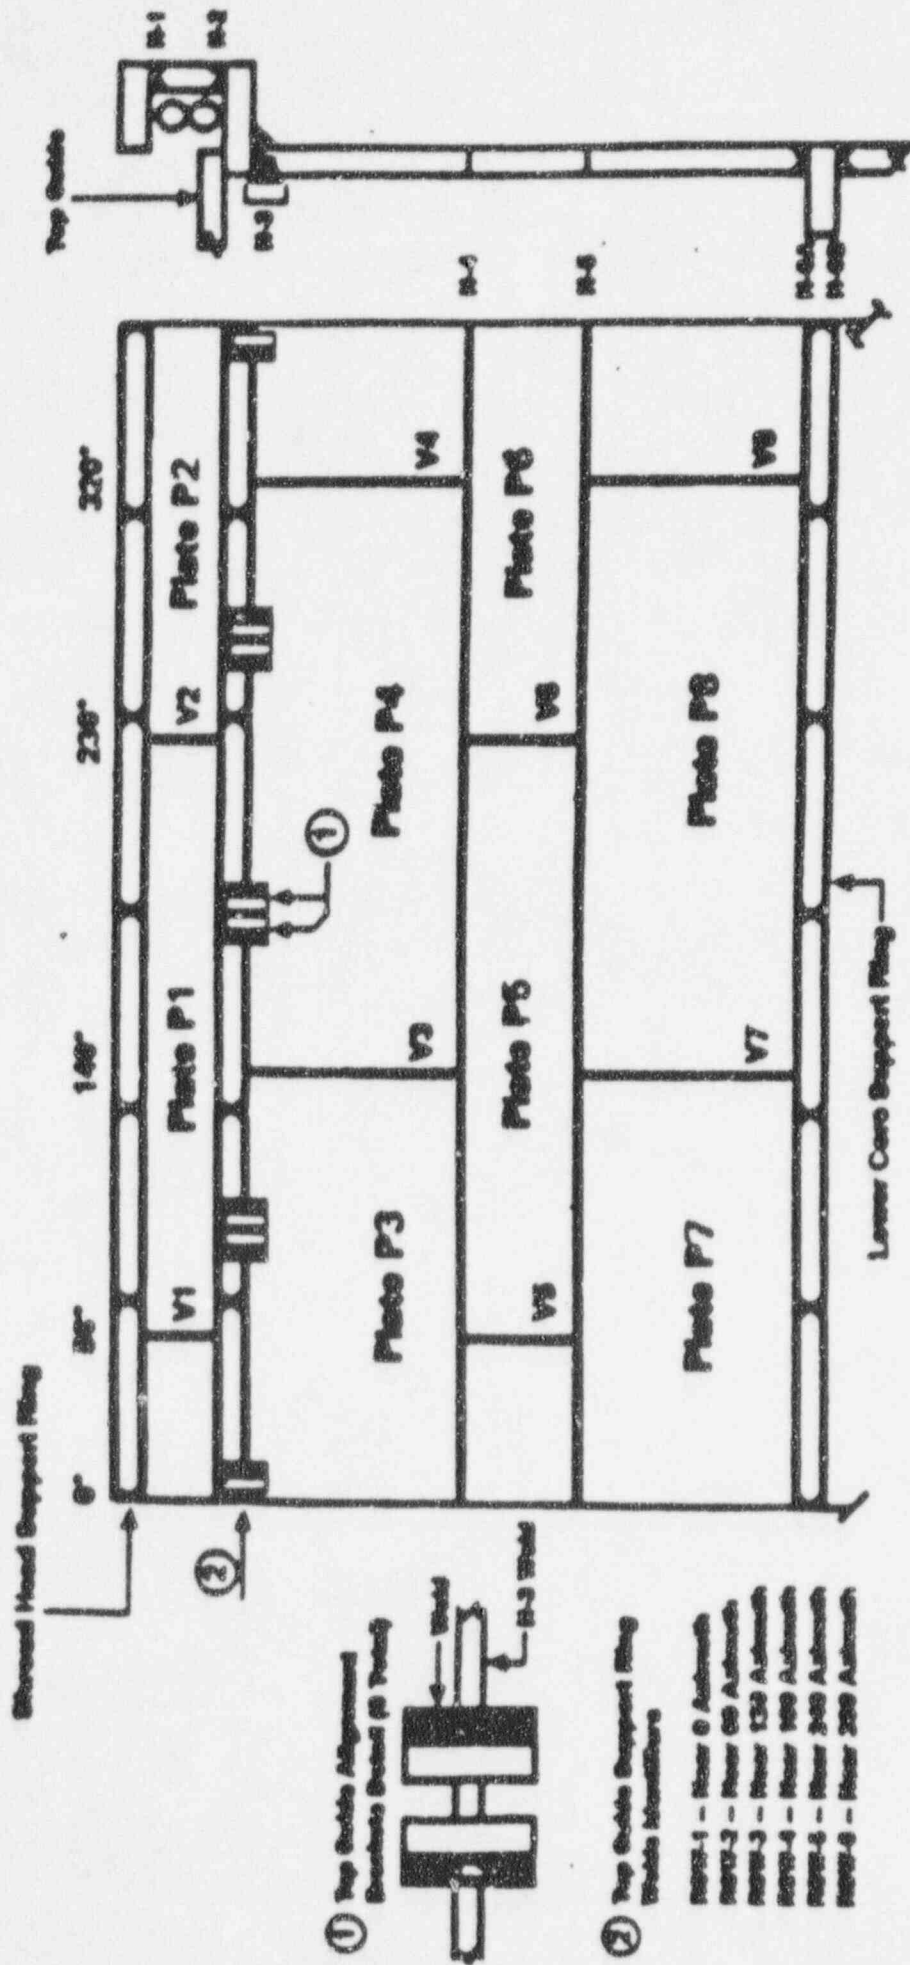
Figure 2. Weld and Plate Locations in the Beltline Region of the Brunswick Unit Core Shroud (From CP&L)

The specific cracking observed at Brunswick Unit 1 is illustrated on Figures 2 and 3. Numerous cracks were observed in the lower elevations of the vertical portion of the core shroud surrounding the core. These cracks predominantly ranged from one to three inches in length, with several longer cracks of 9 and 30 inches in length. None of these cracks penetrated through the shroud wall. A 360° circumferential crack was observed at weld location H3 which connects the upper ledge of the core shroud to the vertical portion of the core shroud which surrounds the core. At this location, the weld thickness is 2.25 inches. Using UT, the crack depth was found to range from 0.8 to 1.7 inches.

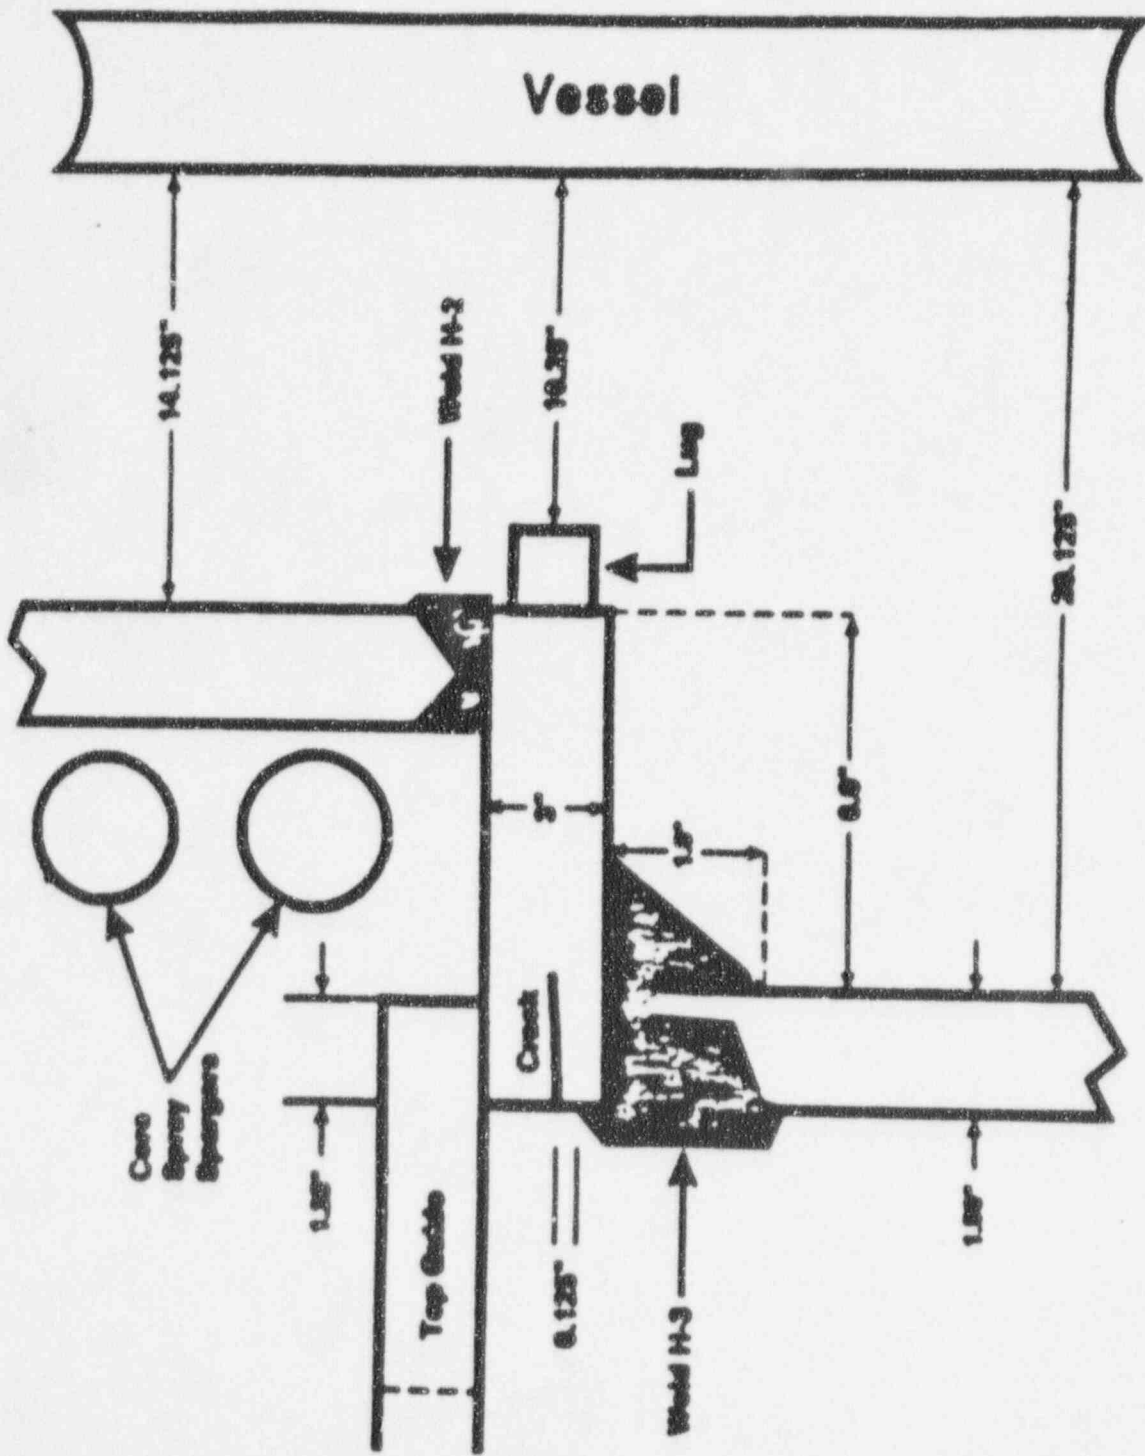
Figure 3. Details of Welds and Cracks at Weld Locations H-2 and H-3 in the Brunswick Unit 1 Core Shroud (From CP&I)

With respect to the cracking observed at the H3 weld location, the licensee has evaluated the structural integrity of this weld under normal operation, accident, and earthquake conditions. The licensee has estimated that if a $\frac{1}{4}$ inch ligament remained around the circumference, the structural margins, including an allowance for crack growth, required by the ASME code would not be exceeded. Therefore, the licensee concluded that the as-found cracks would not impair structural integrity and were not safety significant.

The staff does not believe that sufficiently conservative margins of strength will remain for an additional operating cycle. Additionally, the staff felt that the UT examination was not sufficiently accurate in its indication of crack depth.

The licensee has elected to perform a repair that will provide the

structural requirements for the attachment of the top guide support ring to the lower core shroud. Specifically, the licensee is evaluating structural stiffeners to compensate for the loss of margin in the structural integrity of the H3 weld. In addition, the licensee will start up with H₂ water chemistry (20 scfm) which will reduce the growth rate for the IGSCC cracks and reduce the potential for future crack development. The staff will continue to evaluate the licensee's repair actions.
