NOTE TO: Marty Virgilio, Acting Director  
Division of Systems Safety & Analysis

FROM: Timothy Collins, Acting Branch Chief  
Reactor Systems Branch  
Division of Systems Safety & Analysis

SUBJECT: FERMI-2 SHROUD HEAD BOLT CRACK

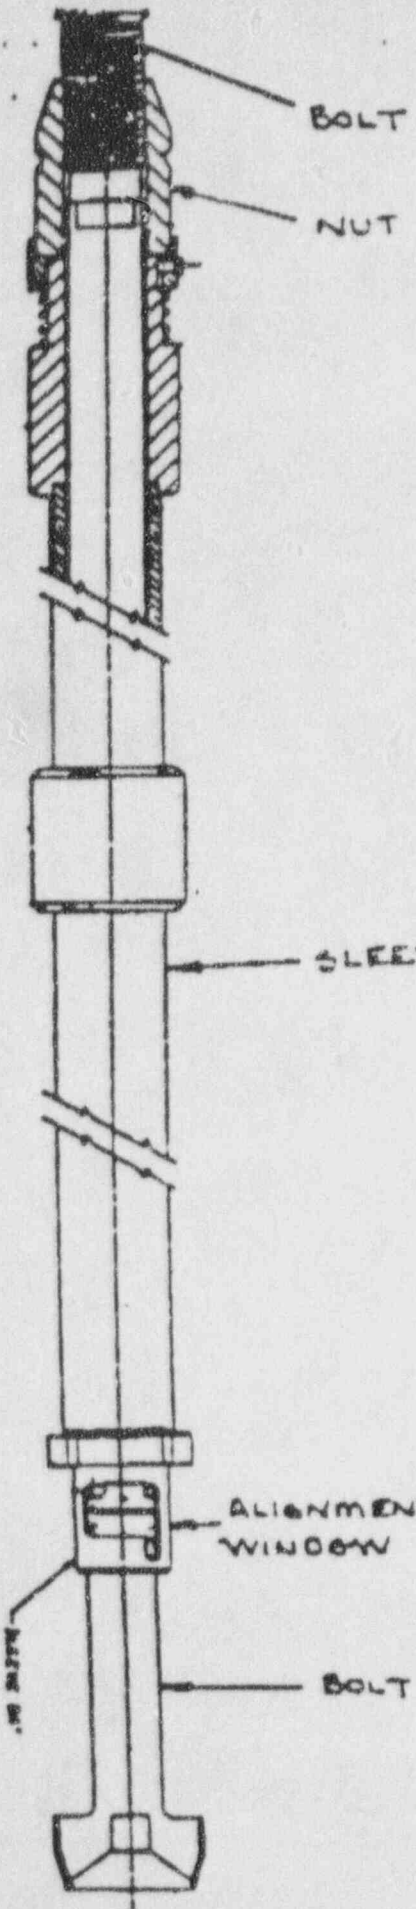
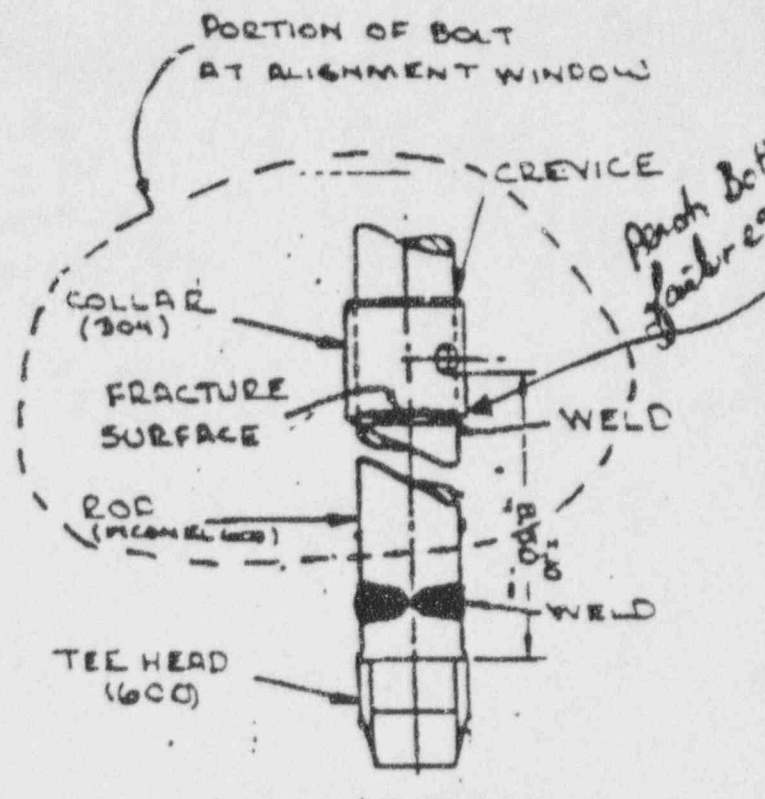
ENLARGED VIEW WITH FAILURE LOCATION INDICATED

NOTE: COMPLETE SEPARATION IS ESTIMATED TO BE AT THE ROOT OF THE COLLAR WELD
