Subject: Quad Cities Station Units 1 and 2  
Core Shroud Repair Hardware Inadvertent Loading  
NRC Docket Nos. 50-254 and 50-265

Revised 10 CFR 50.59 Safety Evaluation - Core Shroud Repair  
Revision 4, June 16, 1995

## 10CFR50.59 SAFETY EVALUATION, REVISION 4

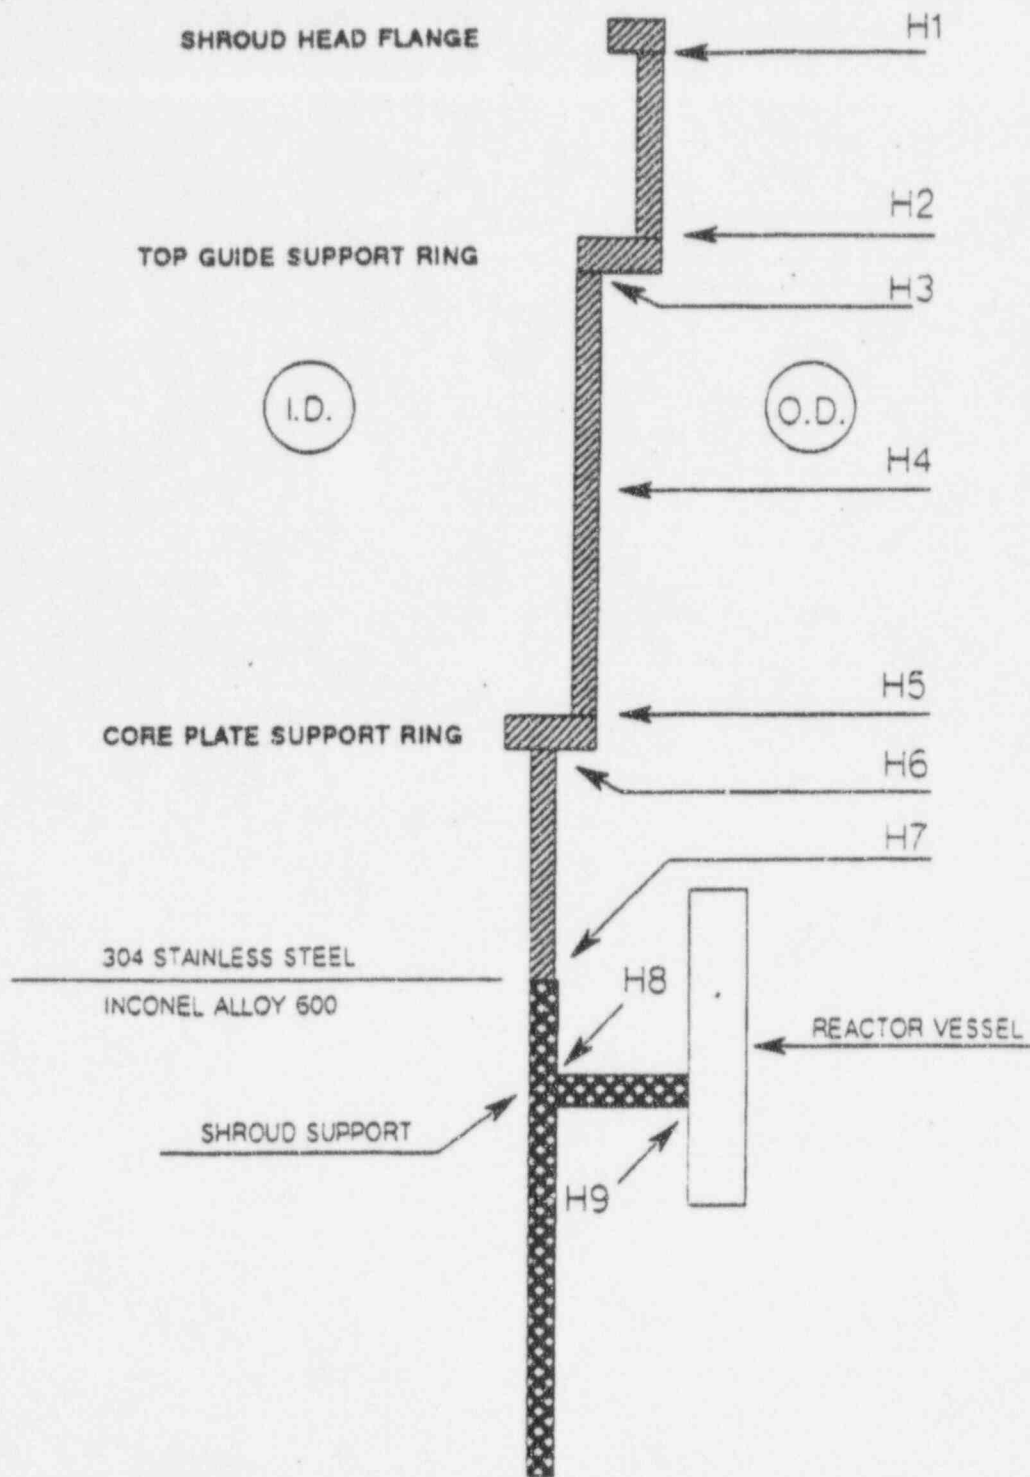
FIGURE 1. HORIZONTAL WELD LOCATIONS

## BACKGROUND INFORMATION (see figure 1):

In-vessel inspections found linear indications in the horizontal core shroud welds at Dresden Unit 3 and Quad Cities Unit 1 during the spring 1994 outages. Visual examination and ultrasonic testing at weld H5 indicated the crack extended 360 degrees around the circumference of the shroud. Two boat samples were taken (Quad Cities; azimuths 154 and 342-size 3"x 2"x 1.5"; Dresden; azimuths 153 and 324-size 3"x 2"x 1.35") to examine/analyze the root cause of the linear indications and compare measured crack depths in the samples to the depths determined by ultrasonic testing. Metallurgical evaluation determined intergranular stress corrosion cracking to be the root cause of the linear indications due to the application of the welded Type 304 stainless steel components in a strongly oxidizing aqueous environment.

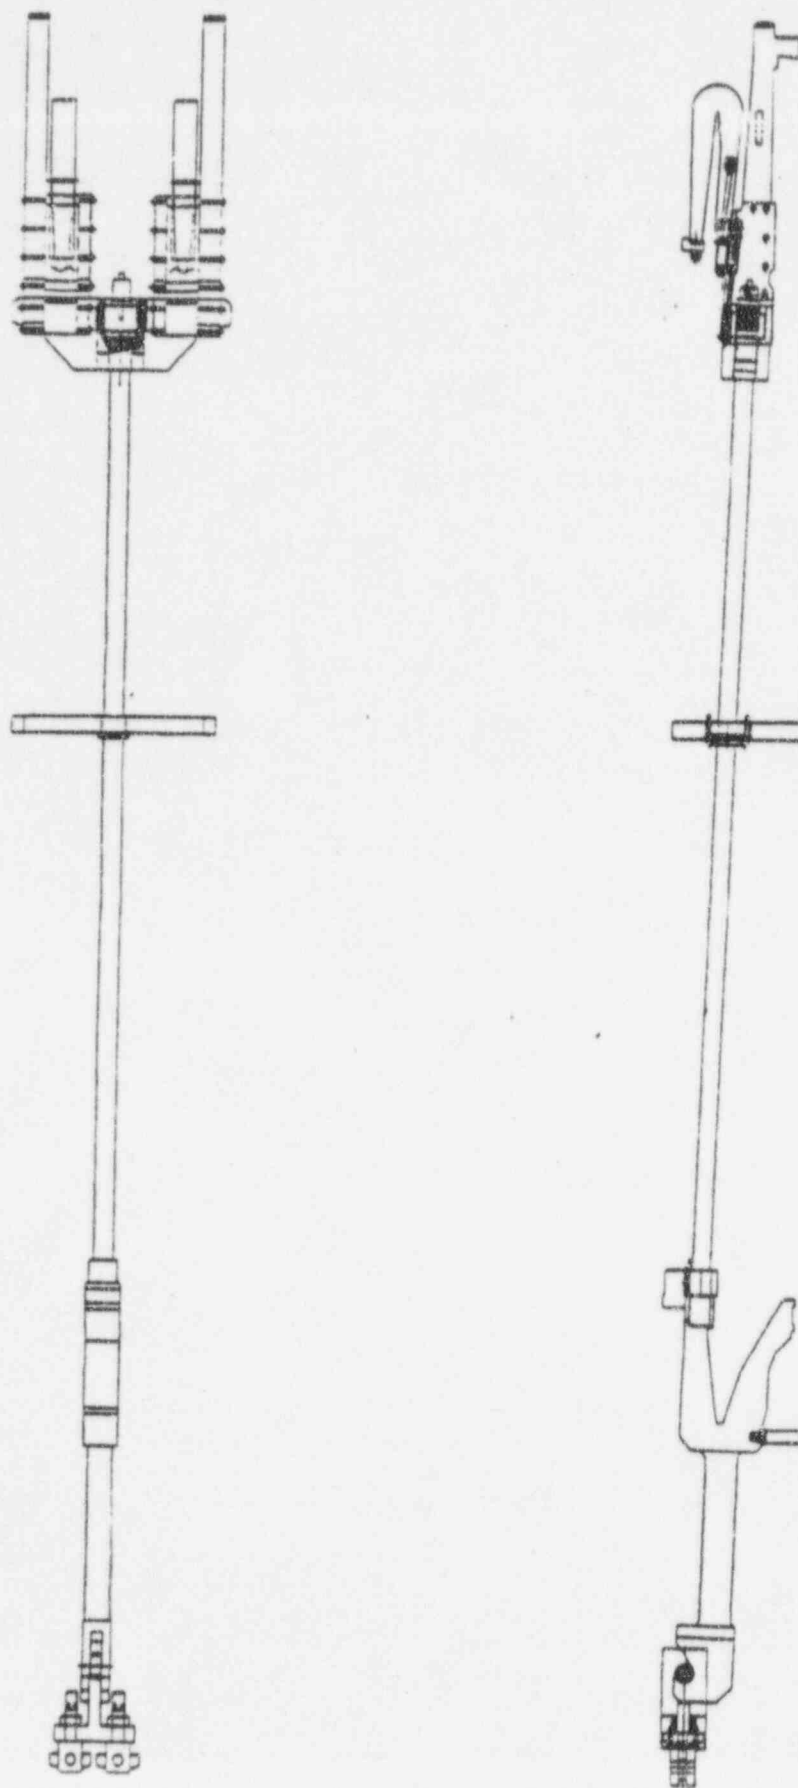
The core shroud repair is designed to structurally replace the core shroud's horizontal welds H1 through H7 and provide vertical clamping forces on the shroud in the event that any or all the seven shroud horizontal weld joints are cracked through wall. In general the core shroud repair design installs low tension tie rods with spring stabilizers connected between the separator head support ring and the jet pump support plate. Four tie rods will be evenly distributed in the annulus region of the reactor pressure vessel. Spring stabilizers will be mounted at the top guide support ring (welds H2/H3) and the core plate support ring (welds H5/H6) in the annulus area between the core shroud and the reactor pressure vessel wall. A middle spring stabilizer is mounted on the tie rod at the same elevation as the jet pump riser braces.

#### SHROUD PROBLEM SOLUTION (see figure 2):

The technical design requirement is that the repair design structurally replaces the core shroud horizontal welds H1 through H7 if these welds fail completely through wall. In addition, for design purposes the circumferential jet pump support plate H8 weld is to be considered cracked completely through and 360 degrees. Also, the design should not result in a driving mechanism for Intergranular Stress corrosion Cracking (IGSCC) in these welds or any other component in the reactor vessel such that it reduces the operating margin available from the remaining ligaments of the welds.
