SUBJECT: ENFORCEMENT CONFERENCE ON FUEL MOVEMENT WITHOUT ESTABLISHING
CONTAINMENT ISOLATION (INSPECTION REPORT NO. 50-289/91-27)

THREE MILE ISLAND
NUCLEAR GENERATING STATION

TMI-1 ENFORCEMENT CONFERENCE
NOVEMBER 20, 1991

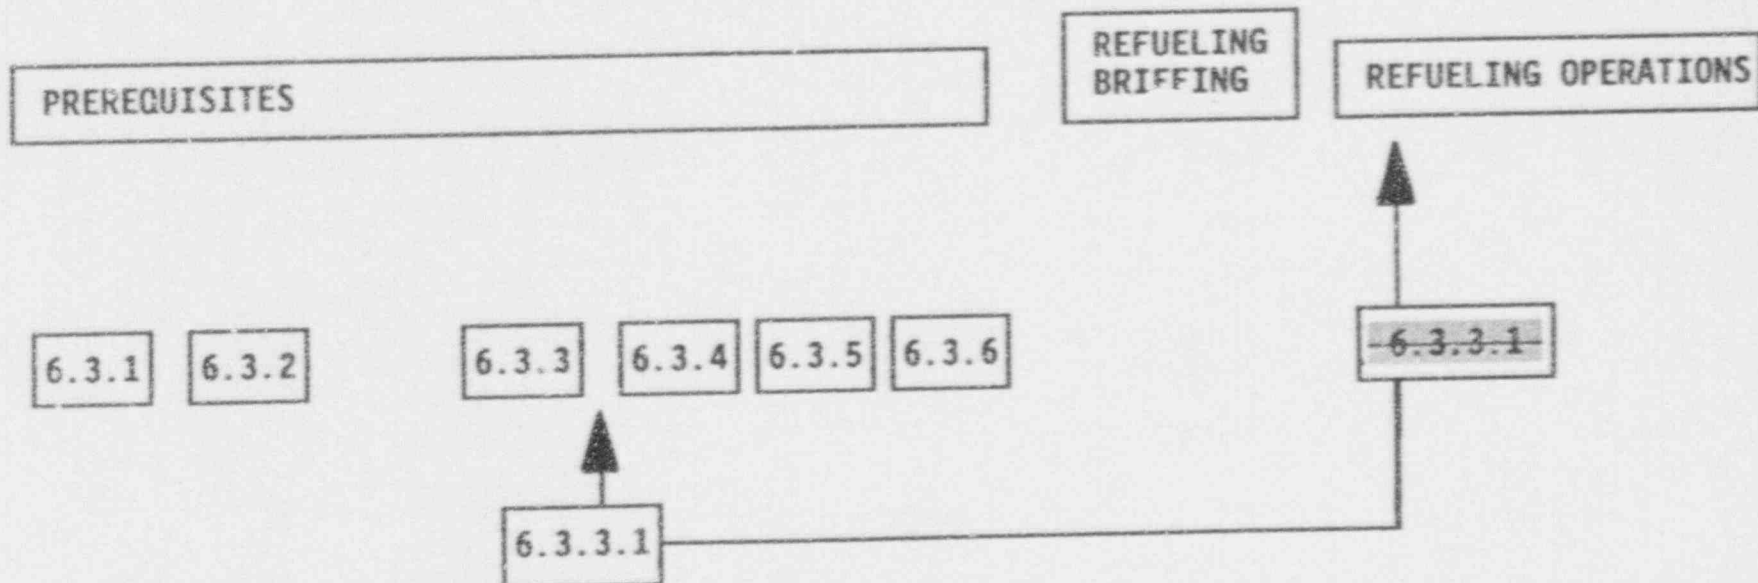
ACTUAL CHRONOLOGY

- o ON OCTOBER 8, 1991 TMI-1 WAS IN A REFUELING SHUTDOWN.
- o AN SRO AND CONTROL ROOM OPERATOR (CRO) WERE ASSIGNED AS THE BRIDGE CREW TO COMPLETE SURVEILLANCE PROCEDURE (SP) 1303-11.4 "REFUELING SYSTEM INTERLOCKS," ON DAY SHIFT.

- o THE BRIDGE CREW BEGAN WORK IN SECTION 6.3.3.1, PERFORMANCE OF INTERLOCK CHECKS. THIS SECTION TESTS THE MAIN FUEL BRIDGE HOIST FAST AND SLOW ZONE INTERLOCKS.

- o REFUELING PROCEDURE (RP) 1505-1 "FUEL AND CONTROL COMPONENT SHUFFLES," WHICH CONTAINS PREREQUISITES FOR THE COMMENCEMENT OF FUEL HANDLING, WAS COMPLETED EXCEPT FOR THREE ITEMS - ONE OF WHICH REQUIRES SECURING THE REACTOR BUILDING HATCHES.

- o THE BRIDGE CREW VERIFIED WITH THE CONTROL ROOM THE CORE LOCATION FOR THE FIRST ASSEMBLY TO BE MOVED, POSITIONED THE BRIDGE, AND GRAPPLED ONTO THE FUEL ASSEMBLY.

- o AT APPROXIMATELY 1040 HOURS, THE FUEL ASSEMBLY WAS WITHDRAWN FROM THE CORE COMPLETELY INTO THE FUEL MAST.

- o THE LAST STEP OF SP 1303-11.4 SECTION 6.3.3.1 REQUIRES CONTINUATION OF THE FUEL SHUFFLE PURSUANT TO RP 1505-1. AT THIS POINT, THE BRIDGE SRO REALIZED THAT THE REACTOR BLDG. WAS NOT CONFIGURED FOR REFUELING OPERATIONS, AND REINSERTED THE ASSEMBLY INTO THE CORE.
