MEMORANDUM FOR: Bruno Uryc, Enforcement and Investigation  
Coordination Staff

FROM: Charles A. Casto, Section Chief  
Test Programs Section  
Division of Reactor Safety

SUBJECT: ALLEGATION NO. RII-94-A-0089 VOGTLE NUCLEAR PLANT UNITS 1  
AND 2 DOCKET NUMBERS 50-424,50-425

## 1.0 Water in the Pneumatic Lines

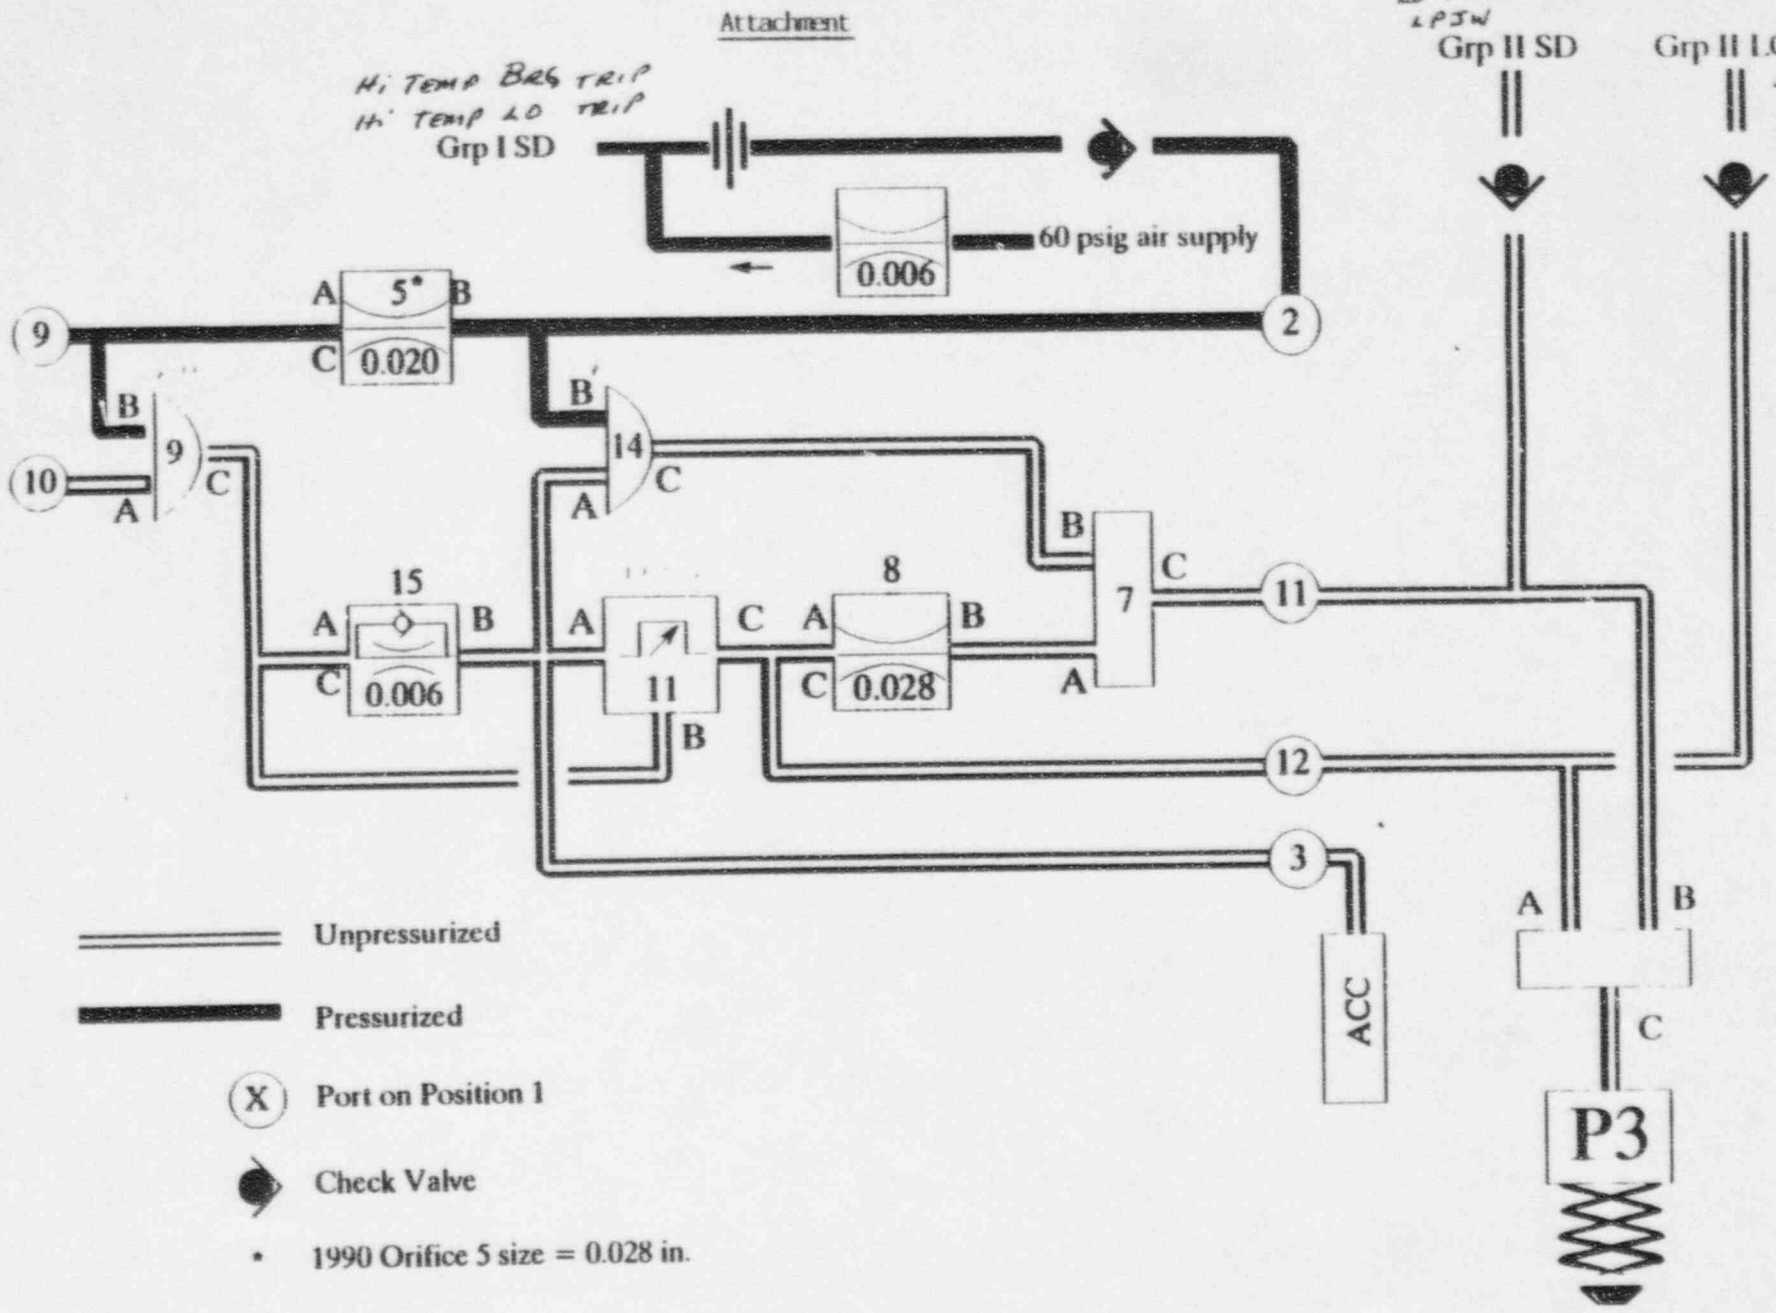
Figure 1. Simplified diagram of Shutdown board logic functions prior to DG start signal.

During normal plant operations the shutdown board logic elements are pressurized as shown in Figure 1. The Group I SD sensors are continuously pressurized through Port 2 on the shutdown board. The Group II SD and Group II LO sensor lines upstream of the isolation check valves are pressurized through Port 11 and Port 12 on the Shutdown board, respectively.

The air supply at port 9 of the shutdown board maintains 60 psig air pressure at AND-9 port B, AND-14 port B, and at port 2 of the shutdown board.

The Group II SD and Group II LO lines are not pressurized until a DG start demand. The P3 switch is in the vent position since neither port 11 nor port 12 are pressurized. Consequently, without either an automatic actuation or a manual override, the DG fuel lines and air supply will remain isolated and the DG will not start.

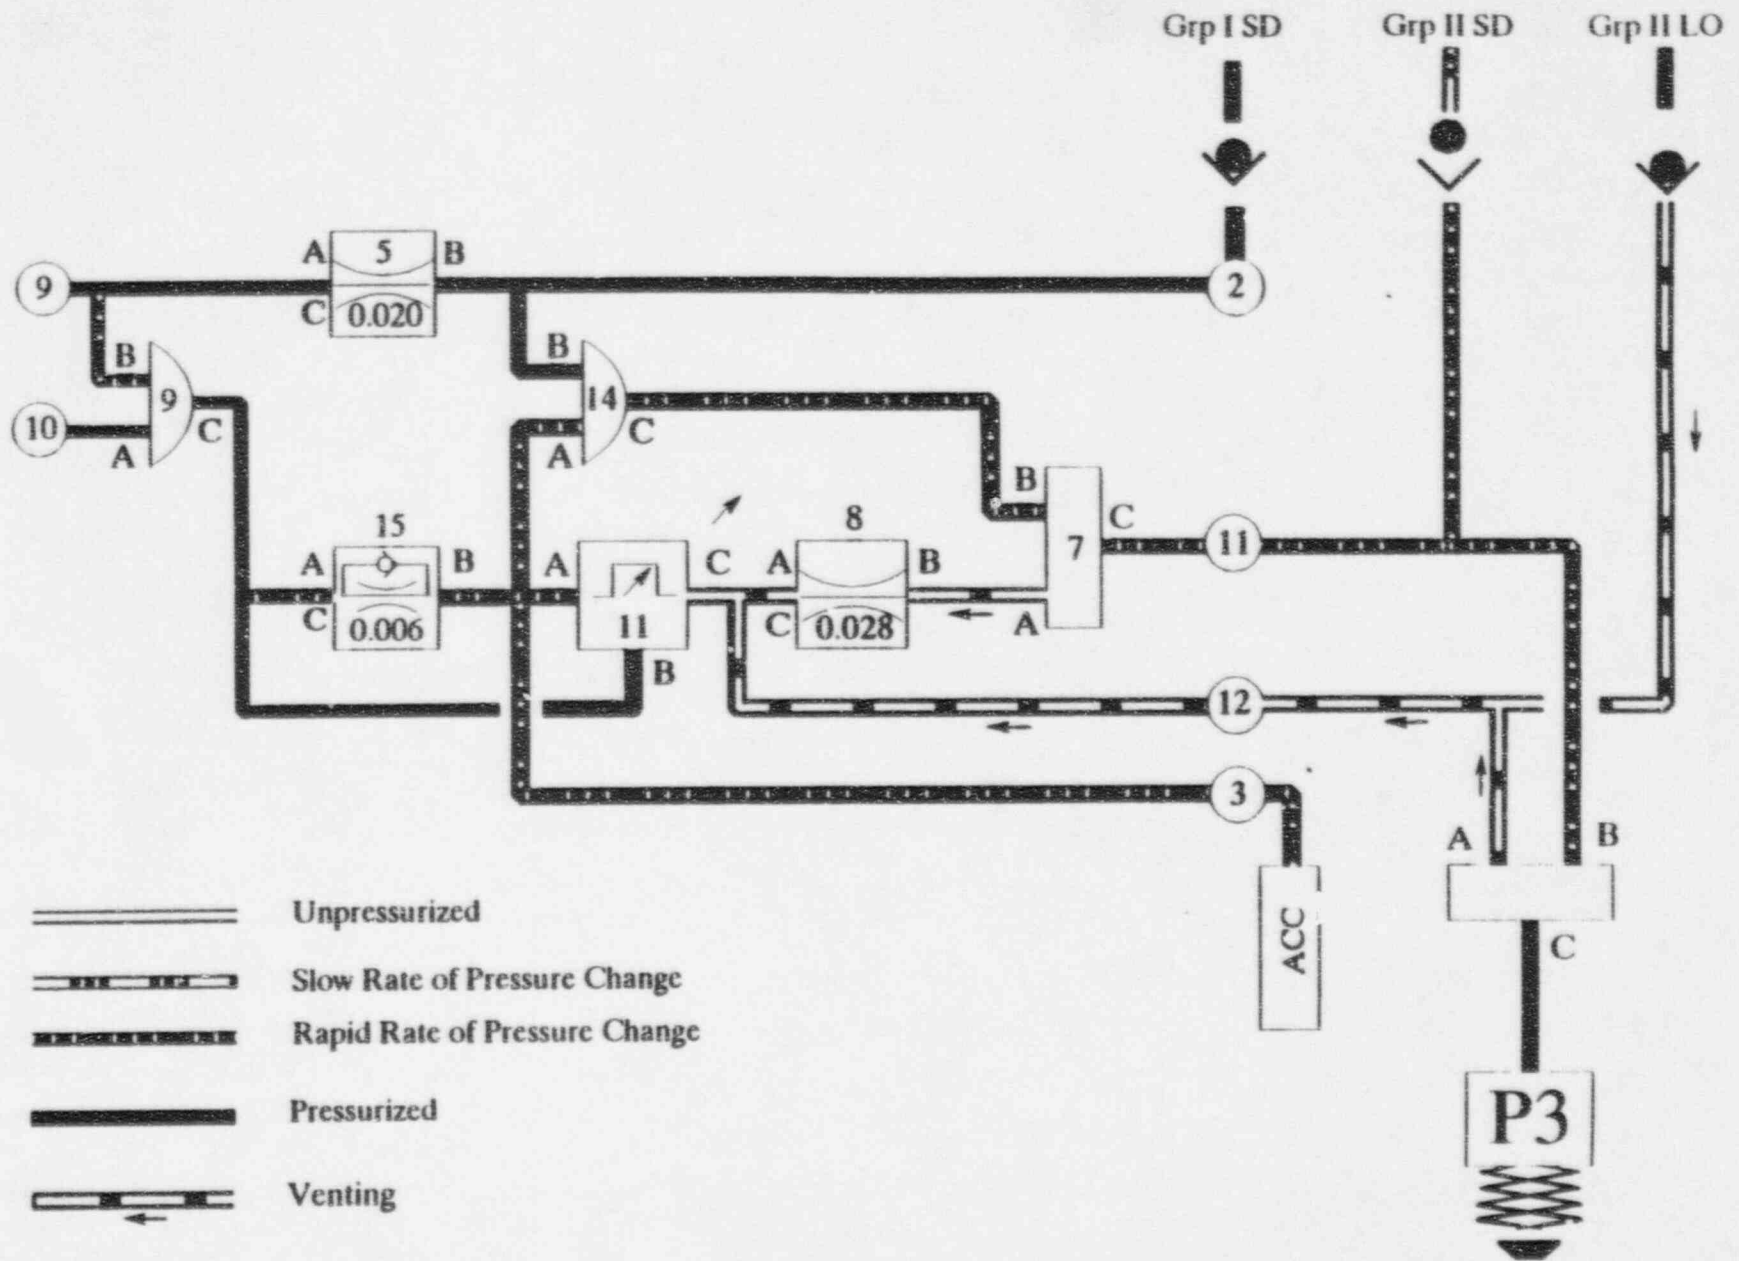
Figure 3. State of essential modules between 40 psig and 60 psig Accumulator pressure.

Figure 3 shows the system response when the pressure in the accumulator exceeds 40 psig but is less than 60 psig. Control air bleeds through POC-15 to the A port of AND-14 and Timer/NOT-11, and to the accumulator (ACC) at port 3 on the shutdown board. Pressure slowly increases to 45 psig in approximately 60 seconds. AND-14 then becomes TRUE, thereby connecting the B port of OR-7 to the Group I SD line. This line then supplies pressure to port 11 (Group II SD sensors) in addition to port 2 (Group I SD sensors).

Note that the Group II SD sensors are pressurized through port A on OR-7 prior to the accumulator reaching 45 psig. Additionally, the AND-14 gate turns true before the Timer/NOT 11 module begins timing down for the port 12 depressurization. Consequently, the pressure at port B on the P3 OR gate should be greater than the trip setpoint before the accumulator pressure reaches 45 psig.

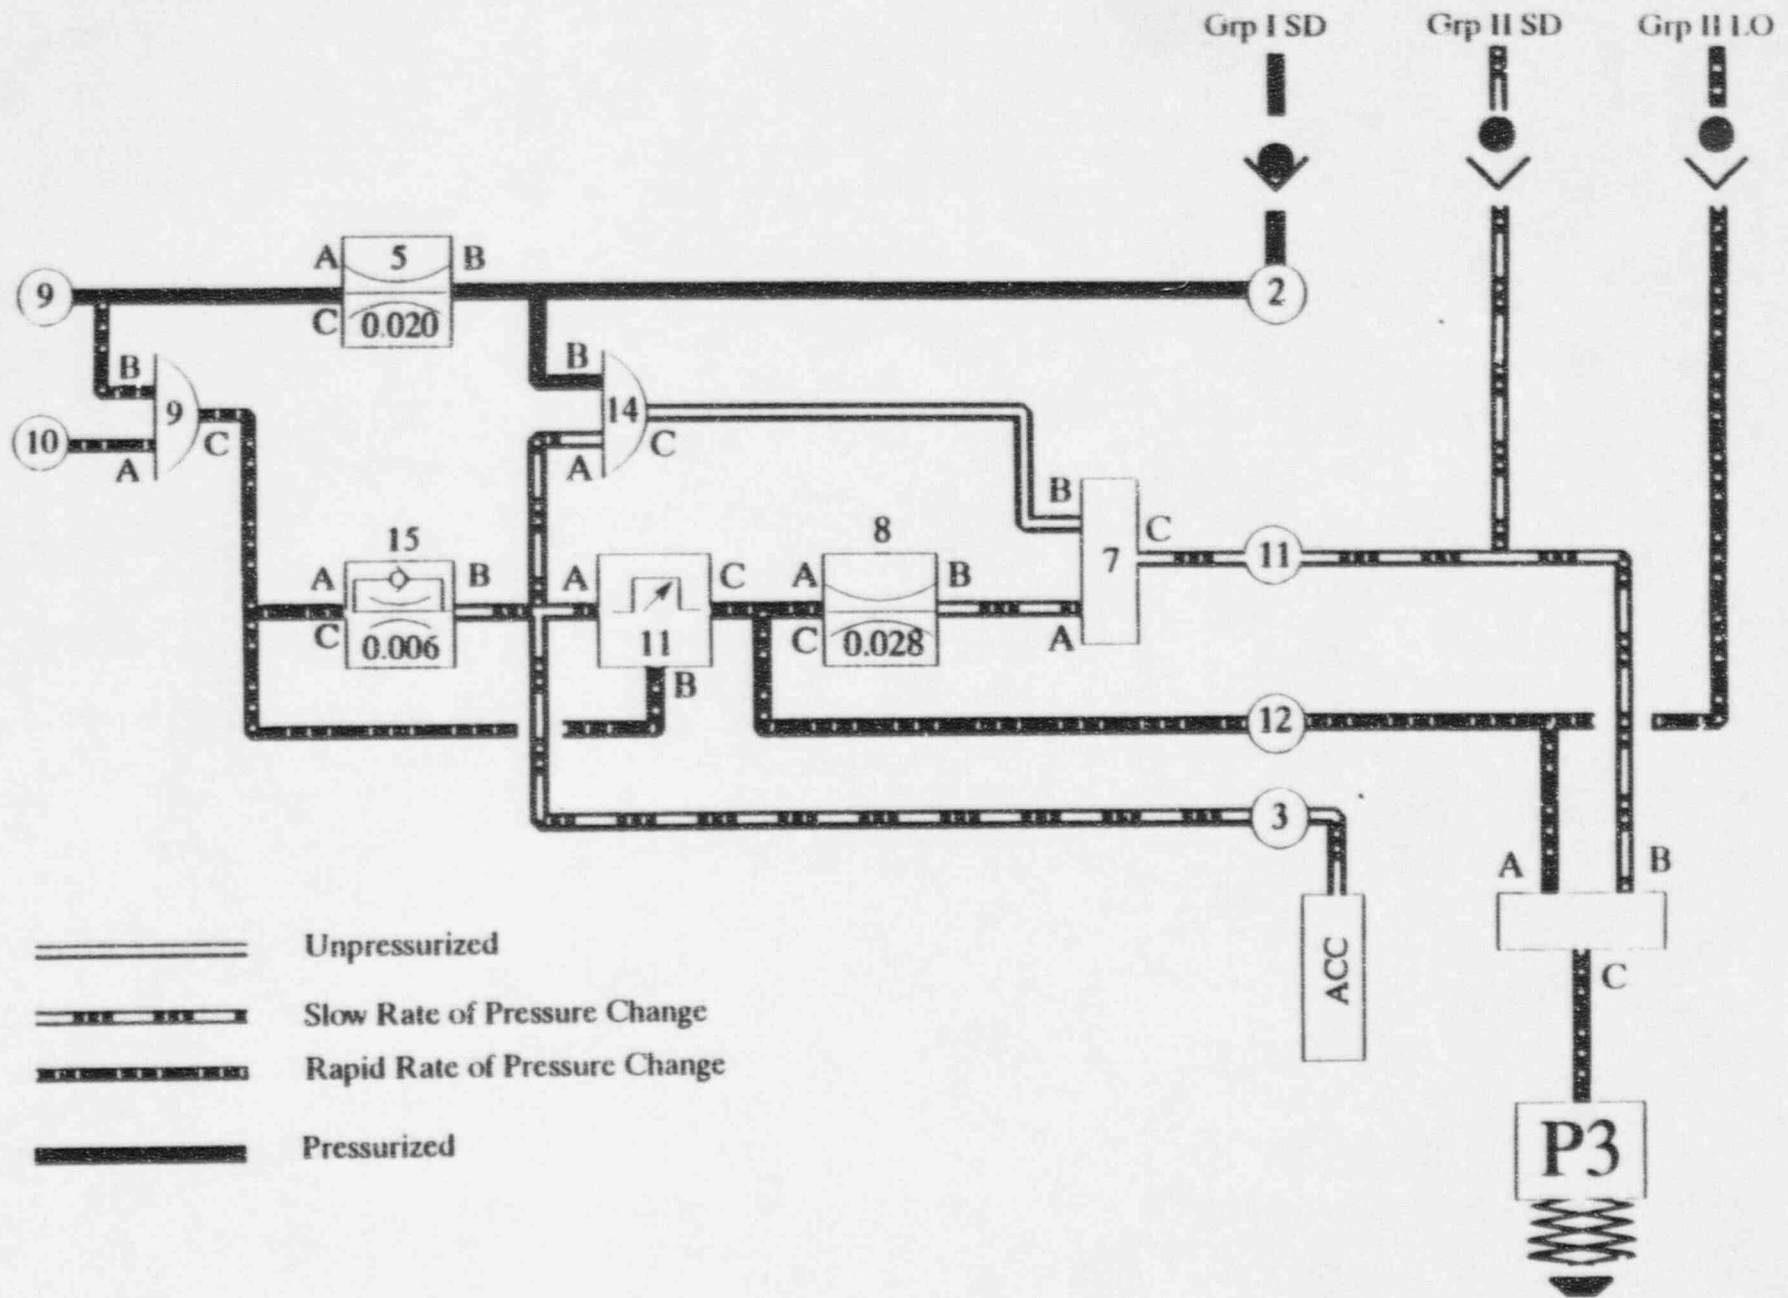
Figure 2. State of essential modules prior to 40 psig Accumulator pressure.

Figure 2 shows the response of the essential Shutdown board logic elements when a normal DG start is initiated, and prior to the accumulator (ACC) pressure reaching 40 psig. The DG start demand causes the Shutdown Activate solenoids (not shown in these figures) to

momentarily align the control system air to port 10 on the shutdown board. Pressure is transmitted through to port A on the AND-9 module. This momentary pressure pulse is held at port A.

When the pressure at AND-9 port A reaches approximately 40 psig, the AND-9 state becomes TRUE, and AND-9 transmits pressure to port B of Timer/NOT-11 and to the A/C port of the 0.006 inch parallel orifice check valve (POC-15). Timer/NOT-11 transmits pressure to the A/C port of orifice 8, and to port 12 of the shutdown board. Port 12 supplies pressure to the Group II lockout logic, which consists of the Group II LO sensors (lube oil pressure sensors and, formerly, the jacket water temperature sensors). Notice that port 12 is not pressurized by air that has been throttled by an orifice, as was stated by the allegor. In fact, all three orifices on the shutdown board are bypassed by the Group II LO logic.

Control air bleeds through orifice 8 and OR-7 to port 11 (Group II SDs). When the Group II SDs have reset, flow from port 11 is blocked on the engine and the pressure builds up to 60 psig.

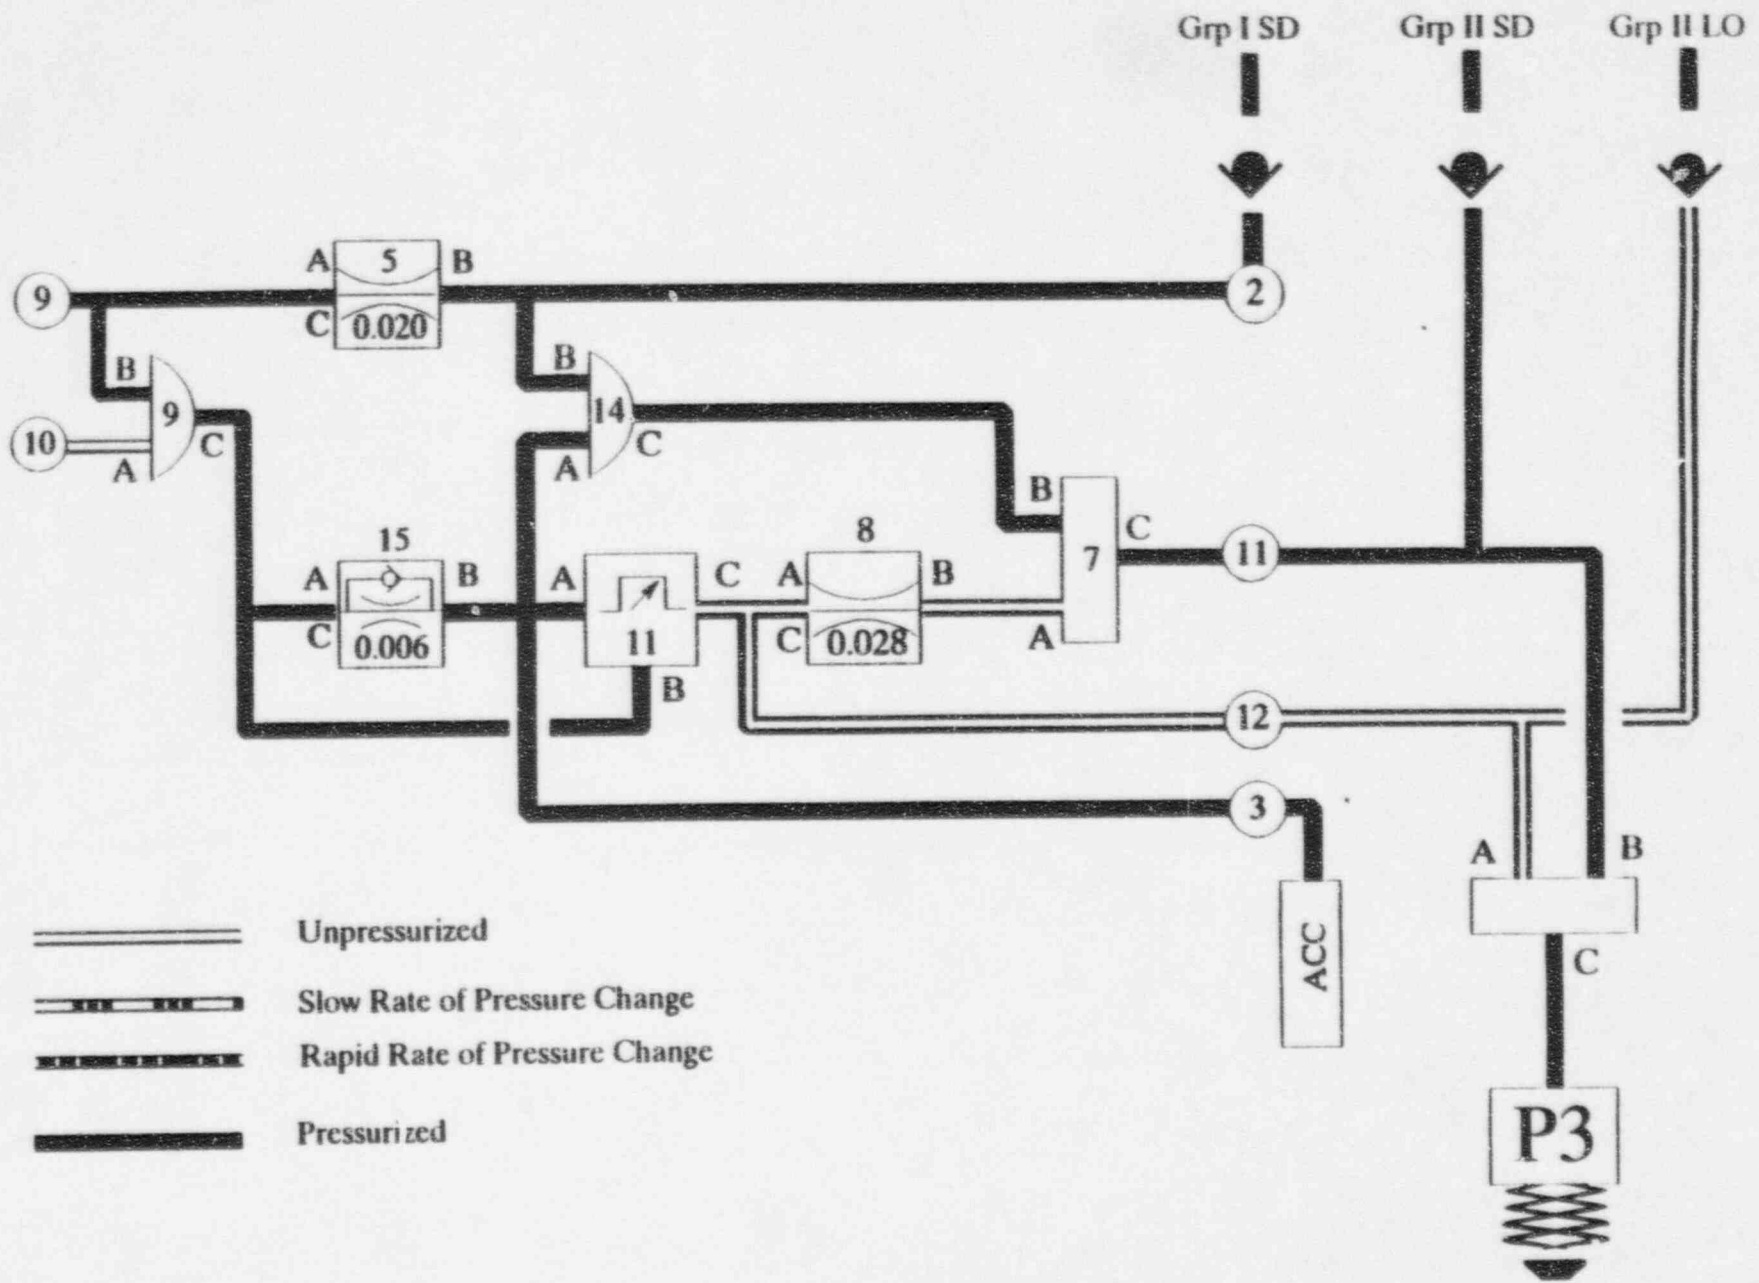
Figure 4. State of essential modules when Accumulator pressure is 60 psig.

When the accumulator pressure reaches 45 psig, Timer/NOT-11 trips. When the timer element times out, the pressure vents at port 12, and through orifice 8, the A port of OR-7. The Group II LO sensors do not trip because there is a check valve in each air supply line that prevents depressurization of the sensors when port 12 vents. The control logic is then in the state shown in Figure 4, and the DG is in operation.

If the Group II LO sensor lines do not pressurize prior to port 12 venting, a trip signal is initiated and port B of the P3 OR gate depressurizes, causing a Group II lockout.
