Subject: Byron Station Units 1 and 2
Braidwood Station Units 1 and 2
Battery Area Woven Wire Fences
NRC Docket Nos. 50-454/455 and
50-456/457

Inspection Report Nos. 50-456/83-17; 50-457 (83-16)

Item 3 - Inspection of Safety-Related 125 Volt DC Battery
Areas for Unit 1 and 2

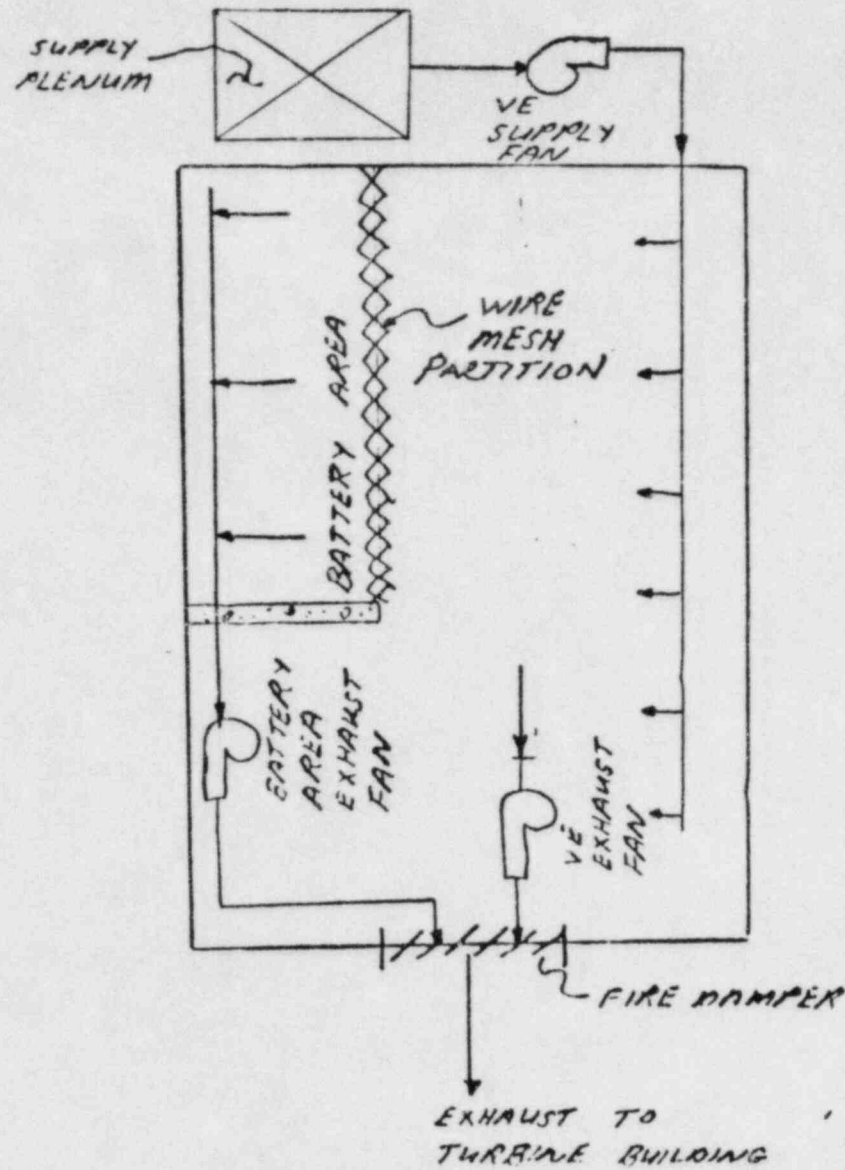
Figure b-1: Miscellaneous Electric Equipment Room
(and Battery Area) Ventilation System
(Typical)

Figure b-1 illustrates the equipment arrangement and air flow for the Miscellaneous Electric Equipment Room ventilation system. As previously noted, the safety-related 125V DC Battery Area is a part of the Miscellaneous Electric Equipment Room, which is enclosed by a three-hour fire-rated barrier. The battery area exhaust ventilation system will remove 475 CFM from the battery area. Based on the volume of the battery area, and on the calculated maximum hydrogen evolution rate (which could occur with a failure of the battery charging system), the ventilation system will limit the hydrogen concentration in the battery area to 1.44%; 28% less than the "2% of the total volume of the battery area" allowed by IEEE Std. 484-1981 (which itself is conservative). All of the make-up air for the battery area exhaust is drawn

from the Miscellaneous Electric Equipment Room. In order to purge (i.e., sweep) the total volume of the battery area, the exhaust duct is located adjacent to the wall opposite the wire mesh partition. The exhaust ductwork is located at the highest practical point in the room (i.e., immediately under the intermediate roof structural steel) and extends over the entire length of the rear battery rack.

Even if it is assumed that a fraction of the hydrogen gas (say 30%) escapes to the Miscellaneous Electric Equipment Room, the maximum concentration of hydrogen in this room is 0.022%, which is insignificant in comparison to the maximum allowable design concentration of 2%.
