EVENT REPORT

EVENT TITLE: DG 2A Start Failure  
 REPORT NUMBER: 2-90-005  
 DATE(S) OF EVENT: 7-11-90  
 EVENT CLASSIFICATION: B

TABLE OF CONTENTS FOR  
EVENT REPORT NO. 2-90-05

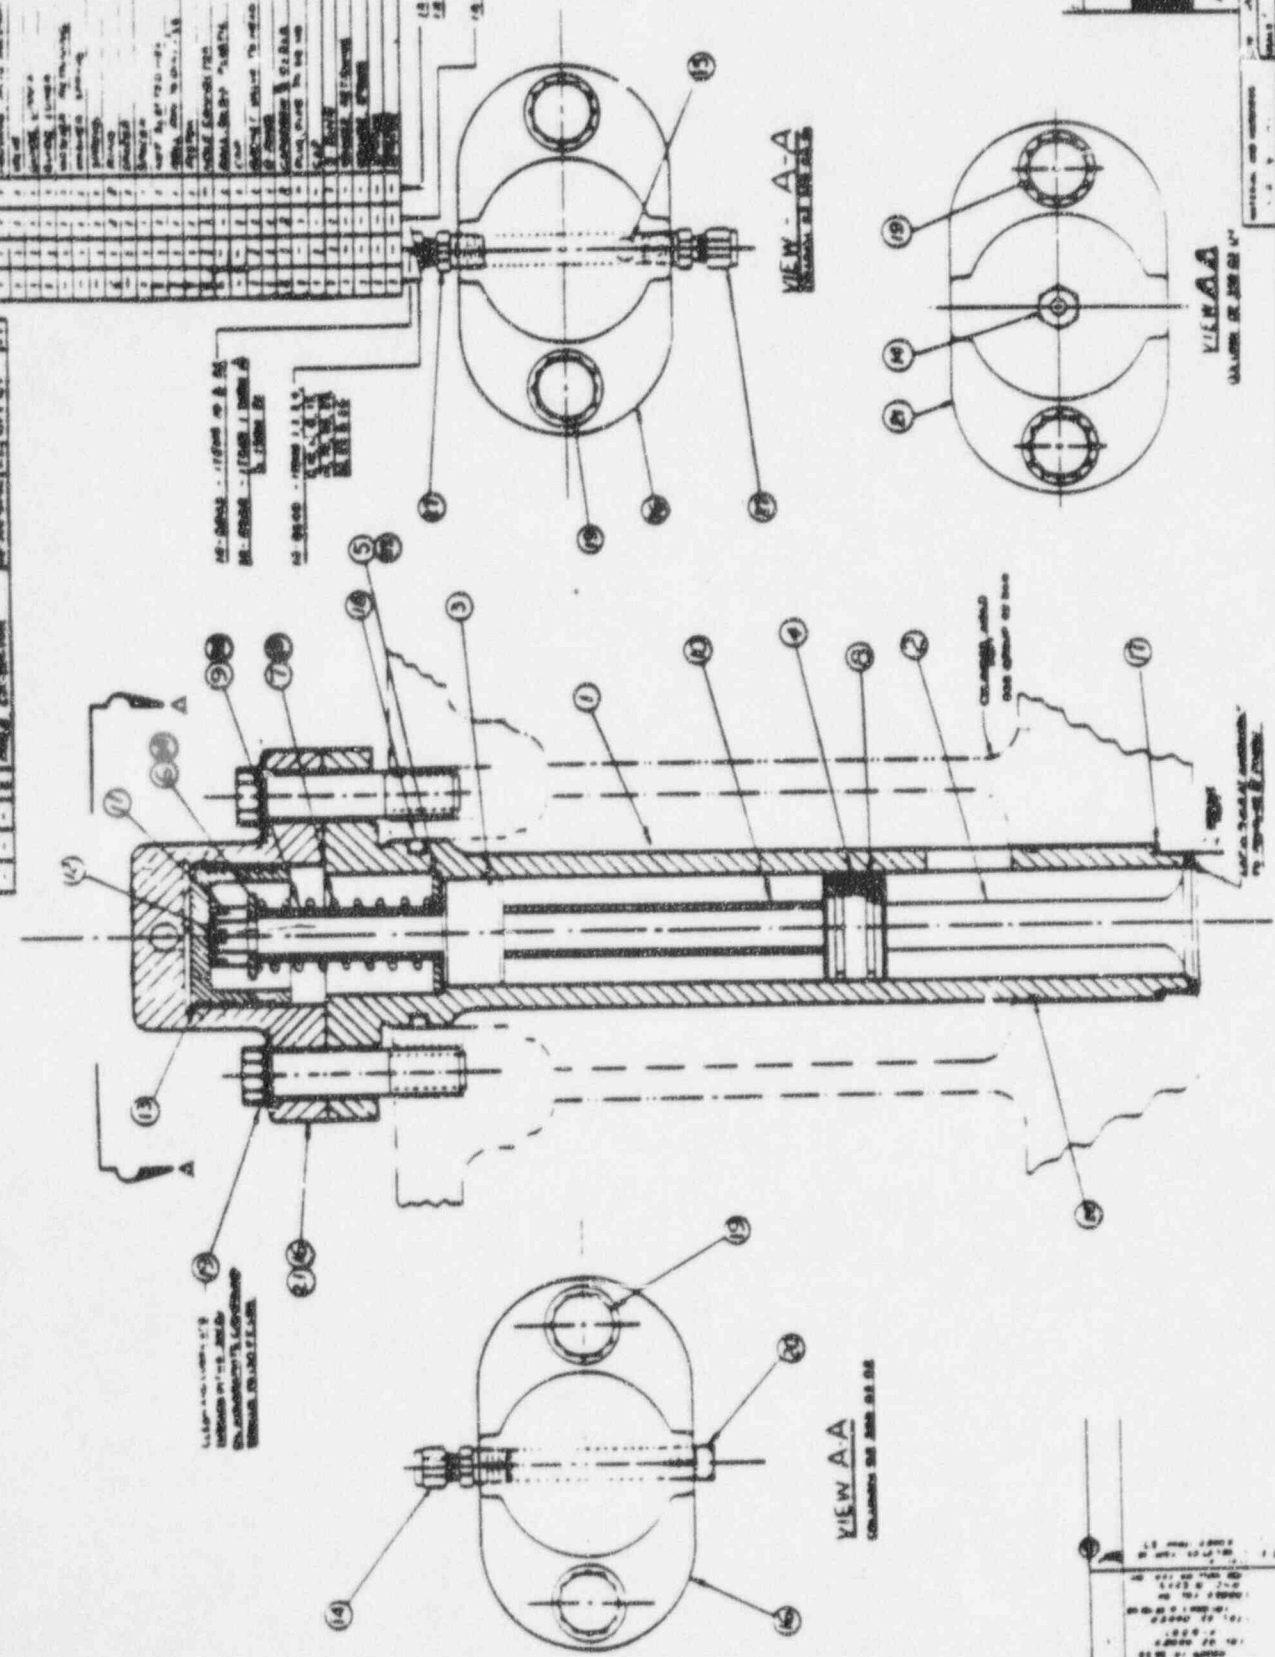
DEVALVE  
AIR START VALVE ASSY  
Q2 359-03

The seizing of these air start valves was discovered by a "pop test" performed under the manufacturer's direction. This test applies approximately 100 psi of air to the starting air valve at the engine subcover. An audible sound can be heard on valve opening and closing, if the valve is not sticking. All valves initially noted to be sticking were machined to a tolerance of 0.002 to 0.003 and retested with no problems found.

Diesel generator 2A failures to start due to starting air valve piston seizure within its associated cap assembly appears to be the result of marginal clearance between the piston and cap. This condition exists apparently due to manufacturer machining process which allow uneven bore conditions on the cap and in some cases caps with flanged surfaces which are not flat. Secondly, the tolerances specified by the manufacturer were 0.001 to 0.003 between piston and cap. This clearance may have been sufficient for ambient temperature but did not allow for expansion of the piston inside the cap during engine standby or operating conditions or to overcome any machining irregularities.

To minimize the possibility of sticking, Engineering is assessing the gap minimum clearance distance between the piston and cylinder walls. Any changes in the desired minimum gap clearance will be reviewed against recorded gap distances for Diesel Generator 1A, 1B, and 2B for possible replacement. Also, changes to the minimum gap clearance will be incorporated into Maintenance Procedures 28714, 28713, 28575 and 28576.
