CATAWBA NUCLEAR STATION
DIESEL ENGINE 1A COMPONENT REVALIDATION INSPECTION
REPORT

PREPARED BY
DUKE POWER COMPANY

June 1, 1984

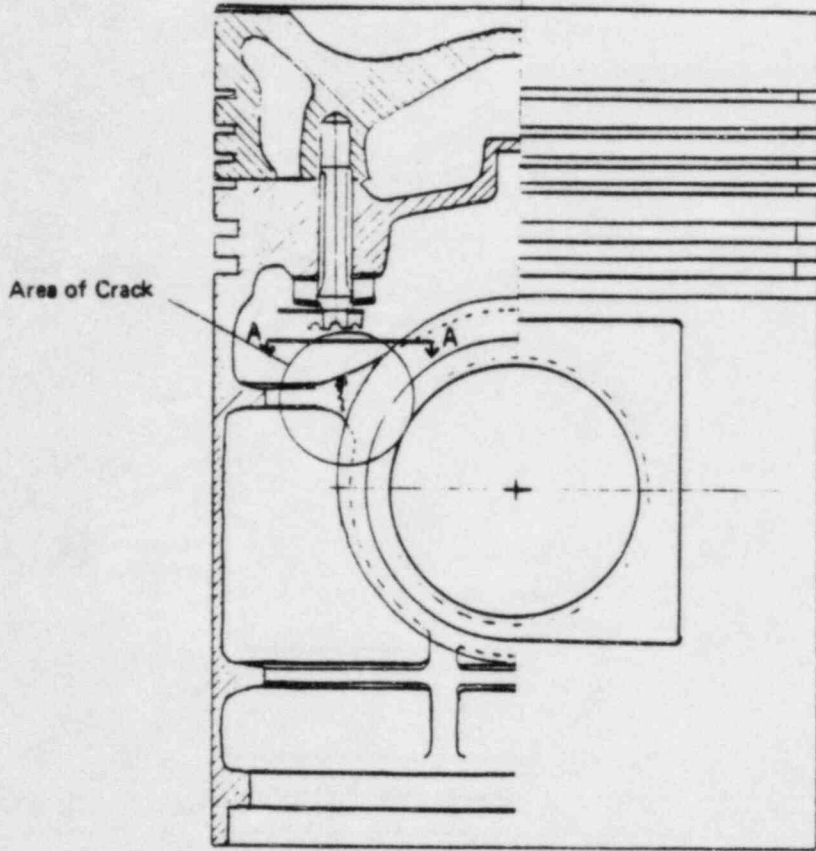
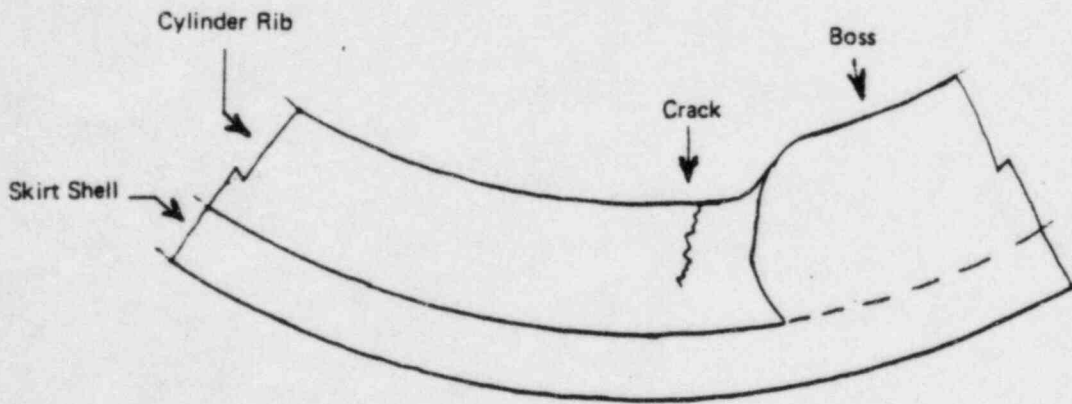
FIGURE 2-1
CRACKED TYPE AN PISTON SKIRT

- One major problem was noted on the 1A diesel. Four of the type AN piston skirts used in the 1A diesel were found to have one or more cracks in the region where an internal circumferential reinforcing rib intersects the piston pin boss (Figure 2-1). This problem is discussed further in Section 2.2.

Four type AN skirts were found to have cracks adjacent to piston pin bosses. (Figure 2-1) These cracks run approximately vertically, and appear to initiate on the inside of the skirt where a circumferential reinforcing rib intersects the piston pin boss. The largest crack, on skirt 3L, was through wall and was about 3 to 4 inches long on the outside.

The most significant condition noted was the presence of cracks in four piston skirts adjacent to piston pin bosses. The largest crack was 3 or 4 inches long and was through the wall. The cracks appear to originate at the skirt ID, on the fillets where a reinforcing rib intersects the piston pin bosses, and to run in an approximately axial direction. The cause of the cracking is unknown at this time but is believed to be due to cyclic fatigue. Skirts have been sent to FaAA for failure analysis.

The cracked AN type piston skirts in the Catawba 1A diesel did not cause any operational problems, and 12 of the 16 skirts were free of cracks. Nevertheless, all the piston skirts will be replaced with improved design AE skirts. The AE skirts have been stress relieved and include improved design features such as a thicker reinforcing rib and better rib-piston boss intersection details. These improvements are expected to adequately reduce the stresses and propensity for cracking in the area which experienced cracking at Catawba. The FaAA/Owners Group program will quantify the benefits achieved by use of AE piston skirts. It is anticipated that this will show that no cracking is expected during the life of the Catawba diesels. The AE piston skirts also incorporate the latest improvements in the stud boss region, which has been a problem area in earlier piston designs at the skirt to head transition.

Cracks were found to be present in piston skirts near piston pin bosses. As a result, all of the piston skirts will be replaced with type AE pistons. In addition, a detailed failure analysis has been initiated, as part of the TDI Owners Group program.

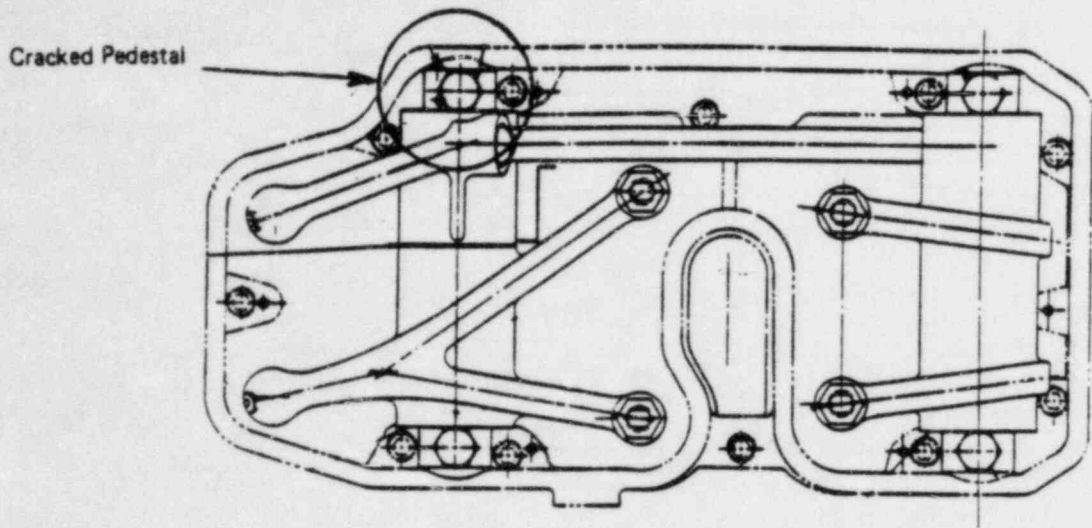
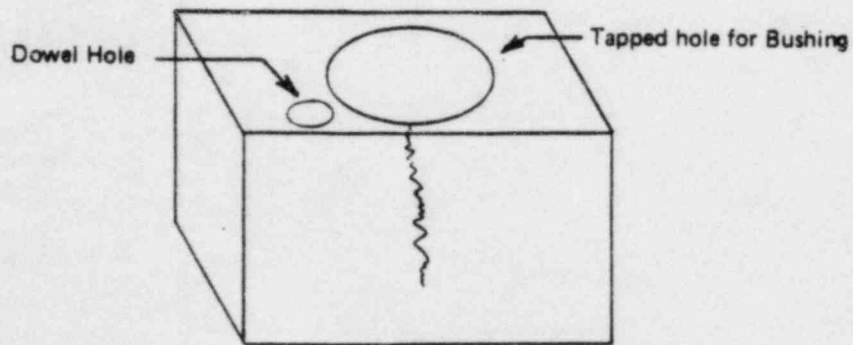
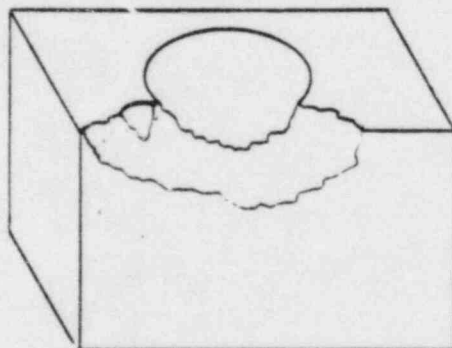
FIGURE 2-2
CRACKED SUBCOVER CASTINGS

- Two subcover castings were found to have cracks in an intake rocker arm pedestal (Figure 2-2). These cracks are discussed in Section 2.3.
- Two Catawba cylinder heads (one on diesel 1A and one on 1B) experienced small jacket water leaks into the fuel injector cavity. Recent metallographic examinations of the head removed from the 1A diesel indicates that the leak was due to a fatigue crack (Figure 2-3). This problem is discussed in Section 2.4.

Two cast iron subcovers were found to have cracks in a pedestal where the intake rocker arm shaft is bolted to the subcover (Figure 2-2B). Prior to the extended operation test, another subcover was found to have a piece of this pedestal missing (Figure 2-2C). None of these cracks have affected diesel operability. However, since similar problems have been reported with other diesels, FaAA has initiated a failure analysis of a Catawba subcover. Preliminary thinking is that the cracks are due to installation tolerances between dowels, bushings, and the pedestal leading to excessive interference. Whether such excessive interference fits will be confirmed as the problem by the failure analysis being performed by FaAA is not yet known.

Two subcovers were found to have cracked bosses following the extended operation test. All of the others were free of defects.

Several cracked bosses were found and the affected subcover assemblies have been replaced. These cracks have not caused a loss of operability of the engines. A failure analysis will be performed by FaAA under TDI Owners Group direction. Until the cause of failure and the frequency of cracking are better established, the Catawba subcovers will be inspected as necessary to verify that additional cracking has not occurred.

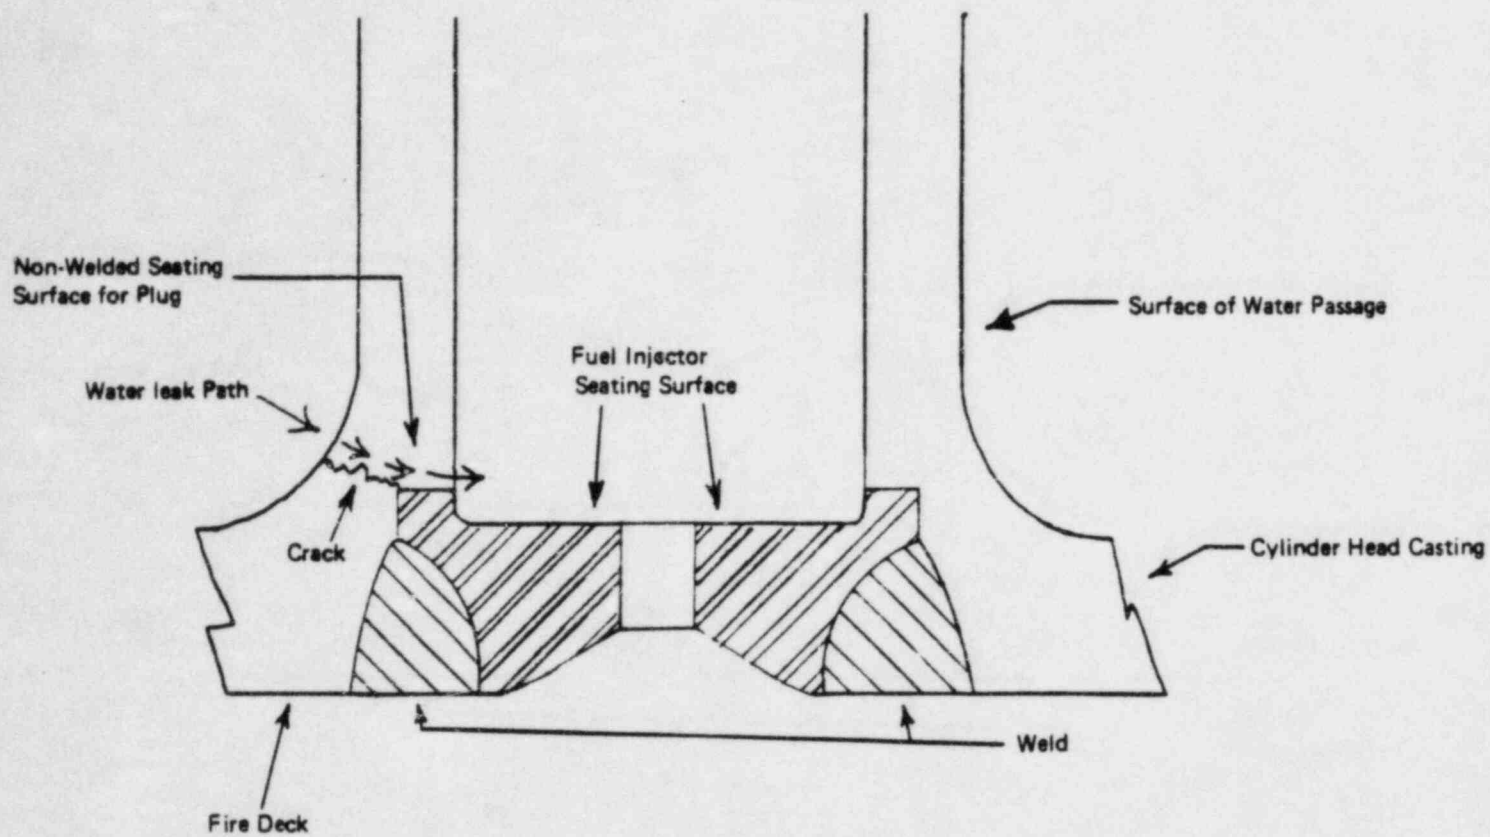
FIGURE 2-3
CRACK IN CYLINDER HEAD

Two cylinder heads at Catawba, one on engine 1A and one on engine 1B, developed small jacket water leaks into the fuel injection cavity. The 1A leak developed during the extended operation test and the engine was shut down due to other problems three days after detection of the leak. The 1A leak did not affect engine operability. The leak on the 1B engine was of similar magnitude to that of 1A. The 1A cylinder head has recently been examined by FaAA. This investigation revealed that the leak was caused by a crack initiating from the corner of a welded-in plug where it was seated in the cylinder head (Figure 2-3). This welded-in plug is reported by TDI to have been used to repair the casting around the fuel injector hole.

The cause of crack propagation has not yet been determined. However, the cause is believed to be thermal/pressure fatigue at the sharp corner of the counter bore for the plug. FaAA will perform a failure analysis as part of the TDI Owners Group program to identify the cause. The leaks caused by the cracks have not affected diesel operability since they result in small amounts of water leaking into the fuel injector cavity and then off of the diesel. This does not affect diesel operation and the heads can be replaced at a convenient opportunity. For this reason, special inspections to check for this condition are not considered necessary. Nevertheless, cylinder heads at Catawba are currently being inspected to determine which ones have been repaired in the injector hole.

Two small jacket water leaks have been experienced at Catawba resulting in water leaking into the fuel injector nozzle cavity. Failure analysis of one of the leaking heads has been partially completed. The leak was due to cracks propagating from a corner where a welded plug was installed in the fuel injector nozzle seating area. This welded plug was used to repair the injector bore during manufacture. (Figure 2-3)
