LICENSEE EVENT REPORT (LER)

FACILITY NAME (1) Duane Arnold Energy Center	DOCKET NUMBER (2) 050003311	PAGE (3) 1 OF 05
---	--------------------------------	---------------------

TITLE (4)
MSIV Failure Due to Disc Separation

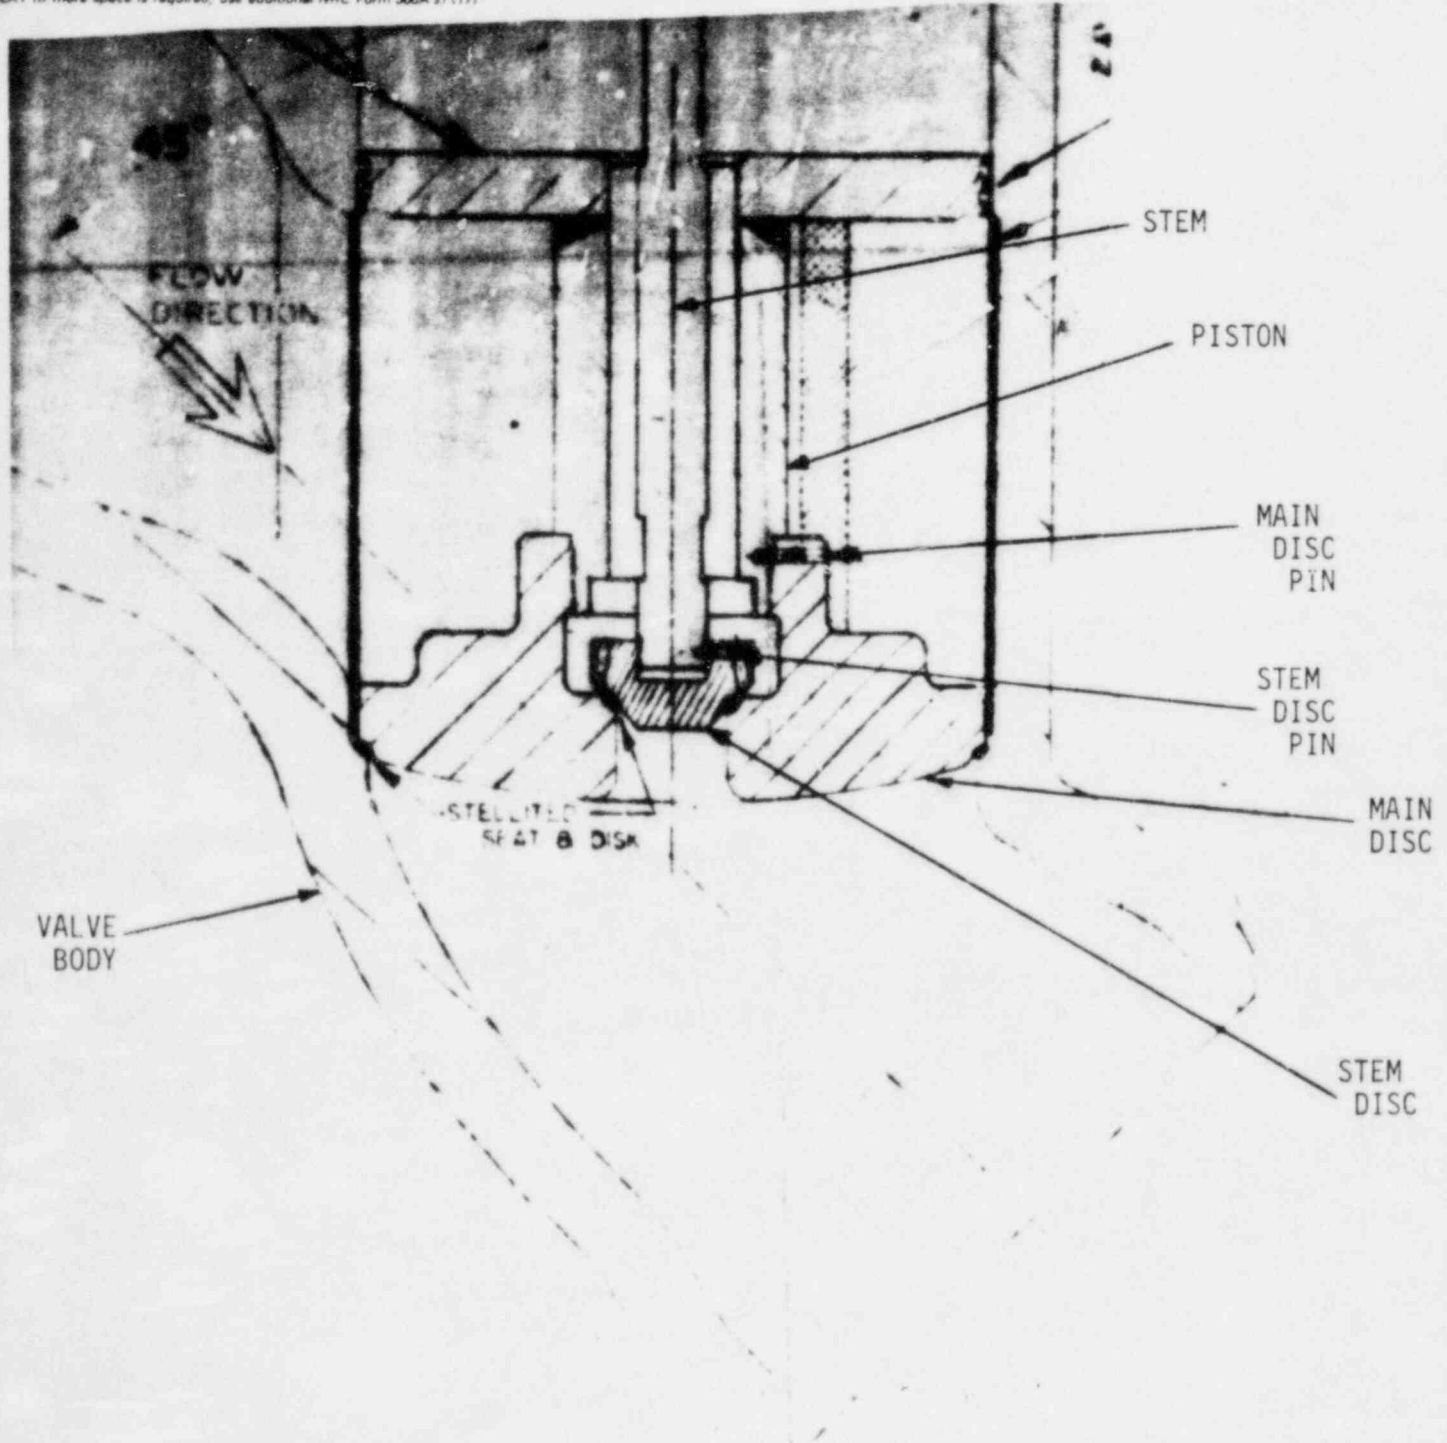
FIGURE 1

Following shutdown, maintenance activities were initiated on the "C" inboard MSIV. This component is a Rockwell International 16" valve (See Figure 1). The as-found condition of the "C" inboard valve was that the main disc had separated from the piston and was turned 90 degrees from its normal position in the valve body. This is the first occurrence of MSIV main disc failure at Duane Arnold. Previous failures at other facilities resulted in the disc seating in the closed position (See, for example, IE Information Notice 81-28).

Removal and inspection of the valve assembly and the loose disc found that: 1) the main disc to piston pin was still in the disc but had been "rolled over" following the separation, 2) the pin hole in the piston was elongated in the axial direction, 3) the piston and main disc threads where the main thread engagement had been were stripped, and 4) the top 2 to 3 piston threads showed no indications of having been engaged. Metallurgical defects or flaws were determined not to be a contributing cause. It was determined that the maintenance reassembly activities when the valve was last reassembled during the Spring, 1982 outage were the cause of the eventual piston/disc separation. The Repair Procedure and instruction manual used to attach the disc to the piston required the disc/piston assembly to be "torqued tight". In this specific case, this left the top threads unengaged and the disc not threaded completely onto the piston. Normal flow conditions caused the disc to vibrate on the piston and eventually wear the threads and locking pin to the point where the assembly separated. Material wear markings on top of the stem-disc indicated the piston/disc assembly was oscillating against it. Over the past two years of operation, the disc began to move on the piston until the threads were finally worn down and only the pin held the disc in place. The final result was a piston/disc separation. This failure mode is the joint conclusion of Iowa Electric Engineering, Maintenance, and an onsite Rockwell service representative. Rockwell has recently revised the torque recommendation for reassembled piston/disc assemblies to 500 ft-lb. However, Rockwell and IE Engineering agree that the revised recommendation does not necessitate piston/disc disassembly and retorquing of the remaining valves in service. As discussed below, our lack of prior piston/disc failures, inspections during previous valve maintenance activities and disassembly of two additional MSIVs support this conclusion.

- 1) MSIV repair procedure have been updated to include the new torque recommendations.
- 2) "B" and "C" inboard MSIVs are being reassembled and reinstalled using the new valve assemblies and the updated repair procedure.
- 3) "C" outboard MSIV have been reassembled and reinstalled using the existing valve assembly and the updated repair procedure.
- 4) Each of the three reassembled valves will pass a local leak rate test which is standard practice for a reworked valve.
- 5) The remaining five MSIVs will be disassembled for inspection at the next refueling outage.
