# GULF STATES UTILITIES COMPANY

LICENSEE EVENT REPORT (LER)

FACILITY NAME (1): RIVER BEND STATION

TITLE (4): DESIGN DISCREPANCY IN THE WIRING DIAGRAM FOR TWO HYDROGEN MIXING SYSTEM VALVES

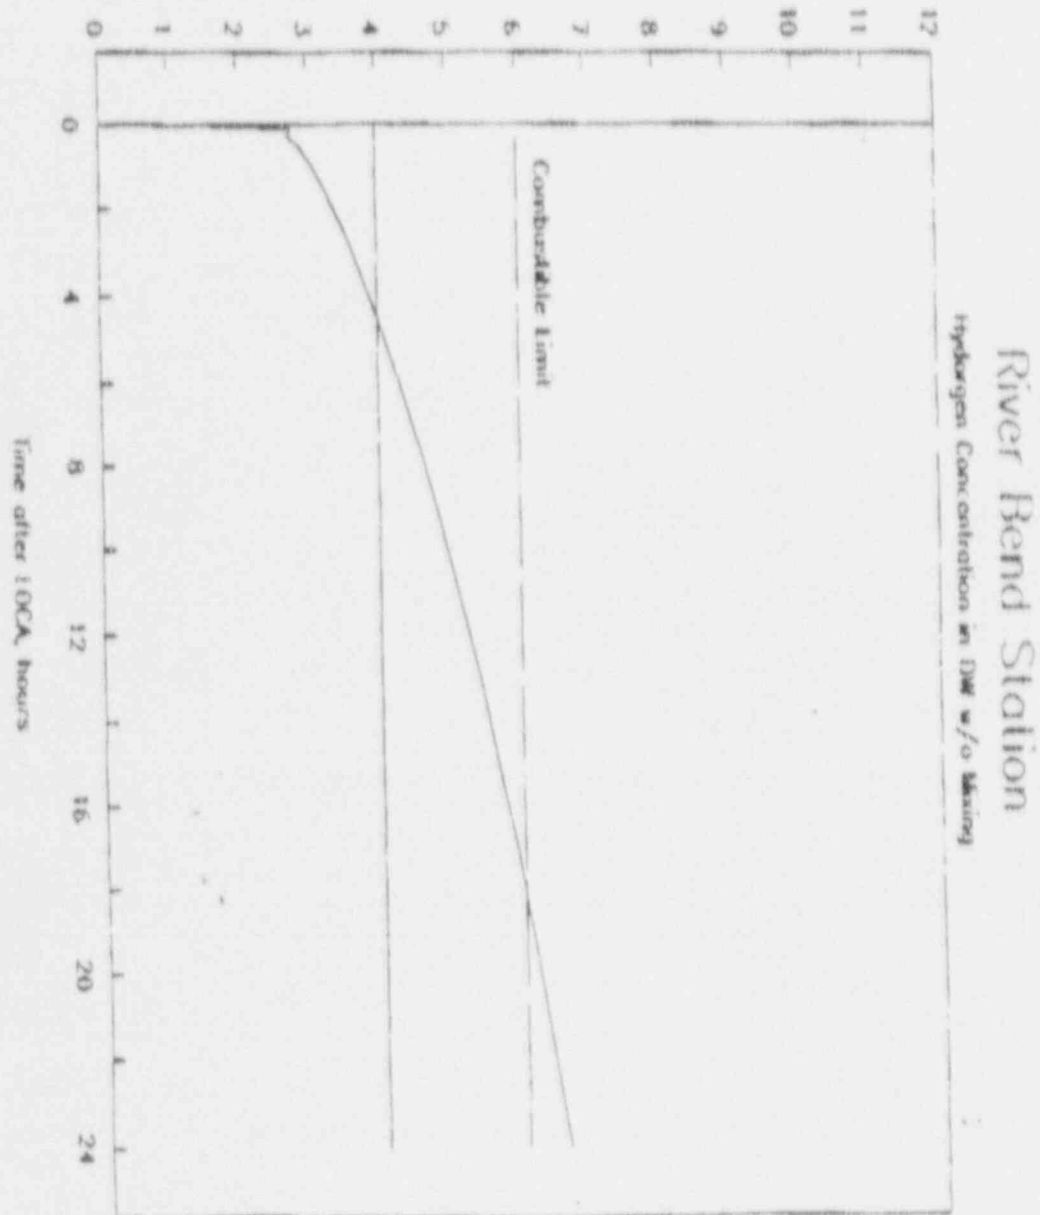
"FIGURE 1"

Based on this regulatory guidance, the hydrogen production at River Bend following a LOCA was calculated in Reference 3. Figure 1 is a plot of the resulting drywell hydrogen concentration (percent) versus time after the LOCA. For this calculation, hydrogen mixing (\*BB\*) was assumed to be inoperable.

As stated in the USAR (Ref. 1), 4% drywell hydrogen is the design basis for hydrogen mixing. This level is reached at about 4.5 hours after the LOCA. Hydrogen mixing (\*BB\*) would be necessary at or before this time to meet the design basis.

Reg. Guide 1.7 discusses hydrogen burning between 4% and 6%, and states that "... a limit of 6 volume percent would not result in effects that would be adverse to containment systems." If 6% is considered limiting, then hydrogen mixing (\*BB\*) operation would be needed within about 17 hours of the LOCA.
