May 22, 1984
ST-HL-AE-1094
File Number: G12.84

South Texas Project
Units 1 & 2
Docket Nos. STN 50-498, STN 50-499
Final Report Concerning
Vendor-Fabricated Structural Steel

Final Report Concerning
Vendor-Fabricated Structural Steel

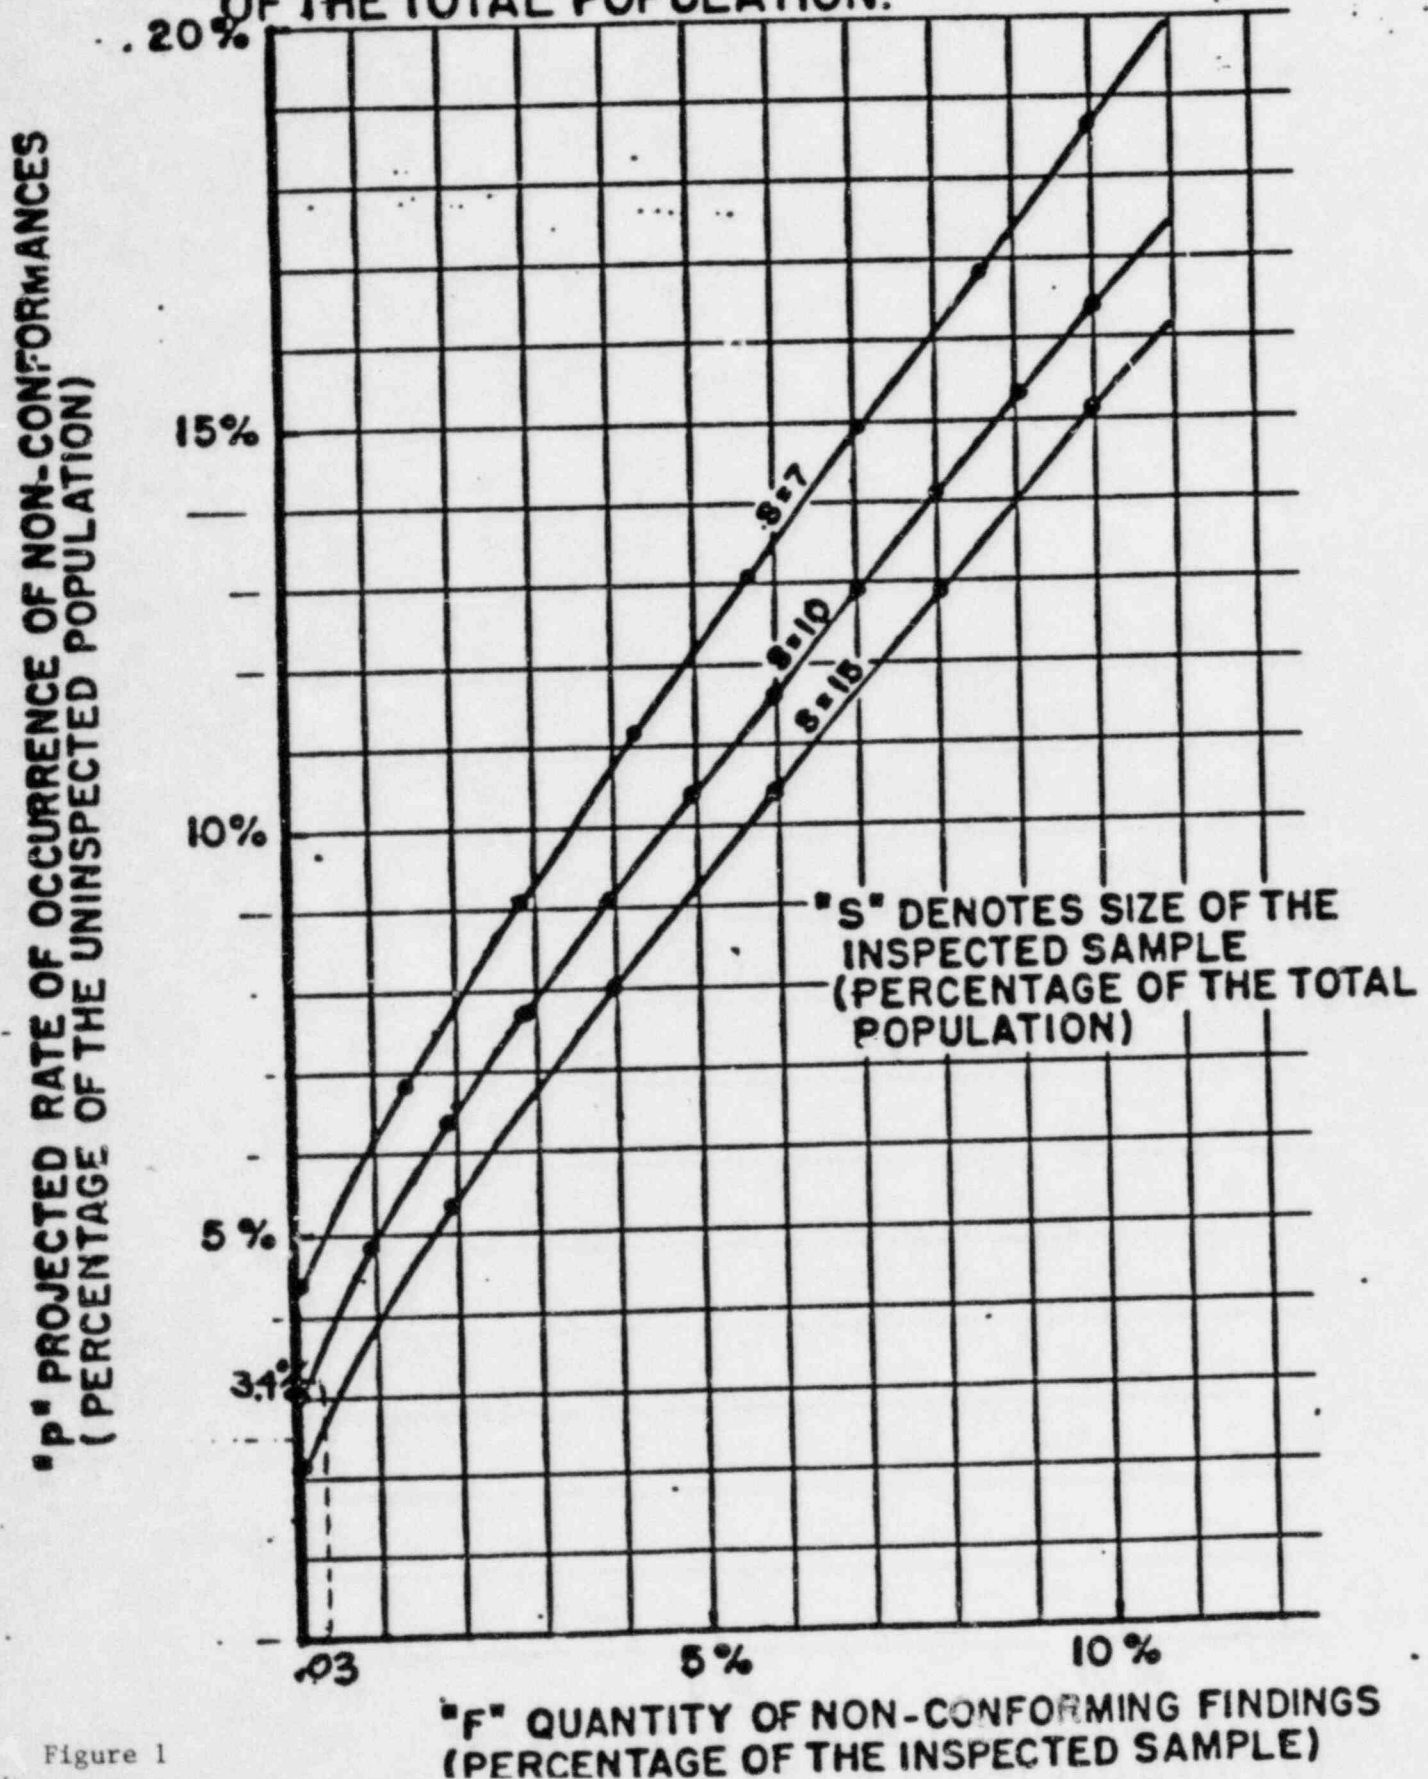
The corresponding projections as a function of observed findings, for various sample sizes, at a 95% confidence level, are presented in Figure 1.

The structural review of 956 non-conforming members resulted in the rejection of weld connections of three members on the basis of the derated load being less than the required design load ("F" on Figure 1 = $3/956 = .03\%$). The sample used for the design review, i.e., the non-conformances out of the inspection sample, represented approximately 11% of the population (S on Figure 1). As illustrated on Figure 1, based on a 95% confidence level statistical projection in accordance with the hyperbinomial distribution, the potential rate of occurrence of rejected members in the balance of the population was 3.4%. The projected occurrence rate of 3.4% is conservatively based on design load, whereas actual loads are typically significantly lower. Further, the worst case overstress in the sample was 18% over the AISC Code. To put this overstress in perspective, the AISC Code values have a 1.6 factor of safety to yield strength load capacity. Based on this analysis, Bechtel concluded and HL&P concurs that inspection of the balance of the population is not warranted. While not essential to ensure plant safety, the welded connections of the three members that were determined to exceed allowables will be reworked since they are accessible and the defects can be easily corrected.

**RATES OF OCCURRENCE IN UNINSPECTED
POPULATION, PROJECTED AT A 95%
CONFIDENCE LEVEL, BASED ON THE FINDINGS
OBTAINED FROM THE INSPECTION OF A RANDOM
SAMPLE REPRESENTING A SPECIFIC FRACTION
OF THE TOTAL POPULATION.**
