**LOUISIANA
POWER & LIGHT**

SUBJECT: Waterford SES Unit No. 3
Docket No. 50-382
Significant Construction Deficiency No. 74
"T&B Undersized Socket Welds"

Subject: LOUISIANA POWER & LIGHT COMPANY
WATERFORD SES - UNIT NO. 3
NCR 7680 IMPACT ON SCD 74; SCHEDULE 80
UNDERSIZE SOCKET WELDS

REPORT NO. 103-7680

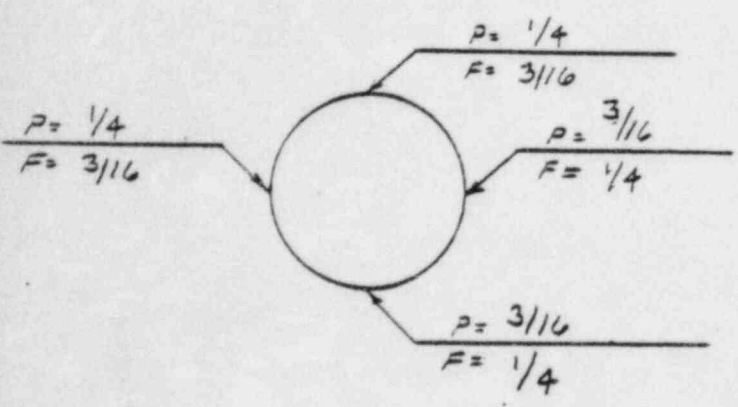
WELD NO. FW-2
EL. LOOKING S.W.

Walkdown shows 90° ELL, WCR states 45° ELL.

A review of Weld Control Record (WCR) shows HT#S201, review of CMTR shows HT#S201 to be 90° ELL. Based on this review and field verification we find no basis for the concern.
