NUCLEAR REACTOR LABORATORY
AN INTERDEPARTMENTAL CENTER OF
MASSACHUSETTS INSTITUTE OF TECHNOLOGY

August 18, 1995

Subject: Reportable Occurrence 50-20/1995-5, Malfunction of a Shim Blade Drive Mechanism

1. Report No.: 50-20/1995-5
- 2a. Report Date: 18 August 1995
- 2b. Date of Occurrence: 9 August 1995
3. Facility: MIT Nuclear Reactor Laboratory
138 Albany Street
Cambridge, MA 02139
4. Identification of Occurrence:

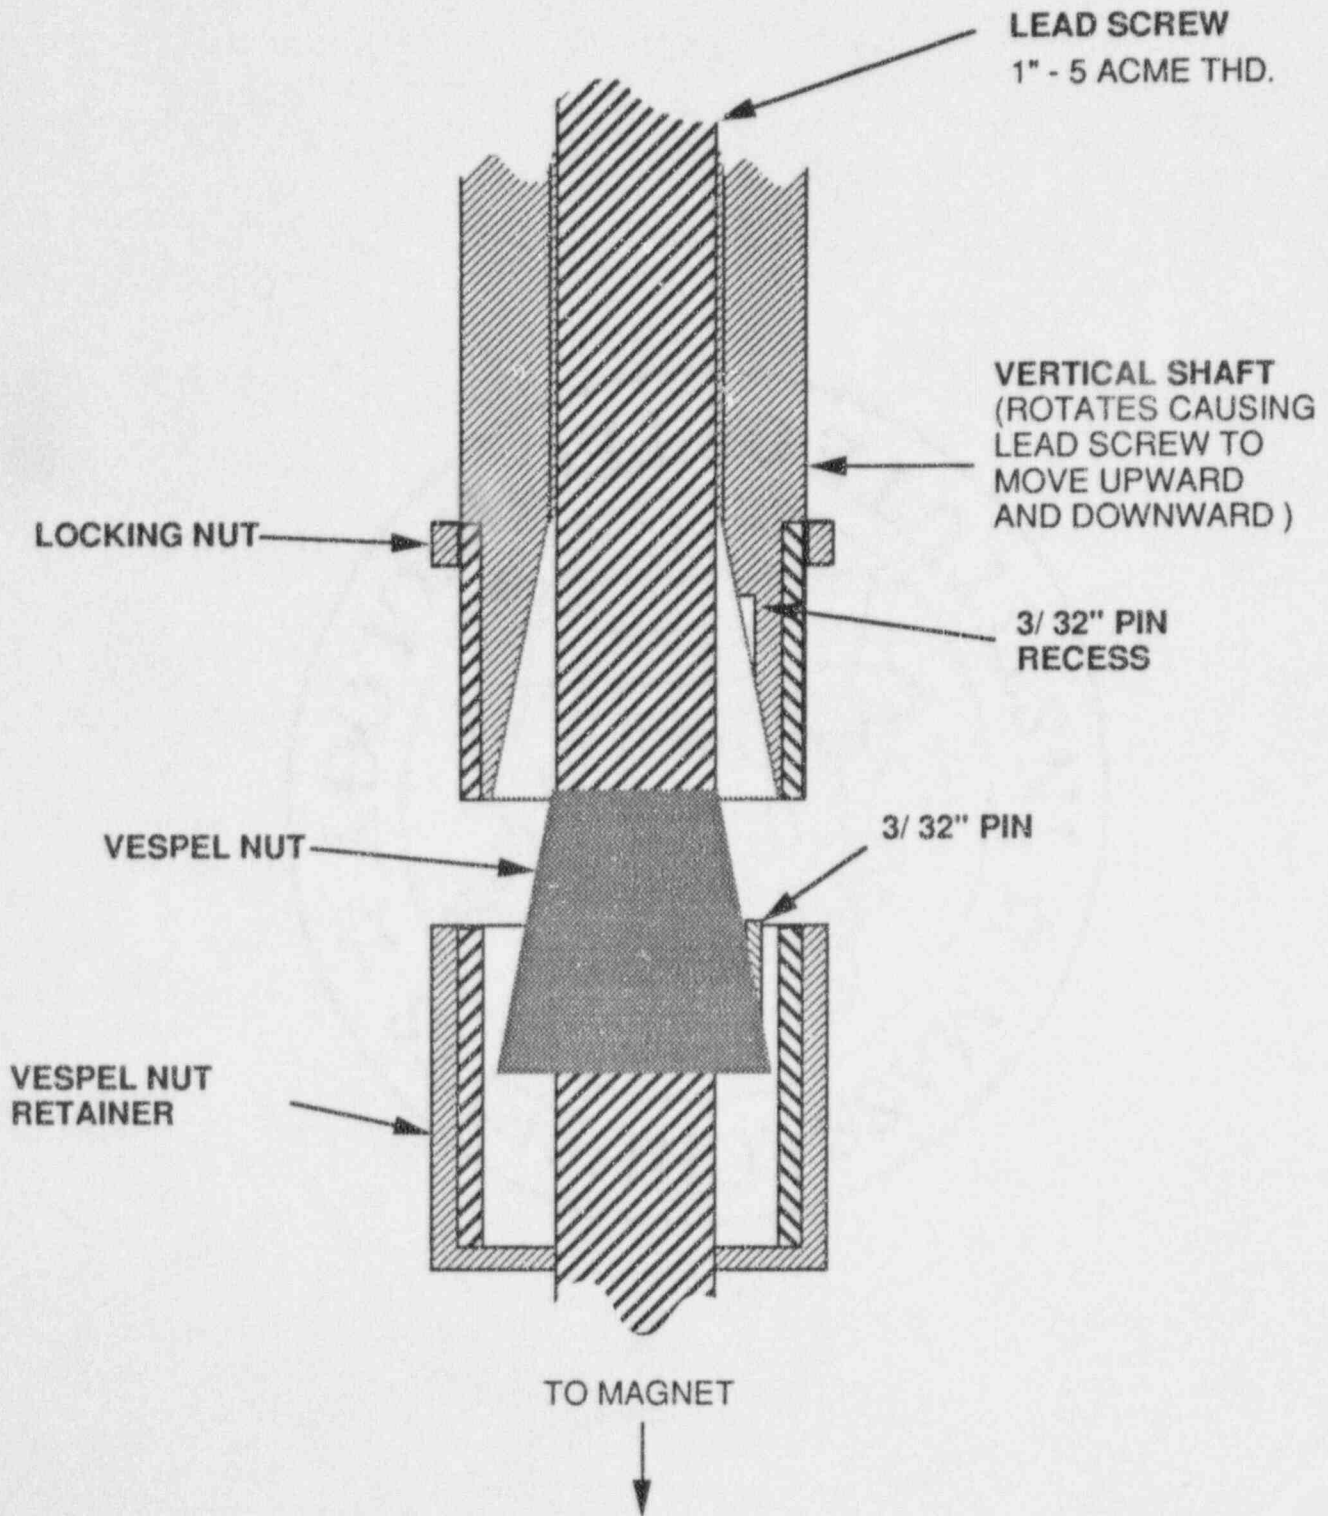
DETAIL OF VERTICAL SHAFT, VESPEL NUT, LEAD SCREW AND PIN

Upon examination of the blade drive, it was determined that the mechanism experienced intermittent slippage when the blade was being withdrawn. No slippage was observed during insertion. Since the drive position indication is coupled with the drive mechanism, the position indication in the control room continued to show a withdrawal even if no actual blade withdrawal occurred due to slippage. A series of ex-core test withdrawals to 10 inches (the approximate critical position) showed consistent slippages of 4 to 6 inches. It should also be noted that with an otherwise even bank height, shim blade #4 being inserted 4.25 inches will result in a reactivity worth effect of 670 m β , approximately the same worth as the difference between the ECP and the actual critical position.

The drive mechanism was removed on 08/11/95 and disassembled for examination. The suspect components consist of a vertical shaft which is connected to the horizontal drive shaft via a bevel gear. Inserted at the bottom end of the vertical shaft is a vespel nut which is held in position with a 3/32" diameter stainless steel pin (see attached figure). The vespel nut rotates on the lead screw, driving the blade magnet in or out. Examination showed that the pin was worn and that scoring marks were on the inside of the vertical shaft.

This drive assembly was assembled in accordance with MITR Procedure PM 7.1.1.1, "Shim Blade Drive Mechanism Disassembly and Reassembly Procedures," in mid July of 1995. It is speculated that some time during the assembly the pin was improperly positioned outside of the slot. The friction between the pin and the vertical shaft held the vespel nut in place for some time until the pin began to wear (in about eight days) and slip in the vertical shaft.

It should also be noted that because of the shape of the vespel nut, a downward movement of the vertical shaft would create a greater friction force on the vespel nut and pin, reducing the likelihood of slippage while driving the blade in.

The blade drive mechanism assembly procedure, PM 7.1.1.1, will be reviewed and modified to include an extra step with two person verification to ensure that the vespel nut and pin are properly rotated and seated at maximum depth prior to and during tightening of retaining collar and lock ring.
