SETTLEMENT UPDATE
FOR
MIDLAND PLANT UNITS 1 AND 2
CONSUMERS POWER COMPANY
DOCKET NUMBERS 50-329 AND 50-330

Report Date: September 14, 1980

Settlement Update

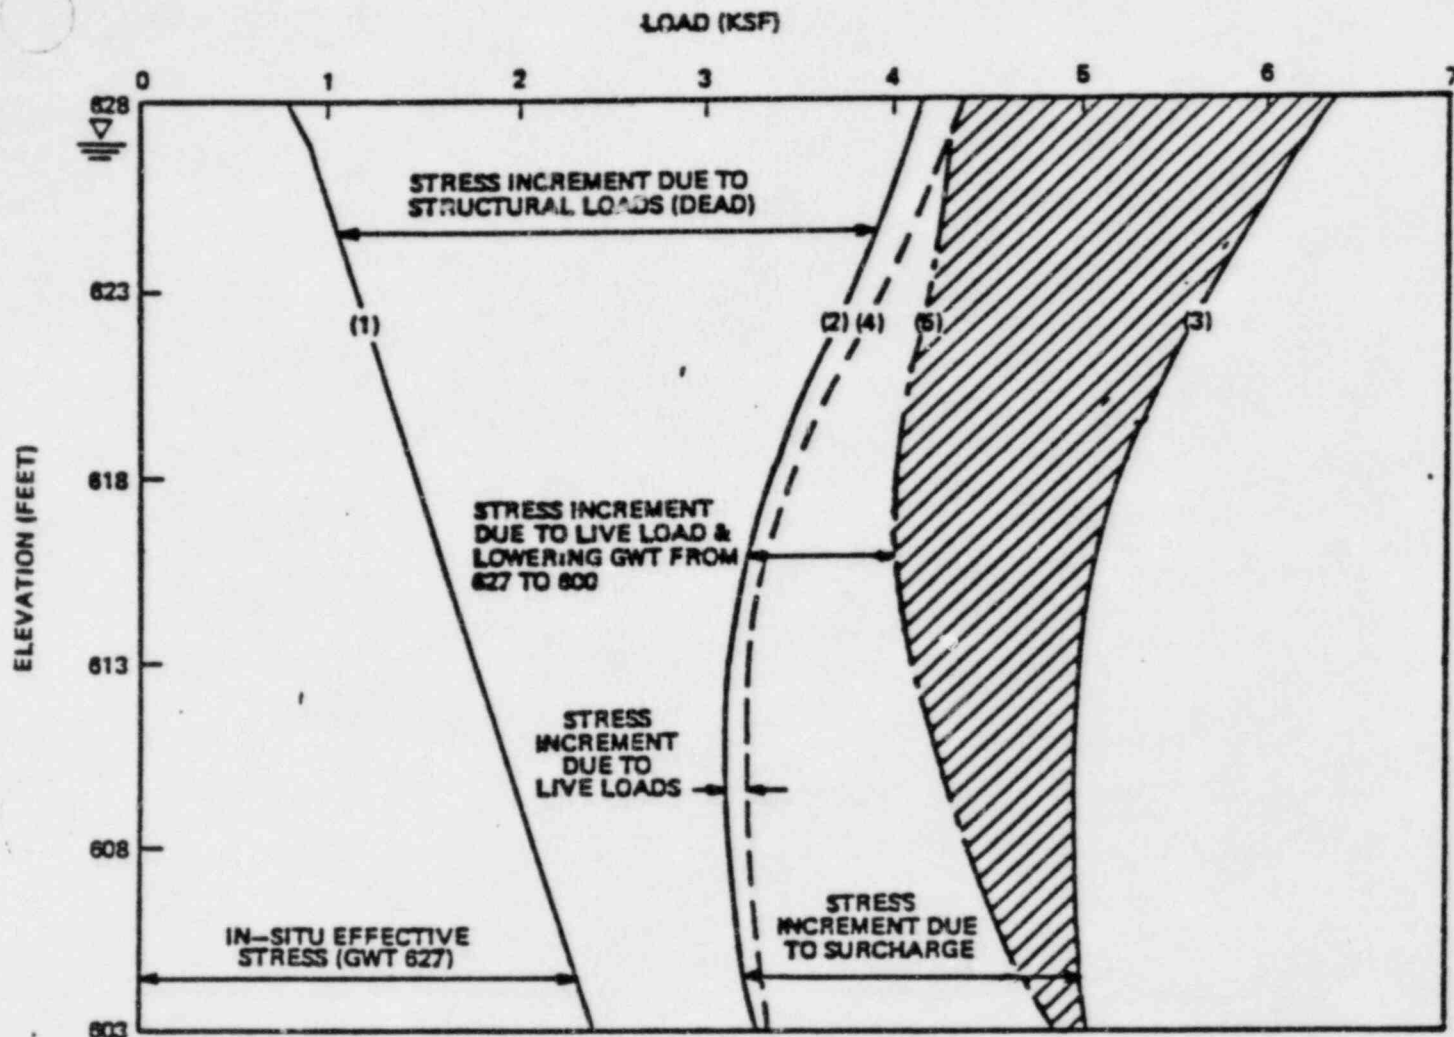
Vugraph No.5

3. CPCo Position No. 2 concerning stresses produced in fill under surcharge
Vu No. 5

1. (1) In-situ effective overburden pressure GWT at 627.
2. (2) Total effective pressure due to in-situ effective overburden pressure and structural dead loads.
3. (3) Total effective pressure at the end of surcharge due to in-situ effective overburden pressure, structural dead loads, & surcharge loads.
4. (4) Total effective pressure due to in-situ effective overburden pressure, structural dead loads, & live loads.
5. (5) Total effective pressure during the life of plant operation due to in-situ effective overburden pressure, structural dead loads, dewatering loads, & live loads.

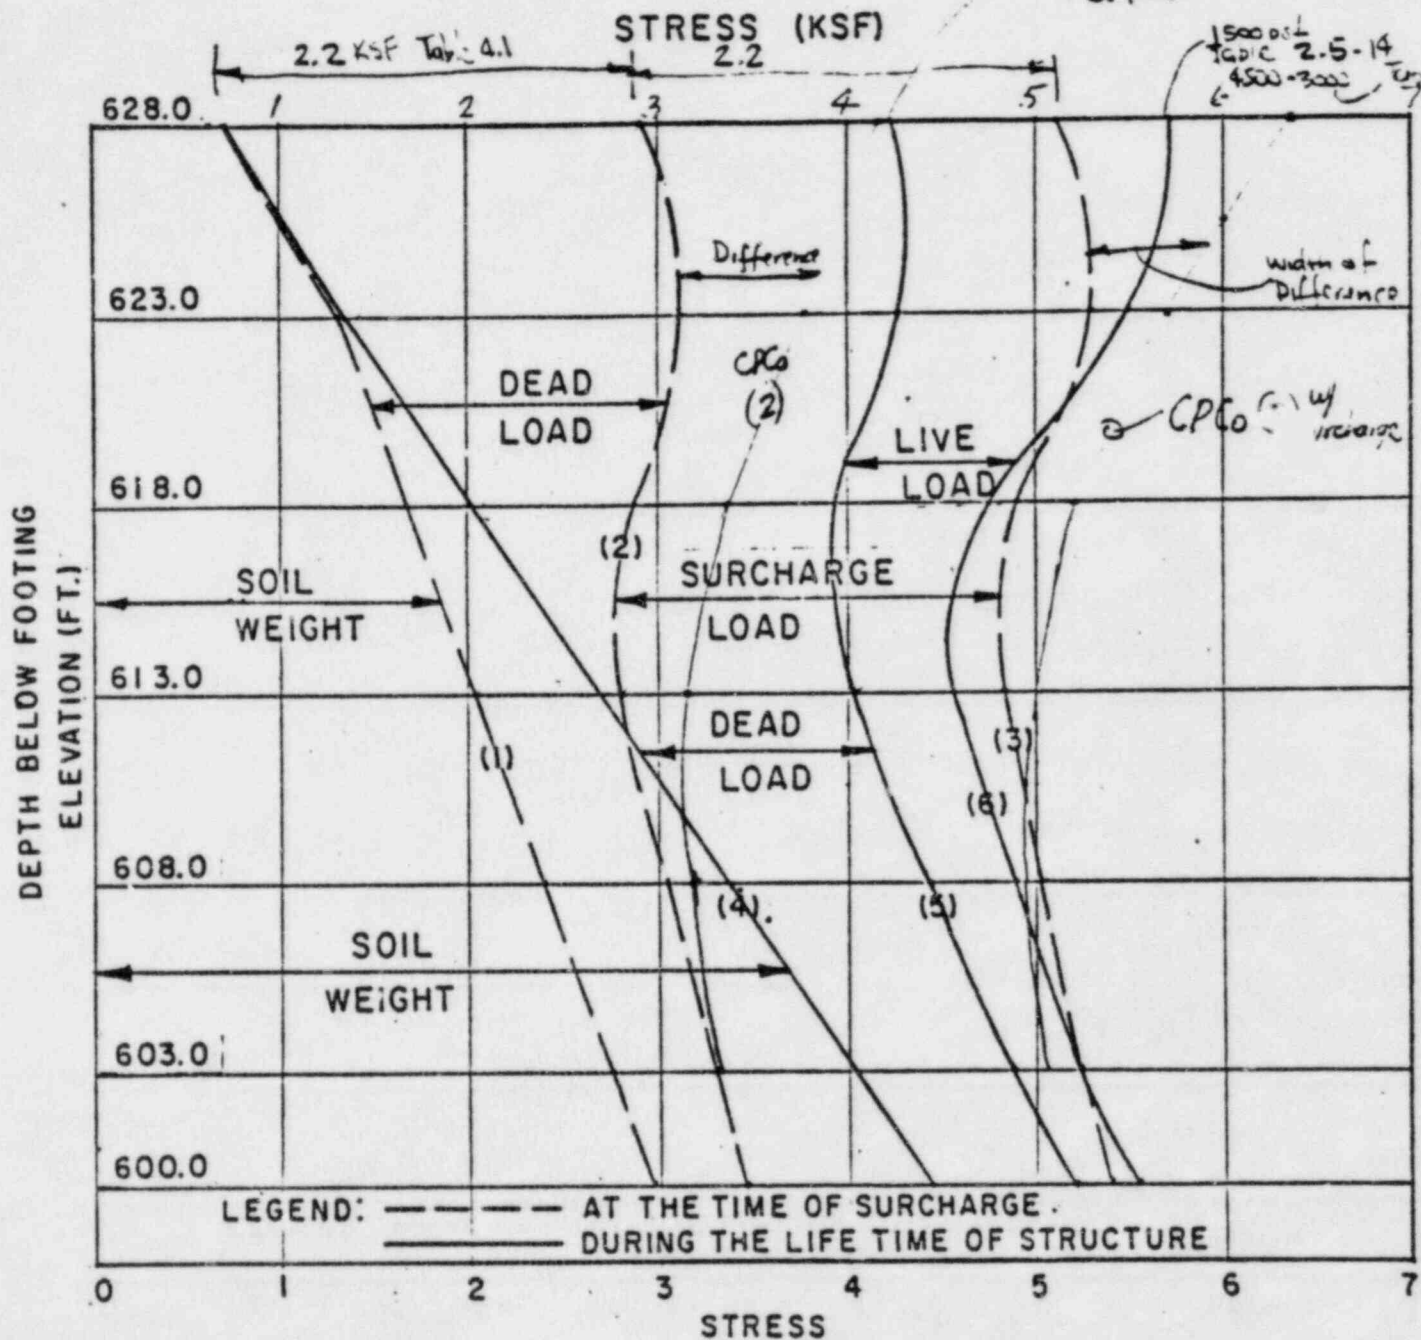
Vugraph No. 6

4. Staff Position - Vu No. 6
Surcharge load apparently just meets DL+LL+
Effect of Deaerating. Does not allow for additional environmental loads.
Normal practice in surcharge programs - Place a surcharge
load that is 1.5 times final load to assure secondary
consolidation is reached.

COMPARISON OF ~~TOTAL~~ STRESS DISTRIBUTION DURING LIFE OF PLANT OPERATION AND END OF THE SURCHARGE LOAD.

MIDDLE OF EAST WALL OF D.G. BUILDING

NOTE - EARTHQUAKE LOAD NOT INCLUDED

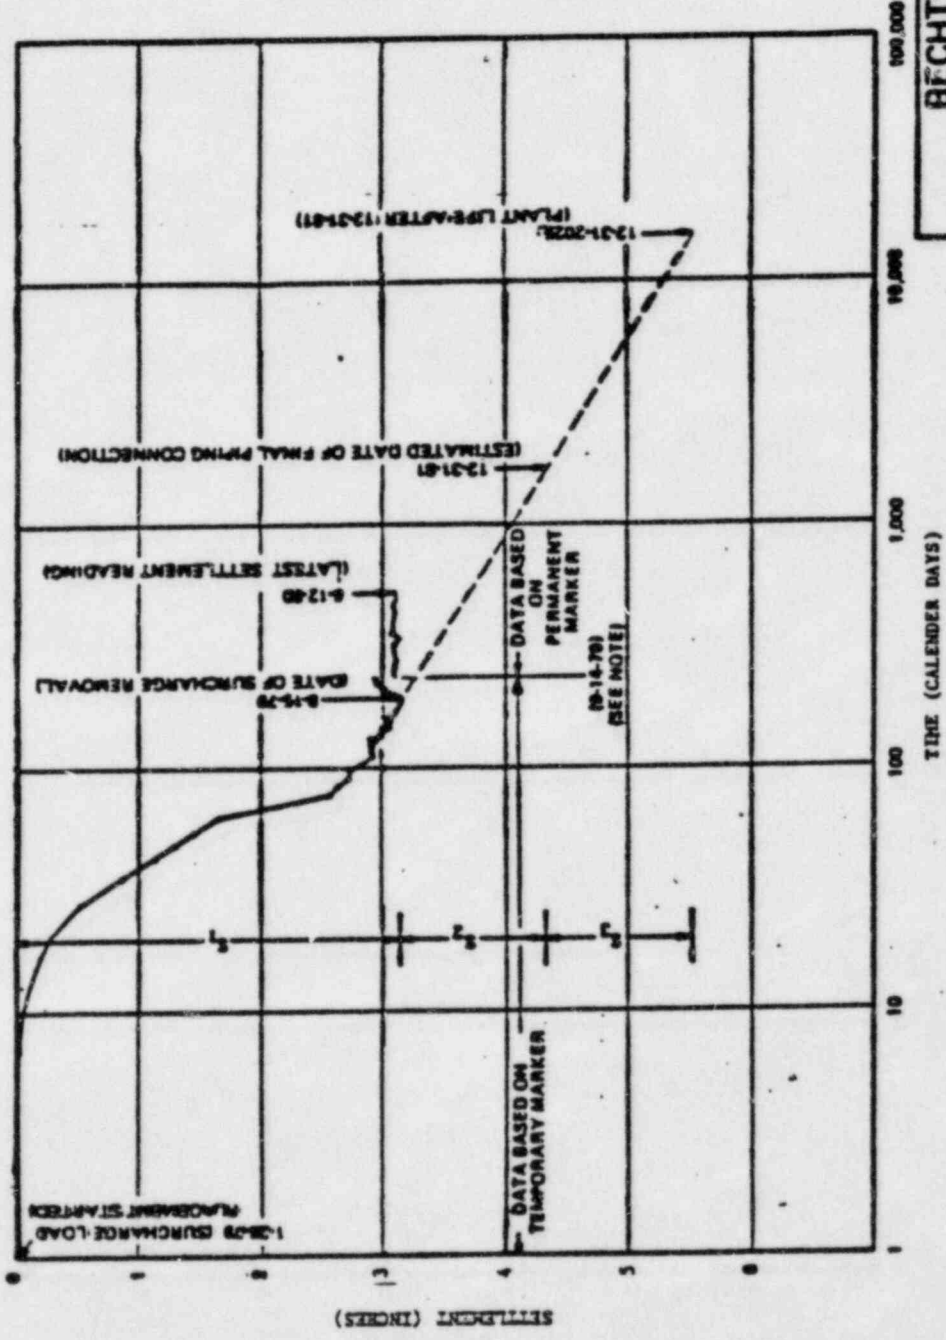
Yugraph No. 7

5. CPCo Position No. 3 **Vu No. 1** - Settlement Data
Vu No. 7 Presented by Dr. Peck at Aug. 29, 1980 meeting
- Shows decrease in rate of settlement after 100 days. Rebound.

- Time period where surcharge was imposed in secondary consolidation was approximately 90 days.
 - Note that graph conveniently plots only settlement after surcharge was placed.

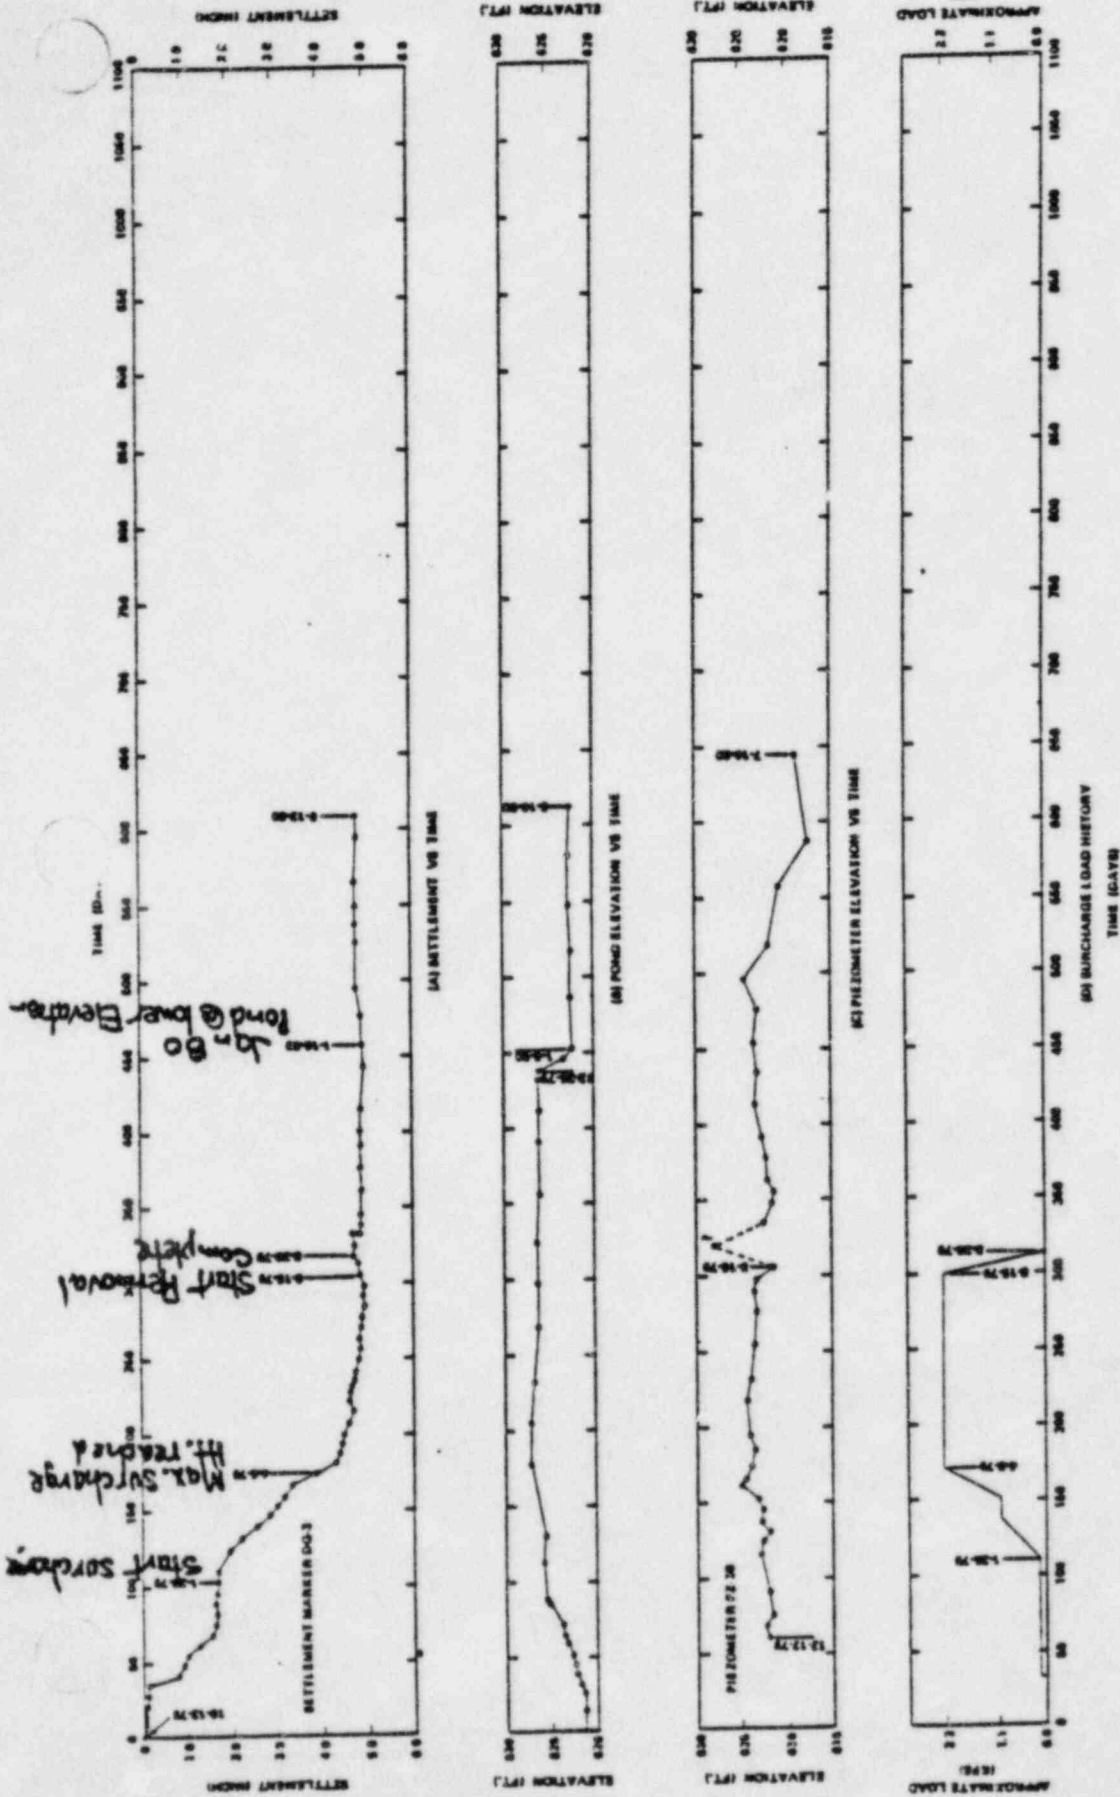
Vugraph 8

6. CPCo Position No. 4 **Vu No. 1** - Settlement & Piezometer Data
(Show **Vu No. 8**) Presented by Dr. Peck at Aug. 29, 1980 meeting
- Cover info presented (Settlement - arithmetic scale, pond levels, PZ-30 behavior (particularly after removal) & surcharge load history)

7220 FIGURE 179
MIDLAND POWER PLANT		
DISSEL GENERATOR BUILDING TYPICAL WATER SHEET, LOCK HOLES, POND LEVELS PIEZOMETER LEVELS AND BURCHARGE LOAD HISTORY

NOTE:
On 10-13-72 the measured settlement of marker DG-3 was 2.082 inch.

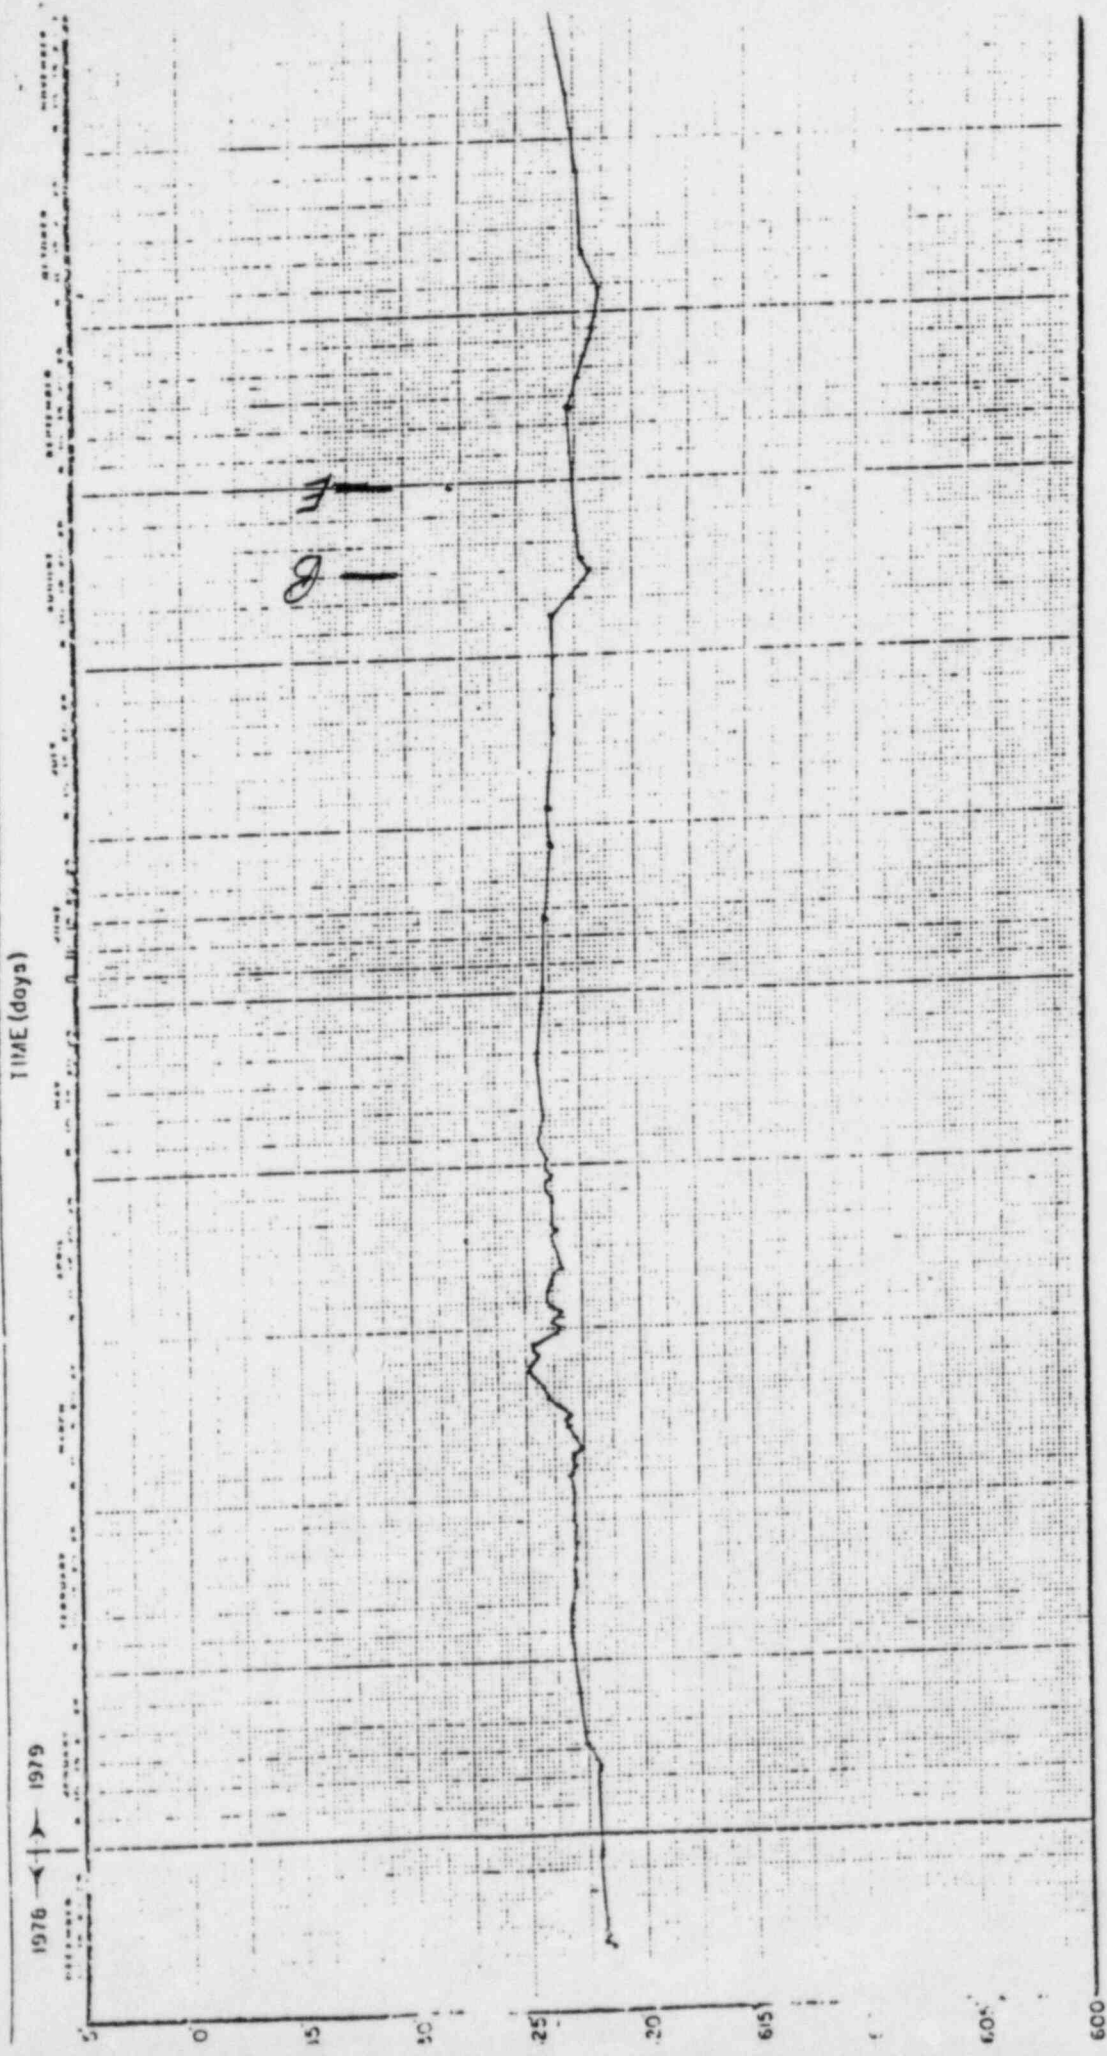
- Show disagreement with previously submitted data (**Vu No. 9**) at critical time of surcharge removal for PZ-30.
 - Show previously submitted Fig 27-5 (**Vu No. 10**) where PZ-23 behavior at time of surcharge removal has been deleted & replaced w/ PZ-30 data but all other data (Settlement of DG-3, pond & surcharge) remains unchanged. Show how PZ-23 supports our concern that secondary consolidation was not reached by observed behavior. Show other piezometers, PZ-36 **Vu No. 11** and piezometer PZ-47 **Vu No. 12**

Reading may be less accurate than normal.
See Table 3.
