UNITED STATES
NUCLEAR REGULATORY COMMISSION
REGION III
727 ROOSEVELT ROAD
GLEN ELLYN, ILLINOIS 60137

MEMORANDUM FOR: Ray Sutphin, Reactor Inspector
FROM: E. J. Gallagher, Reactor Inspector
SUBJECT: INPUT FOR SALP APPRAISAL ON MIDLAND 1 AND 2

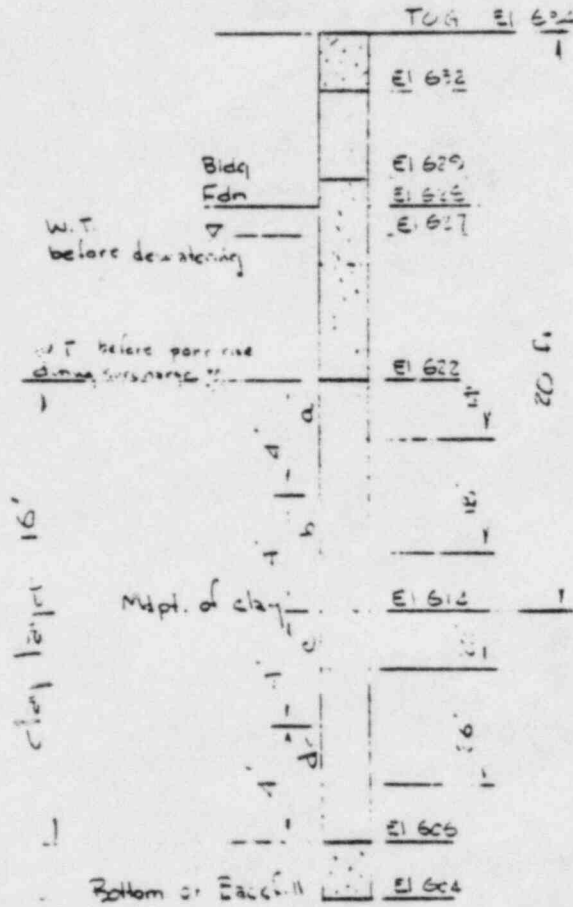
Settlement Marker DG-3

Boring DG-1 (DG-7 nearby is similar)

Loading

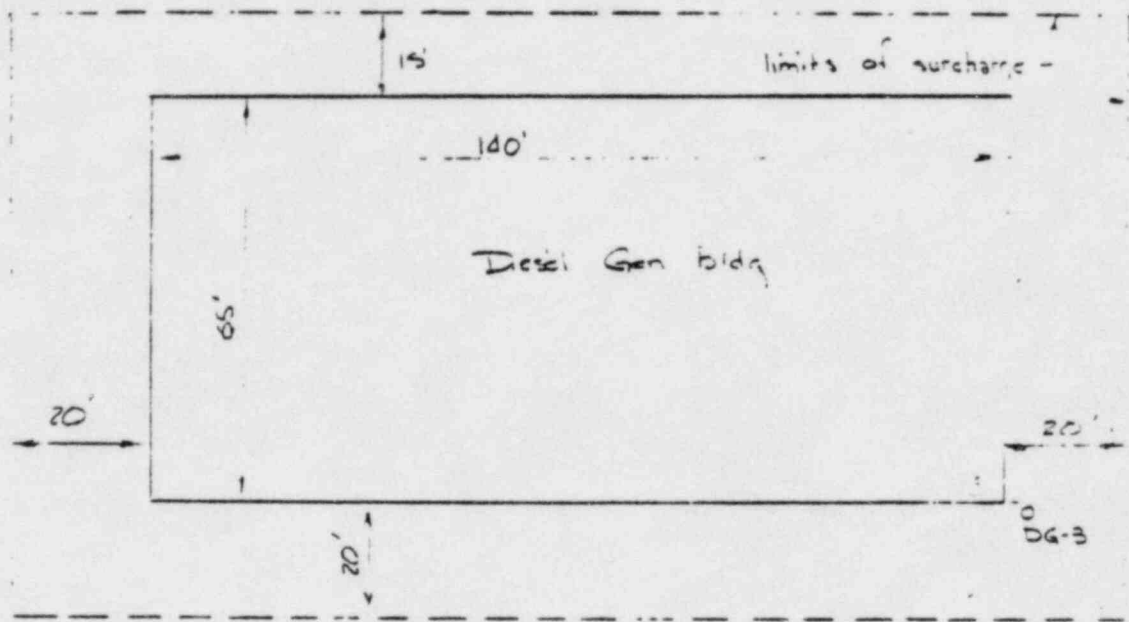
Determination of vertical stress at DG-3 by Boussinesq's Eq.

From building load, $q_b = 2.2 \text{ ksf}$ (bldg not 100% temp. at 100 ft depth see 3.0 spec)
 $m = \frac{140}{20} = 7.0$ $n = \frac{65}{20} = 3.3$ $I_0 = 0.24$ $C_2 = 0.53$

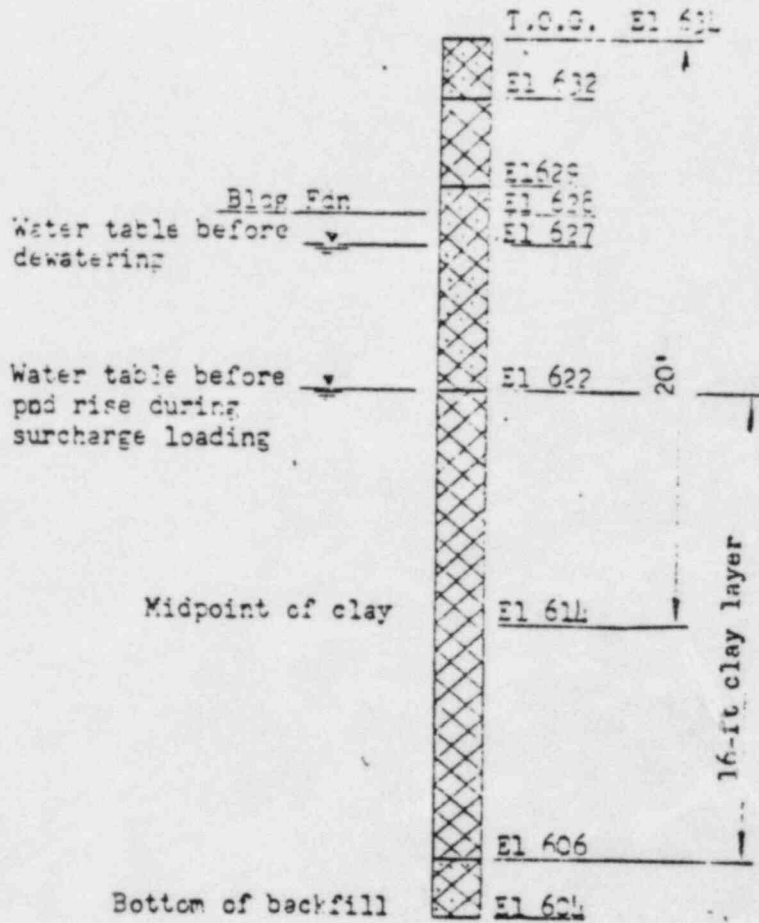
Settlement Marker DG-3

Boring DG-1 (DG-7 nearby is similar)

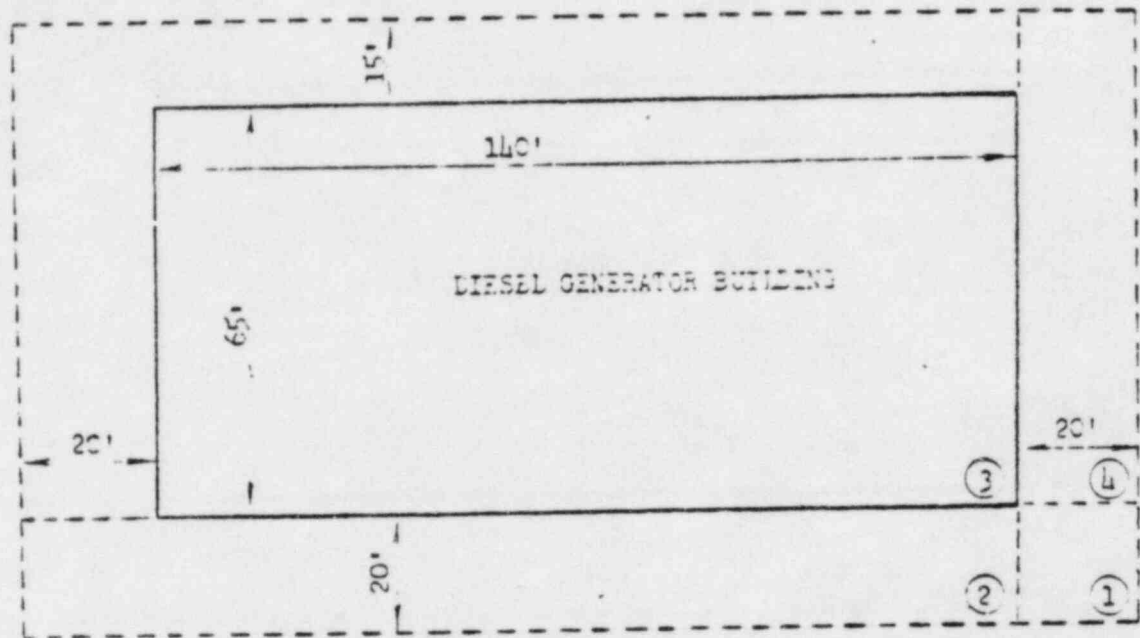
Determination of vertical stress at DG-3 by Boussinesq Method

From building load, $q_u = 2.2$ ksf (bldg not 100% complete
do not use 3.0 ksf)

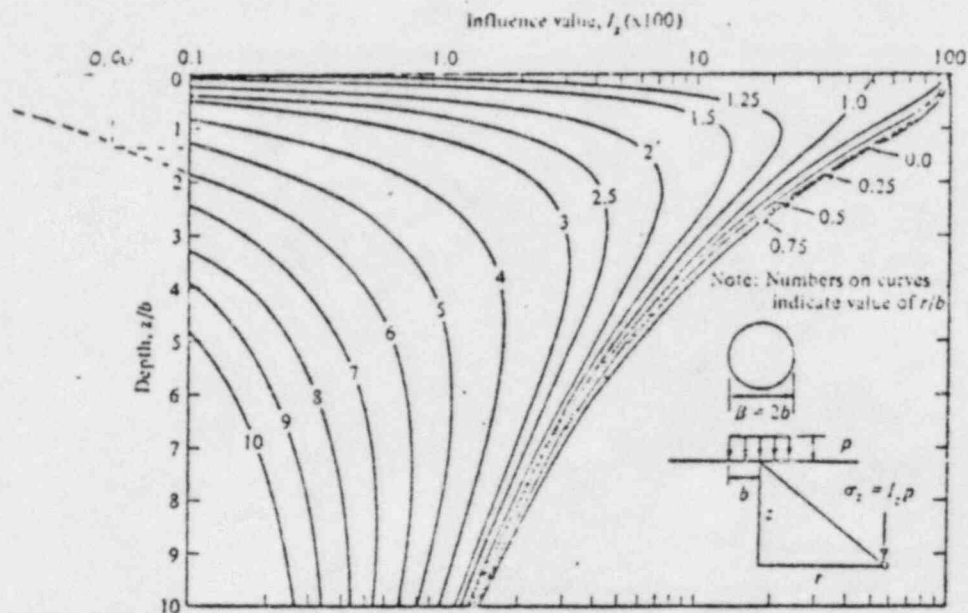
Fig. 4.17 Influence diagram for vertical normal stress σ_z at various points within an elastic half-space under a uniformly loaded circular area. (After Foster and Ahlvin, 1954.)

(2) Influence of Second Tank. The influence factor of the loading of one tank on the other is shown by the following diagram.

From diagram, $I_z = 0.0006$
