MP-92-86

Reference: Facility Operating License No. NPF-49
Docket No. 50-423
Licensee Event Report 91-025-01

FACILITY NAME (1) Millstone Nuclear Power Station Unit 3	DOCKET NUMBER (2) 0 5 0 0 0 4 2 3	PAGE (3) 1 OF 0 6
---	--	------------------------

TITLE (4) Procedure To Verify De-energization of Solid State Protection Input Relays For Cold Overpressure Protection Due to Procedural Deficiencies

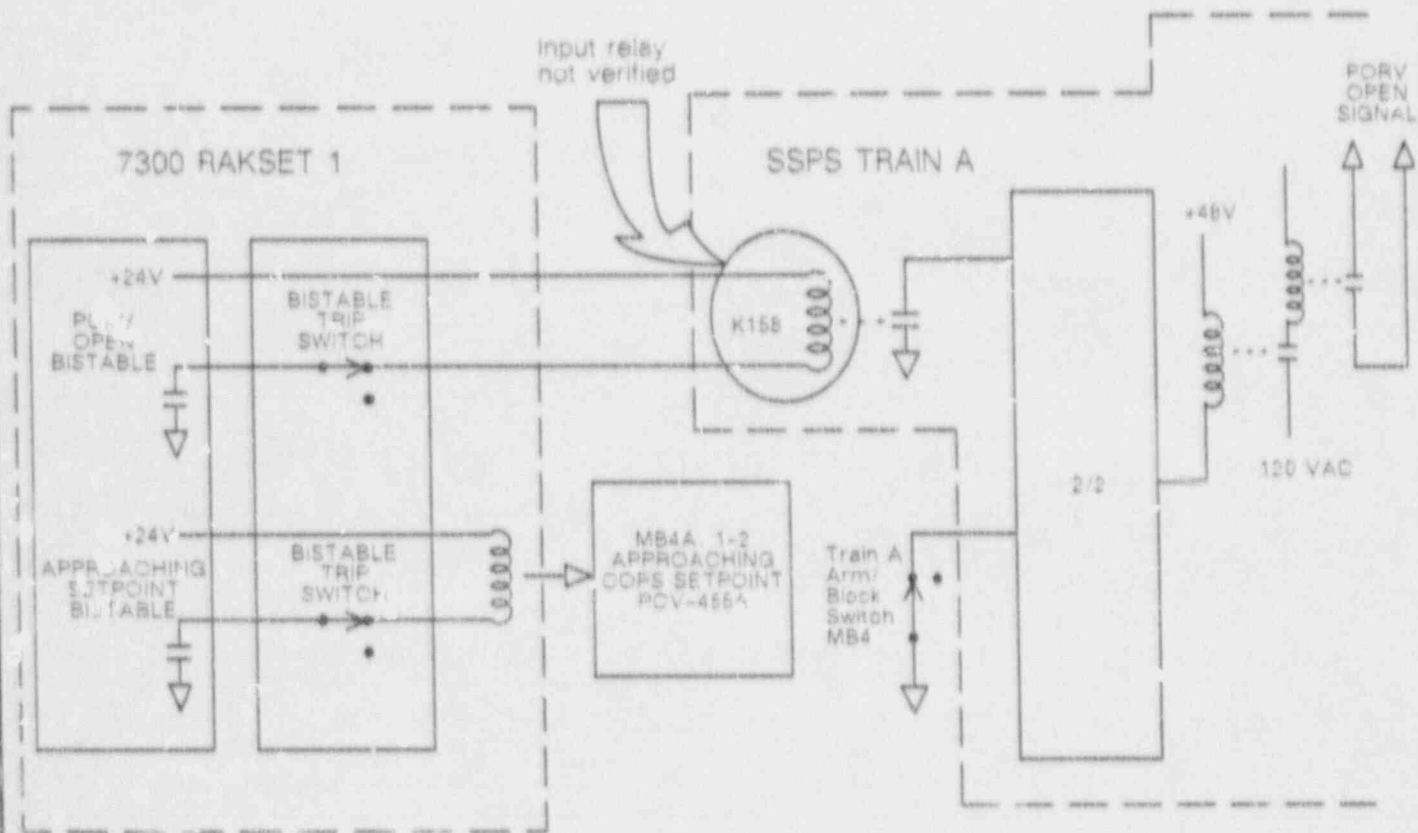
COPS Actuation Circuit
(Simplified)

The de-energize to actuate design of the COPS circuit does not provide annunciation which directly monitors relay status. The typical protection channel design places the channel in "trip" during testing and utilizes annunciators to provide indication of off-normal contact status. The COPS bistable annunciator is upstream of the input relay. This annunciation does not verify the SSPS input relay status. To verify de-energization of the input relays for COPS, a voltmeter must be placed across the associated SSPS contact output to verify continuity.
