PHILADELPHIA ELECTRIC COMPANY

June 4, 1984

Docket Nos. 50-277
50-278

SUBJECT: Generic Letter 84-11, "Inspections of
BWR Stainless Steel Piping"

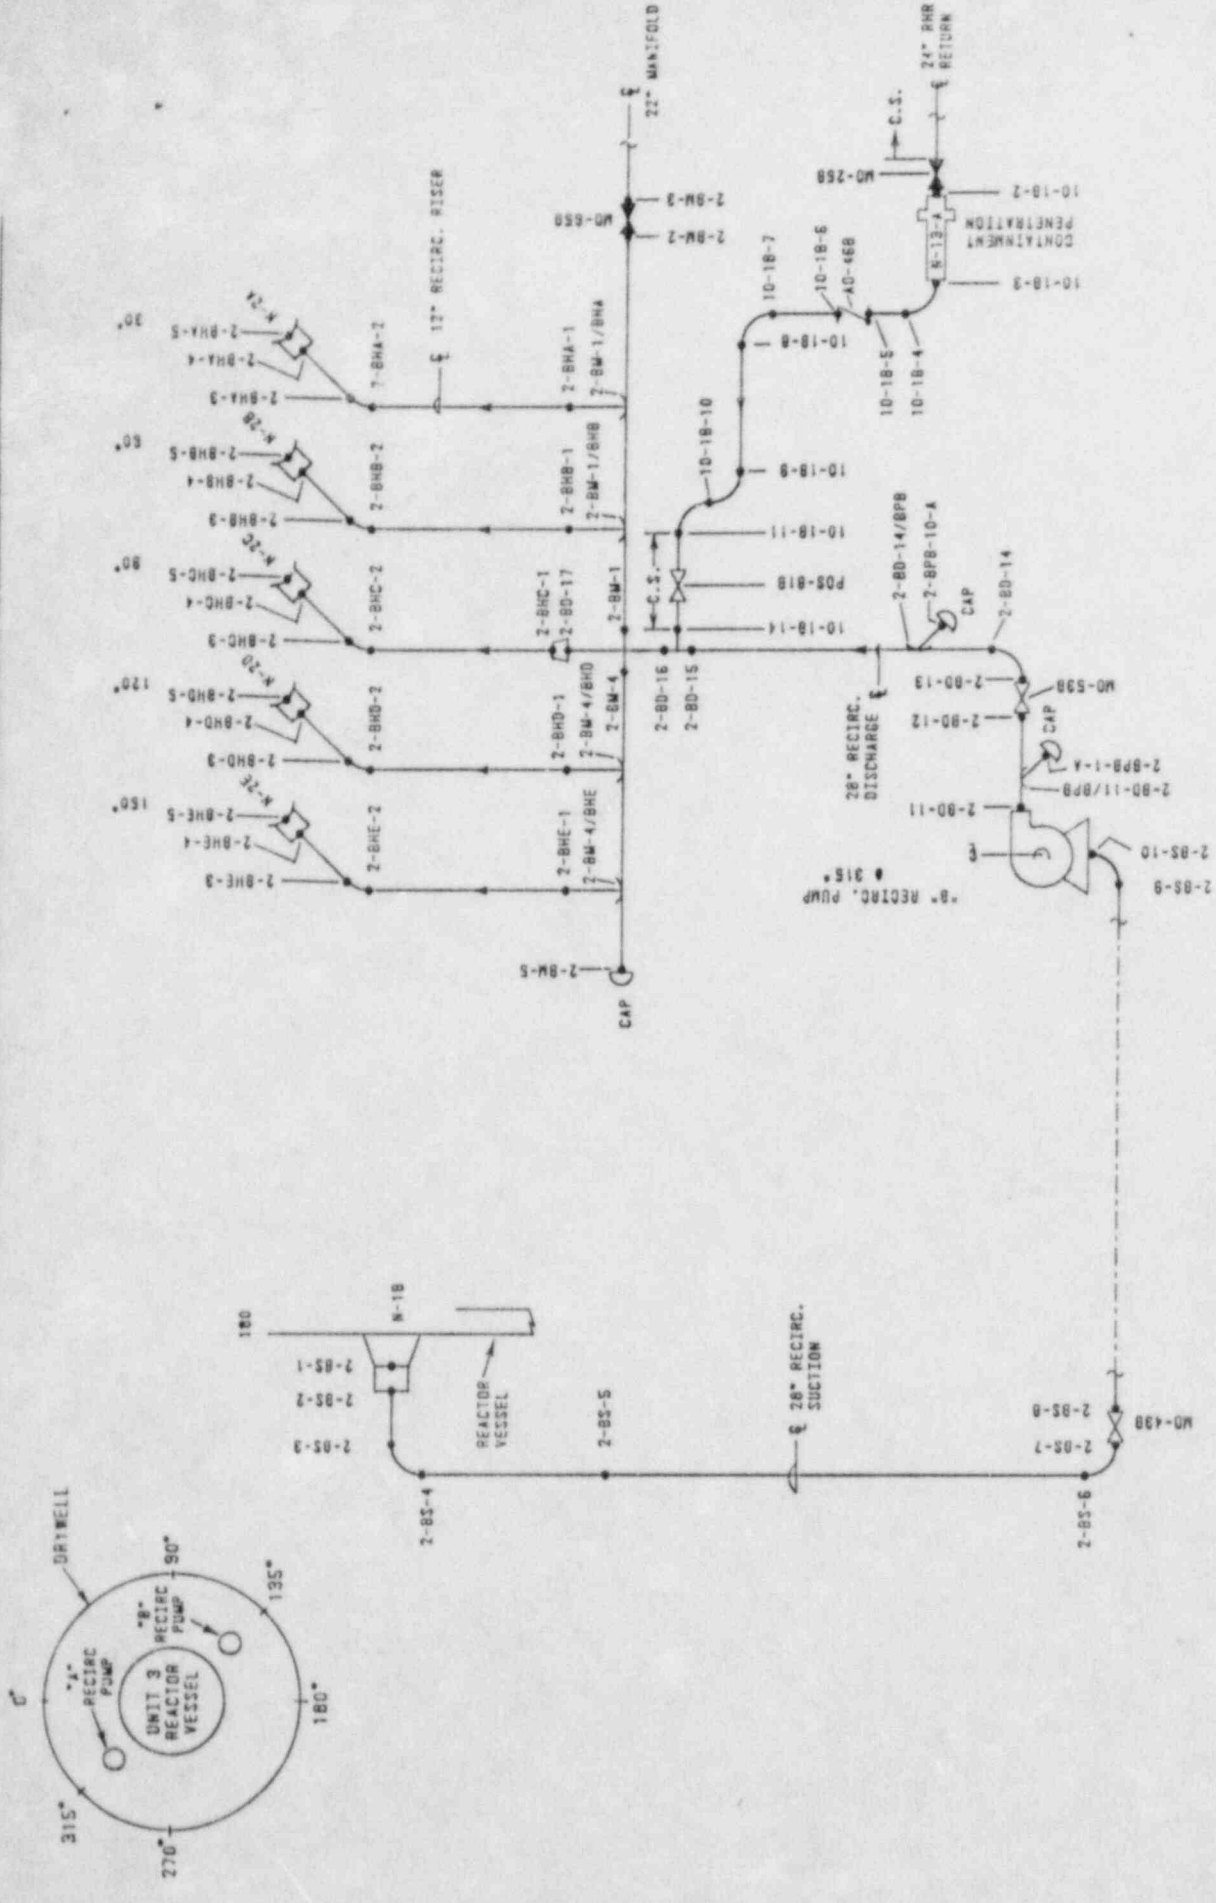
COAST UNIT 3 "B" RECIRCULATION PIPING & RHR SHUTDOWN COOLING SUCTION/RETURN PIPING

The reinspections specified below will be performed during the next Unit 3 refueling outage currently scheduled to begin March 30, 1985. Recirculation and RHR system inspections were previously performed during the summer of 1983. Based on results of those inspections, the scope of the reinspections is as follows in accordance with items 2a through 2e of the Generic Letter. Attachments 1 and 2 depict the Unit 3 Recirculation and RHR System.
