LICENSEE EVENT REPORT (LER)

Facility Name (1) SAN ONOFRE NUCLEAR GENERATING STATION, UNIT 3 Docket Number (2) 0 5 | 0 | 0 | 0 | 3 | 6 | 2 Page (3) 1 of 0 4
 Title (4) Reactor Coolant System Pressure Boundary Weepage

SAN ONOFRE NUCLEAR GENERATION STATION UNIT 3	DOCKET NUMBER 05000362	LER NUMBER 95-001-00	PAGE 2 of 4
---	---------------------------	-------------------------	----------------

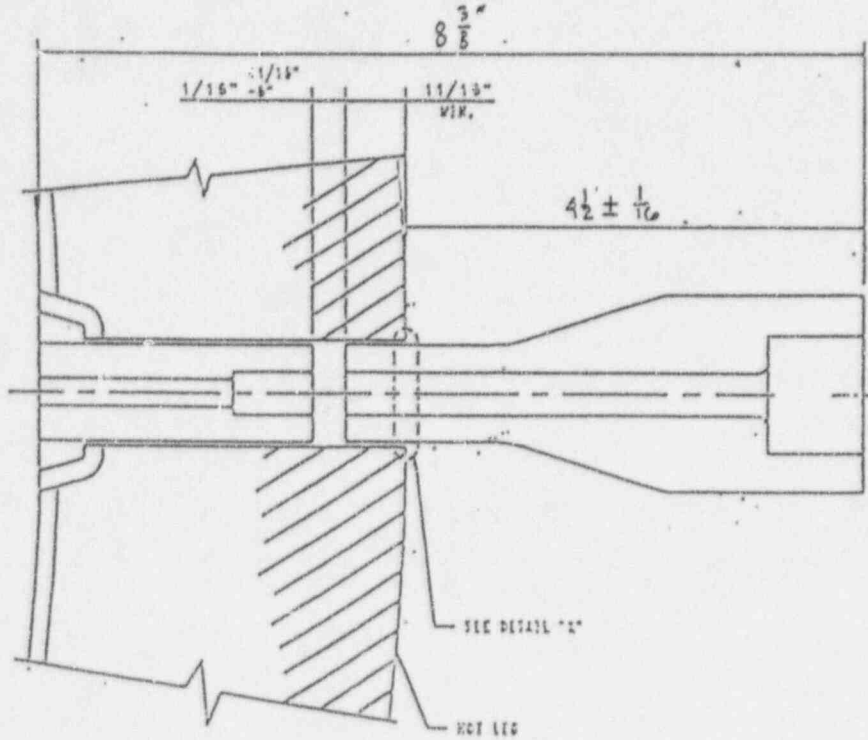
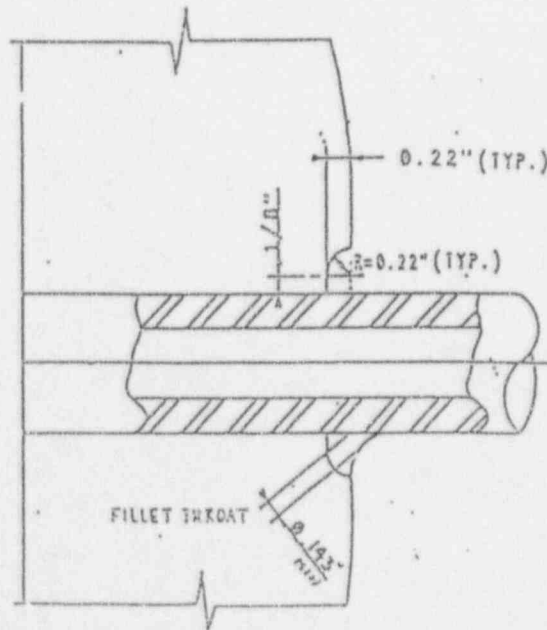
New Hot Leg Nozzle Design

The RCS hot leg instrument nozzles with leakage indications were alloy 600 nozzles, Edison believes the cause of the identified leaks to be PWSCC as well. Inaccessibility to the interior of the RCS hot legs precluded confirmatory inspections.

The accessible exterior of the two RCS hot leg nozzles will be replaced with new alloy 690 nozzles. Access to the interior of the RCS hot leg piping prevents welding from the

interior of the RCS. Therefore, the existing nozzles will be cut off half way through the RCS hot leg material and the new nozzles welded to the exterior of the RCS pipe (see attached diagram). All repair work is being performed in accordance with ASME Section XI.
