OPERATION INSPECTION REPORT
for
THE NUCLEAR REGULATORY COMMISSION

Date of inspection November 15, 1994

Dam (name) Standby Nuclear Service Water Pond Dam

Location McGuire Nuclear Station Mecklenburg North Carolina
(Facility) (County) (State)

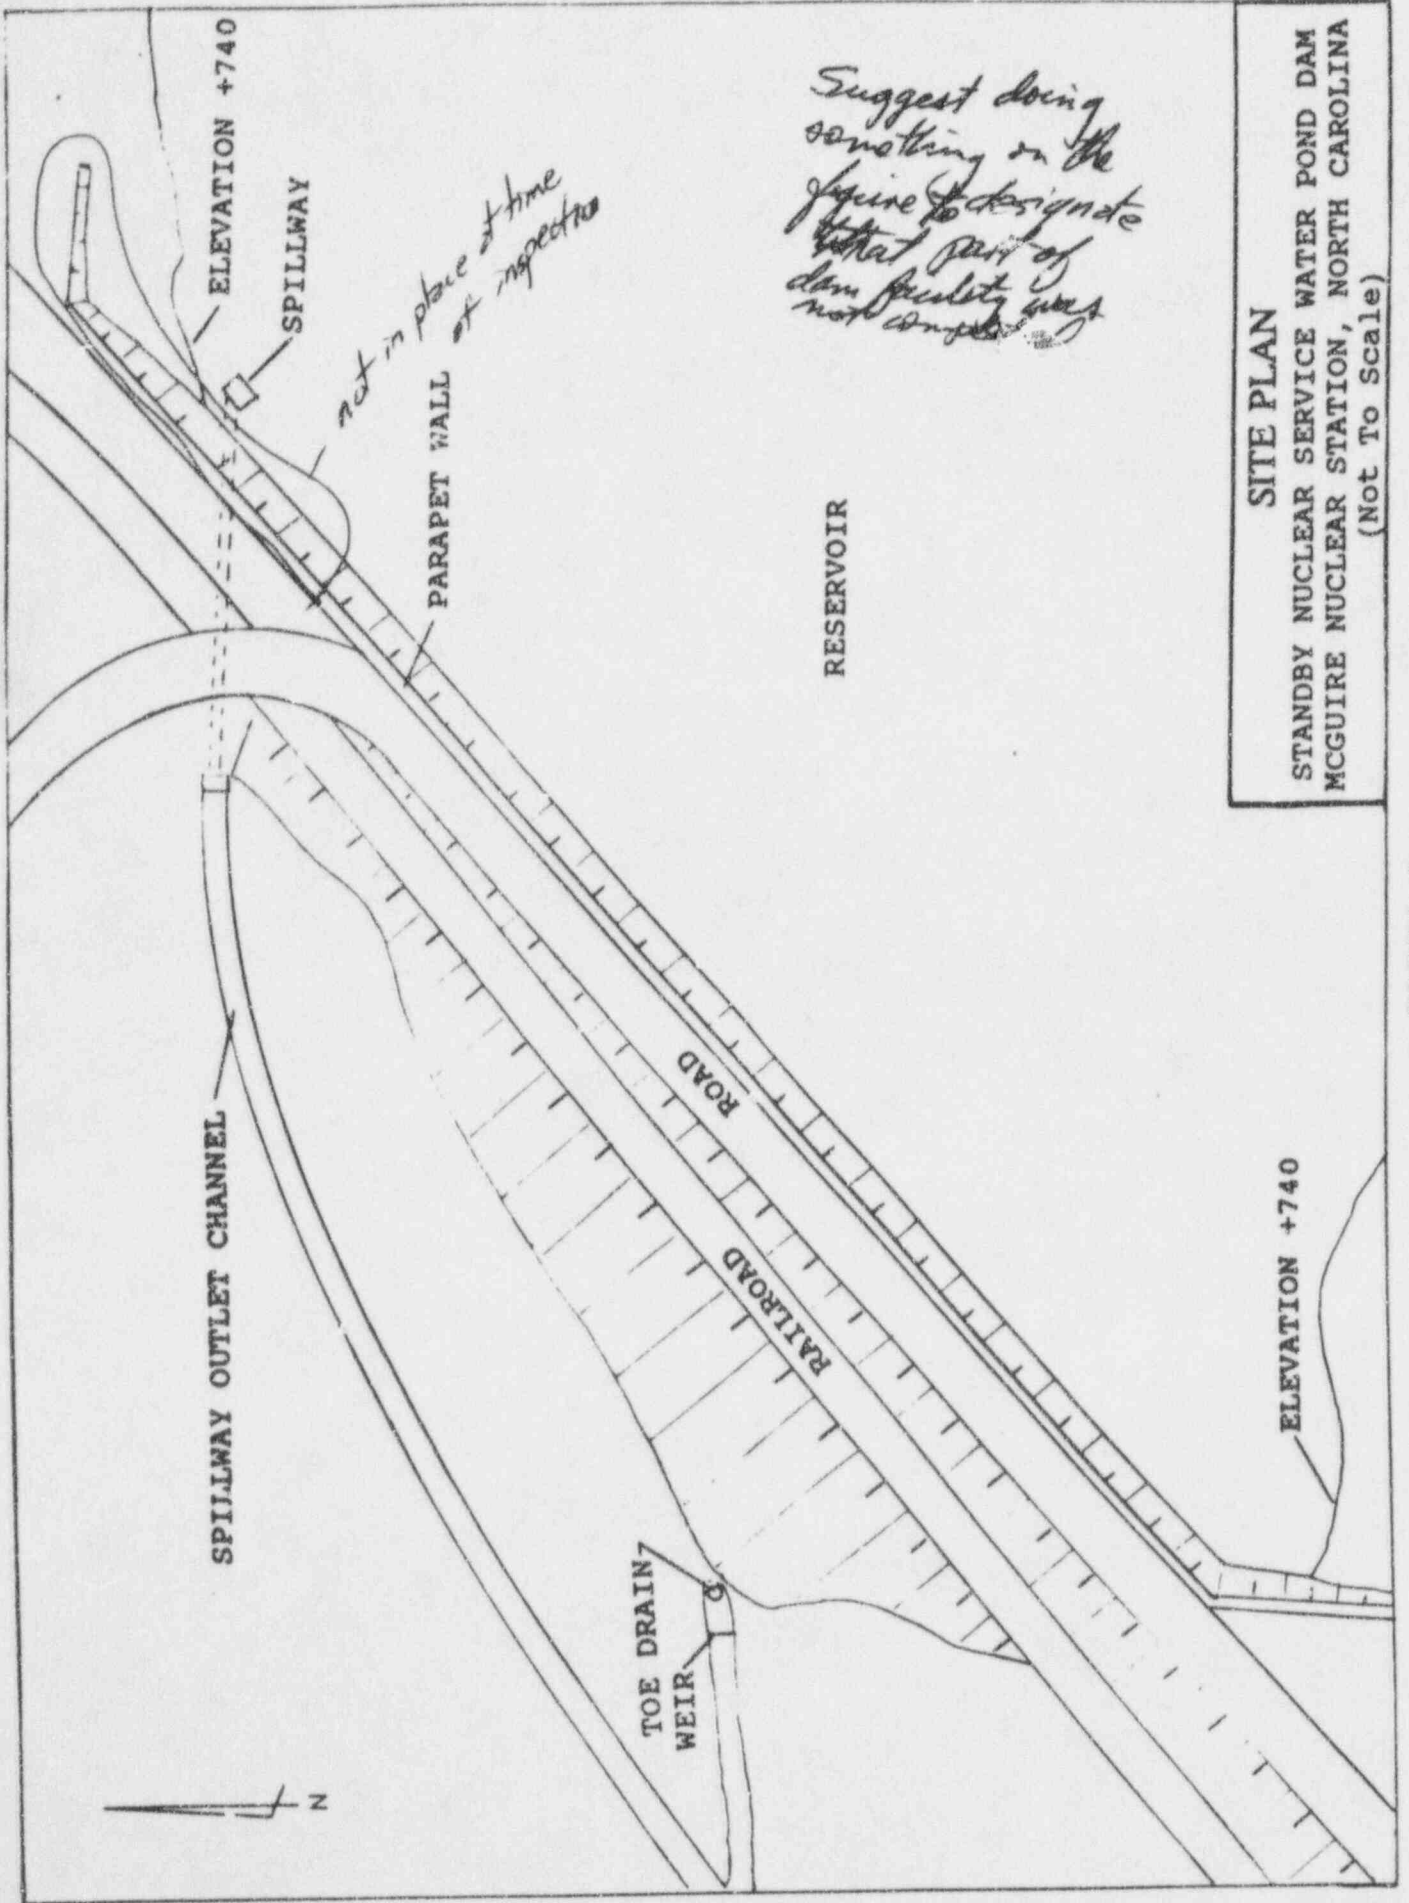
FIGURE 1

SITE PLAN
 STANDBY NUCLEAR SERVICE WATER POND DAM
 MCGUIRE NUCLEAR STATION, NORTH CAROLINA
 (Not To Scale)
