SUBJECT: COMANCHE PEAK STEAM ELECTRIC STATION (CPSES)
DOCKET NO. 50-445
CONDITION PROHIBITED BY TECHNICAL SPECIFICATIONS
LICENSEE EVENT REPORT 91-030-01

Enclosed is Licensee Event Report 91-030-01 for Comanche Peak Steam Electric Station Unit 1, "Personnel Error Leading to Mispositioned Residual Heat Removal System Crosstie Valves".

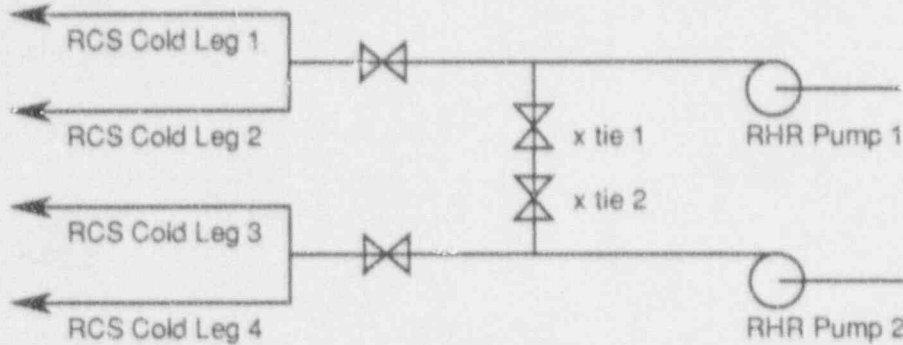
Figure 1

On December 4, 1991, following the first refueling outage, activities were in progress to bring the plant to Hot Standby. Various valves in the Emergency Core Cooling System (ECCS) (EISS:(BP)) associated with the Residual Heat Removal (RHR) system (EISS:(BP)) were placed in the required Mode 3 alignment in accordance with the integrated plant operating procedures. Train A of the RHR system had previously been placed in Standby Readiness, and Train B was operating in the shutdown cooling mode. RHR cross-tie valve 1 (refer to Figure 1) (EISS:(V)(BP)) was open and cross-tie valve 2 was closed in accordance with the alignment specified in the system operating procedure.

The Reactor Operator (utility, licensed) was directed by the Unit Supervisor (utility, licensed) to place the RHR system in standby readiness in accordance with the system operating procedure. While performing the alignment, the Reactor Operator failed to complete all steps necessary to place the RHR system in the required alignment, and inadvertently left the RHR crosstie valves closed. At 1333 the plant was declared to be in Mode 3.

Upon notification and completion of research to determine the correct valve position, the Unit Supervisor directed that the RHR crosstie valves be opened and that the appropriate surveillance test be performed to verify the correct position of other valves in the system. A review of the surveillance database was performed to identify the potential for similar problems. Additional alignment verifications were performed to ensure that no other system configuration problems existed. No valve misalignments were found.
