SUBJECT: Calvert Cliffs Nuclear Power Plant
Unit No. 1; Docket No. 50-317; License No. DPR 53
Licensee Event Report 91-007

LICENSEE EVENT REPORT (LER)

TITLE (4): Emergency Air Lock Inner and Outer Doors Open Simultaneously Due to Mechanical Malfunction

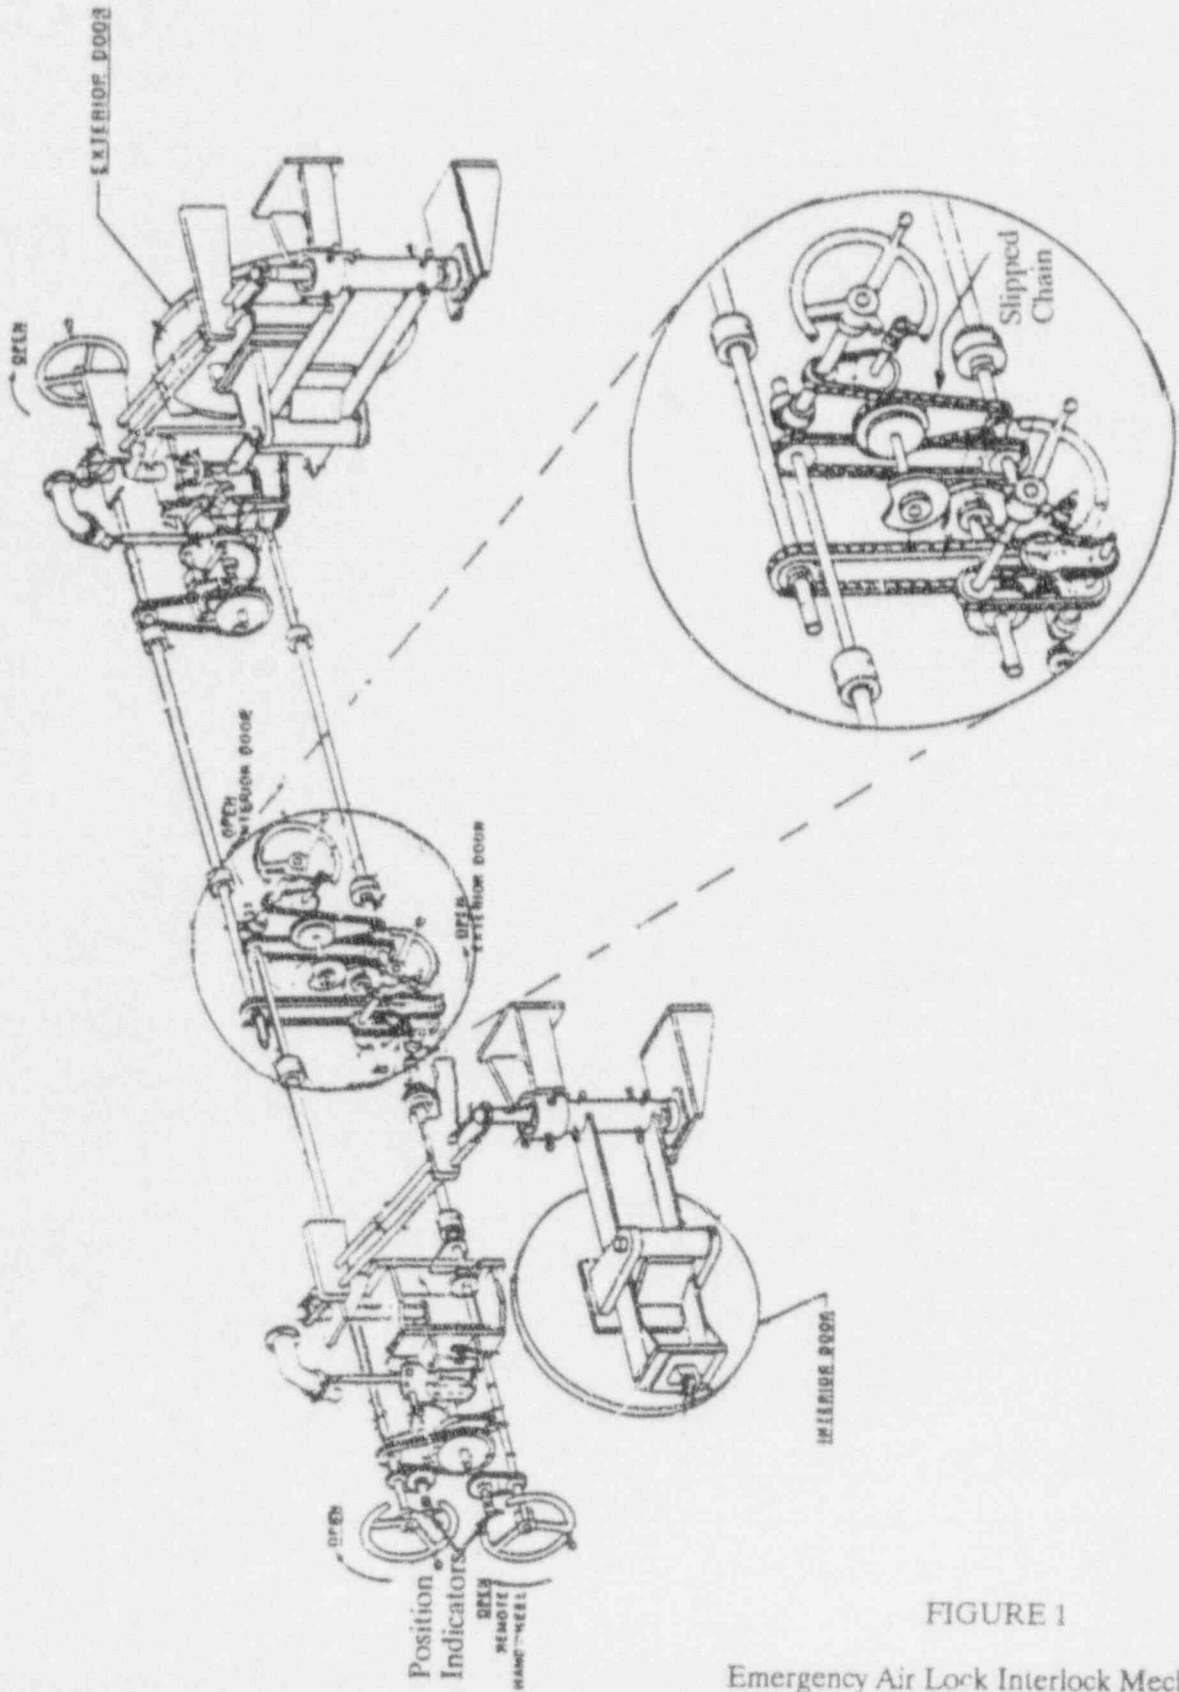
FIGURE 1

The cause of this event is attributed to mechanical malfunction which includes the slipped chain and misaligned cam in the interlock mechanism and inaccurate interior door position indication. Since the door position indicators rotate with the handwheel rather than the door, a misalignment in the interlock could cause an inaccurate position indication. A likely cause of chain slippage and

consequent misalignment is excessive force applied to the mechanism by personnel opening the door. Due to ALARA restrictions, testing to confirm the cause will be postponed until the next refueling outage, scheduled to commence in March of this year.

Emergency Air Lock Interlock Mechanism

1. The chain and cam were realigned and the mechanism verified OPERABLE. A sign has been placed next to the exterior door warning personnel of the loose chain and cautioning them to open the door carefully.
