Omaha Public Power District
1623 Harney Omaha, Nebraska 68102
402/536-4000

May 31, 1984
LIC-84-159

Steam Generator Tube Incident

The purpose of this letter and the attachments is to document information, commitments, and plans which were presented to the Commission during a meeting on May 29, 1984 concerning the Fort Calhoun Station's steam generator tube failure incident and inspections.

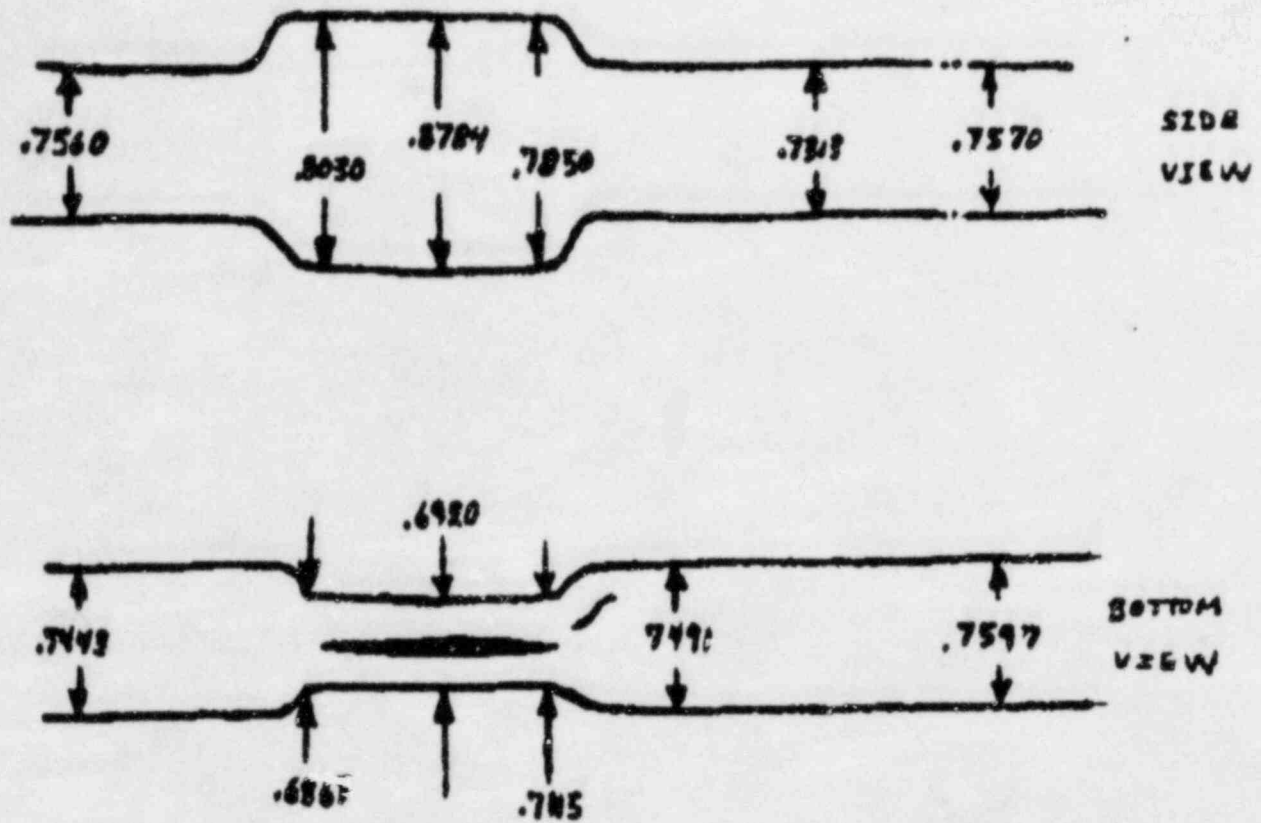
FIGURE 1. Dimensional Measurements

Figure 1 illustrates the dimensional measurements around the defect region. These measurements were taken before descaling and, as such, include the thickness of residual deposits. The measurement data indicate that the tube was ovalized. The major axis (6-12 o'clock) was elongated by 0.046-0.122 inch, while the minor axis (3-9 o'clock) was compressed by 0.045-0.070 inch diametrically.

- A. The failure was O.D. initiated intergranular stress corrosion cracking (IGSCC). There was no evidence of general intergranular attack.
- B. The material, Alloy 600, is in the mill annealed condition, based on microstructural examination and modified Huey testing.
- C. The tube was significantly ovalized. The tube diameter increased approximately 46 to 122 mils in the plane of the "fishmouth" fracture. At 90° rotation, the tube diameter was reduced by approximately 45 to 70 mils. There was no change in the nominal wall thickness.
- D. Chemical species which could have caused the observed intergranular stress corrosion cracking were not identified during this examination.

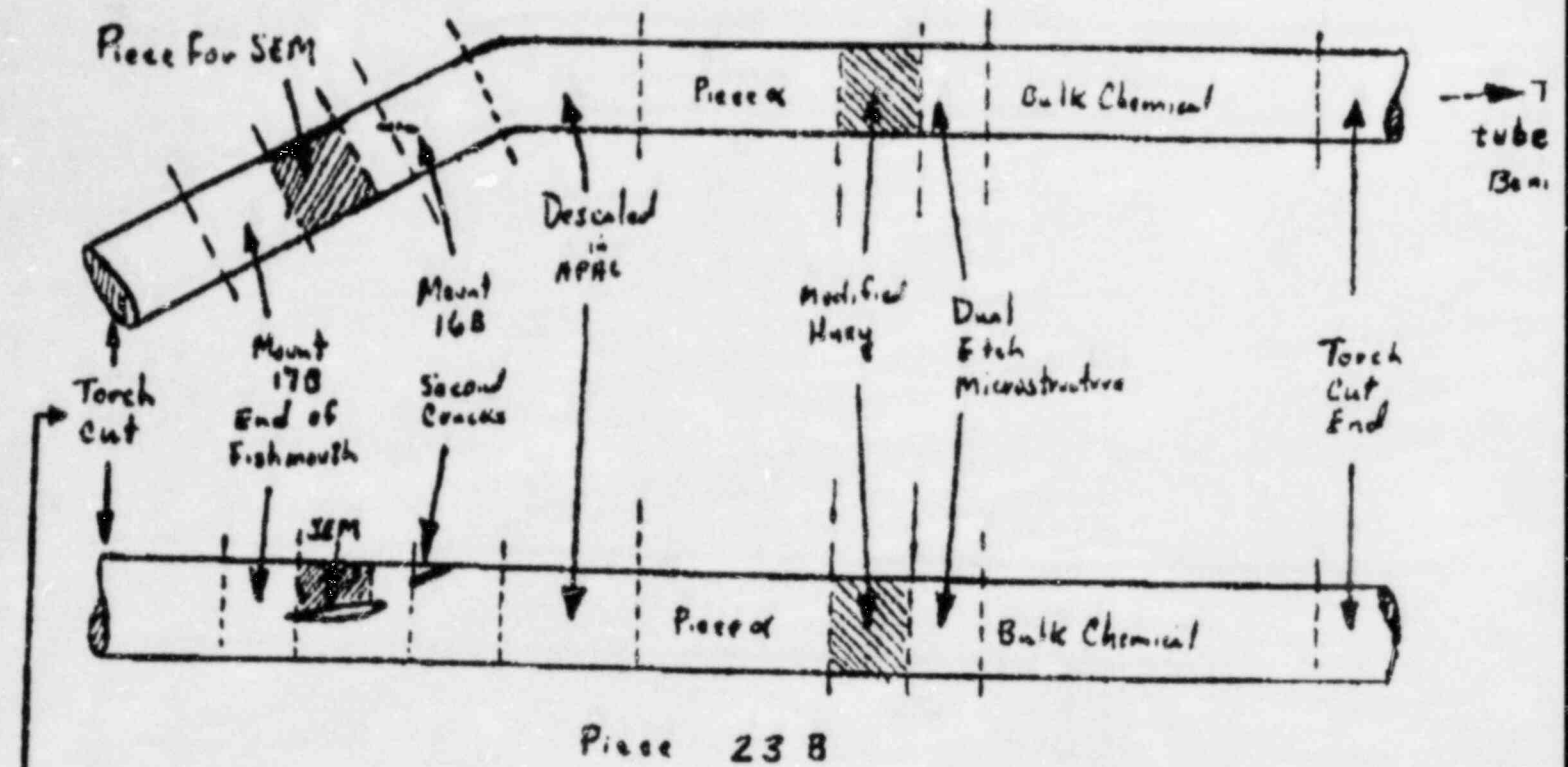
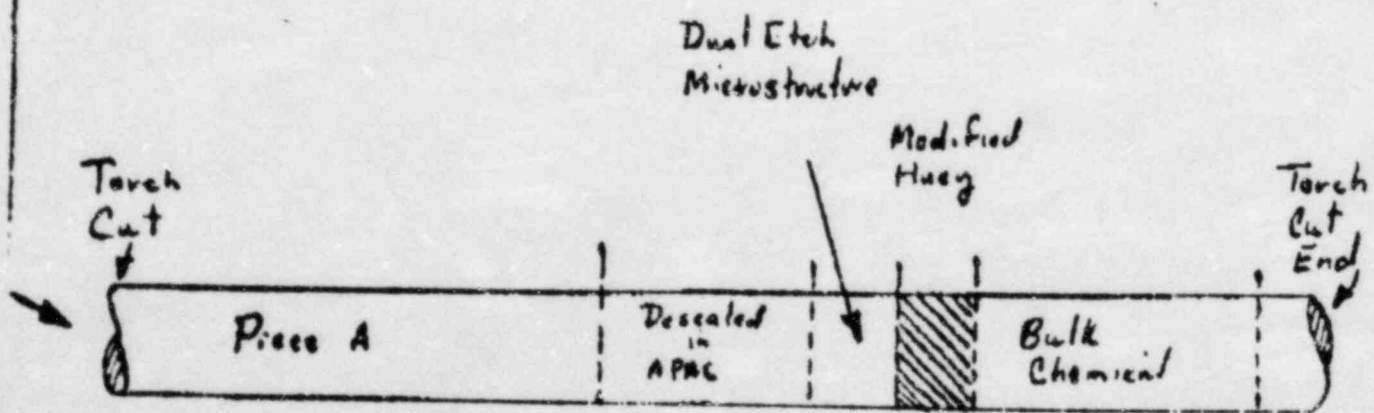
FIGURE 2. Sectioning Diagram

Cutting of the tube sections labeled 23B and 23C is shown in Figure 2, along with relative lengths and disposition of each piece.
