PECO ENERGY

SUBJECT: Licensee Event Report, Peach Bottom Atomic Power Station-Unit 3

Reference: Docket No. 50-278
Report Number: 3-95-003
Revision Number: 00
Event Date: 07/30/95
Report Date: 08/28/95
Facility: Peach Bottom Atomic Power Station
RD1, Box 208, Delta, PA 17314

TITLE (4)
Unit 3 Scram when the "A" Reactor Feed Pump Speed Increased

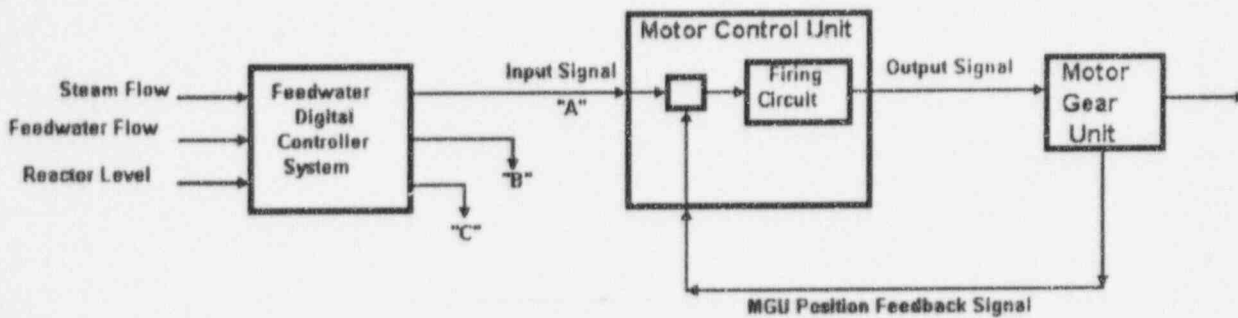
The cause of the scram was that a Main Turbine trip occurred due to a high reactor water level condition. Troubleshooting revealed that the "A" RFP Motor Control Unit (MCU) (see attached figure) failed causing an increase in the "A" RFP speed. This resulted in the high reactor water level condition.

Additional troubleshooting was performed which determined that the Firing Circuit within the "A" MCU failed. The MCU Firing Circuit drives the RFP Motor Gear Unit (MGU) which regulates RFP speed.

The exact cause of the Firing Circuit failure has not been determined yet but a Failure Analysis is being performed at a PECO Energy Test Facility. Based on the results of the Failure Analysis, generic implications will be considered and corrective actions will be implemented as appropriate.

Following replacement of four electronic cards within the Firing Circuit, the instrument loop was tested satisfactorily.

A Failure Analysis is being performed on the electronic cards at a PECO Energy Test Facility to determine the exact cause of the failure. Based on the results of the Failure Analysis, generic implications will be considered and corrective actions will be implemented as appropriate.

In addition, a modification is being considered which may replace the firing circuits with an improved digital logic. The modification is currently in the design stage and is planned for a future refueling outage.
