REPORT ON THE REVIEW OF THE
DIESEL GENERATOR BUILDING AT MIDLAND

OCTOBER, 1983

Structural Engineering Section B
Structural and Geotechnical Engineering Branch
Division of Engineering, ONRR

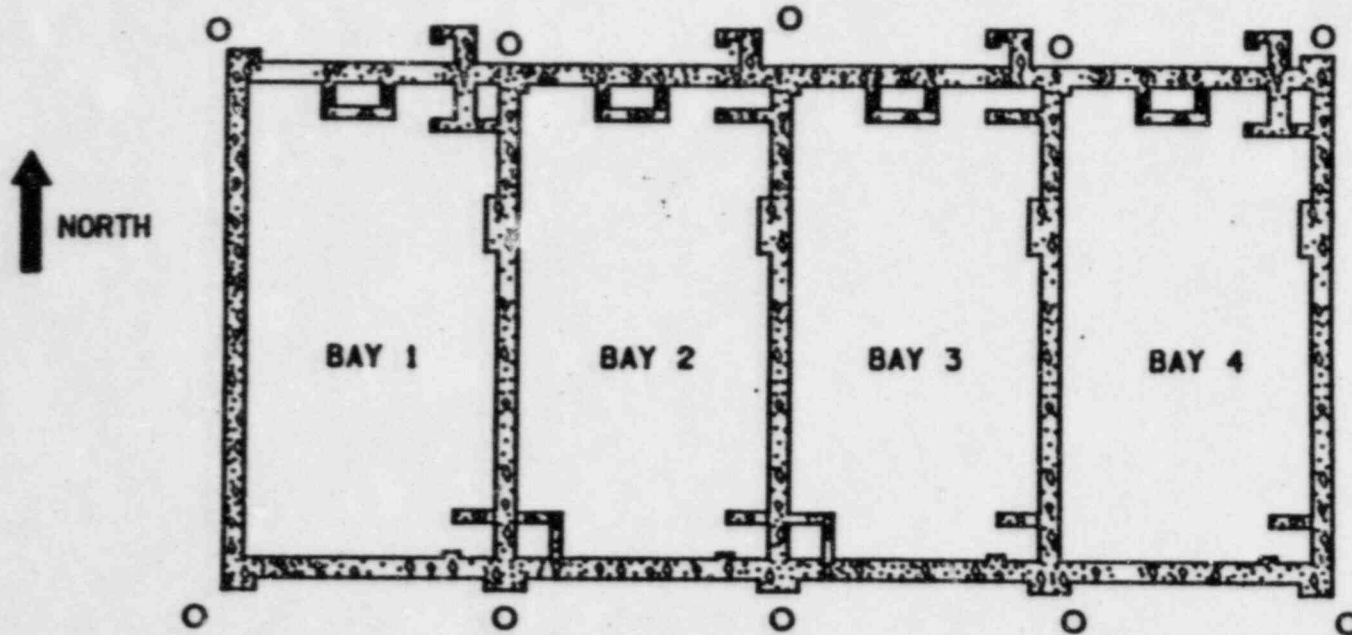
FIGURE 2

The effects of the remedial measures taken can be observed from the amount of settlement which the DGB has gone through as indicated in Figure 2 and also from the crack sizes and crack patterns of the walls as shown in Figure 3. Details of both settlement and cracking issues are discussed in the following sections.

Settlement of the DGB is time-dependent and load-dependent, but a complete and accurate settlement history does not exist. On the basis of the availability of the measured or estimated settlement values at various stages of construction, four cases of settlement analyses were performed by the Applicant as listed in Table 1, with the corresponding settlement values

shown in Figure 2. With the exception of Case 1A which was analyzed by long hand computation and by idealizing the partially completed DGB as a series of individual beams, the other three cases were analyzed by computer through the discretion of the DGB into a number of finite elements as exemplified in Figure 4. Case 1A was accomplished by passing deflection curve through any three measured neighboring settlement points and selecting the one with the largest curvature for moment computation, and eventually, stress determination. This calculation indicated that the measured displacements would result in a maximum rebar stress of 11 ksi. For the other three settlement cases, individual finite-element models were used. For settlement Case 1B, the finite-element model represents the structure as built to el. 662 f 0 in.

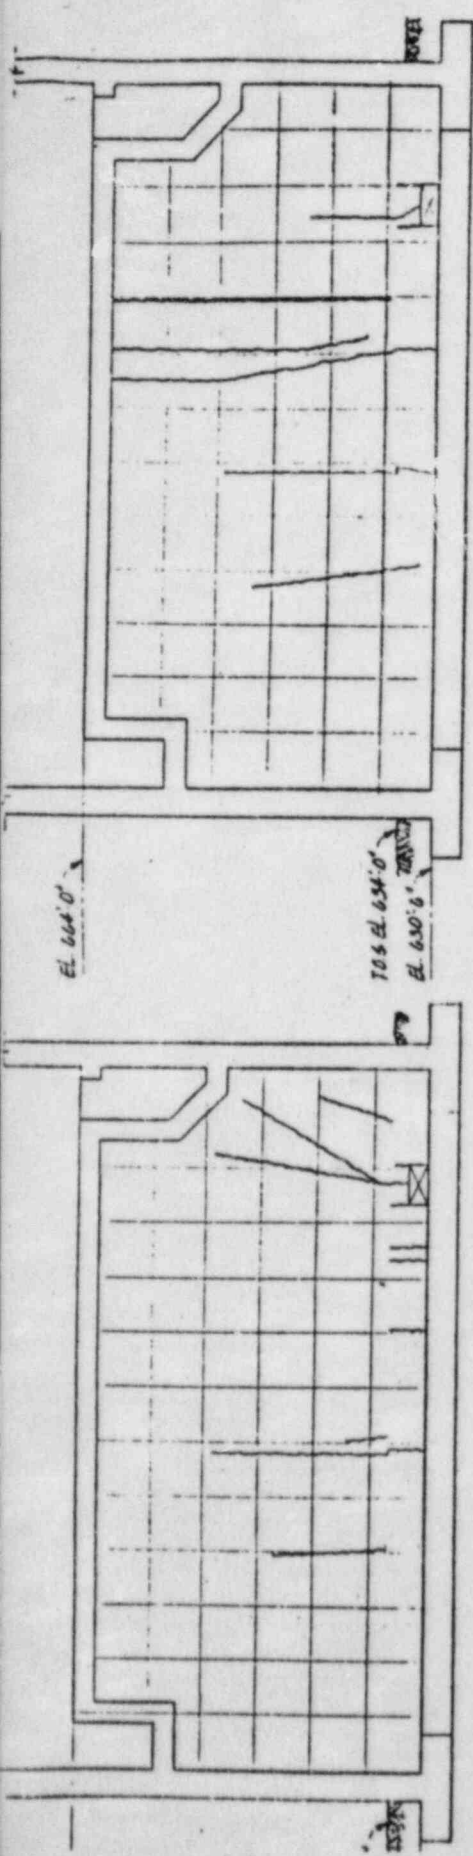
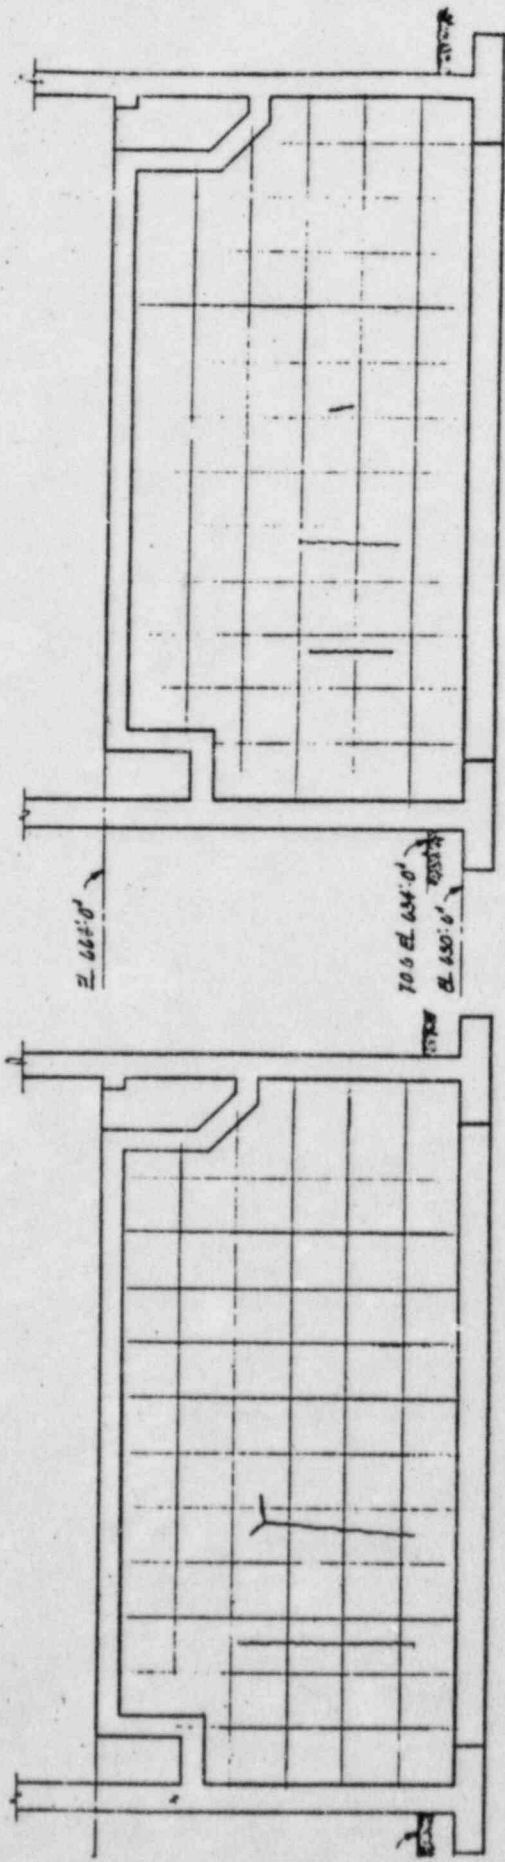
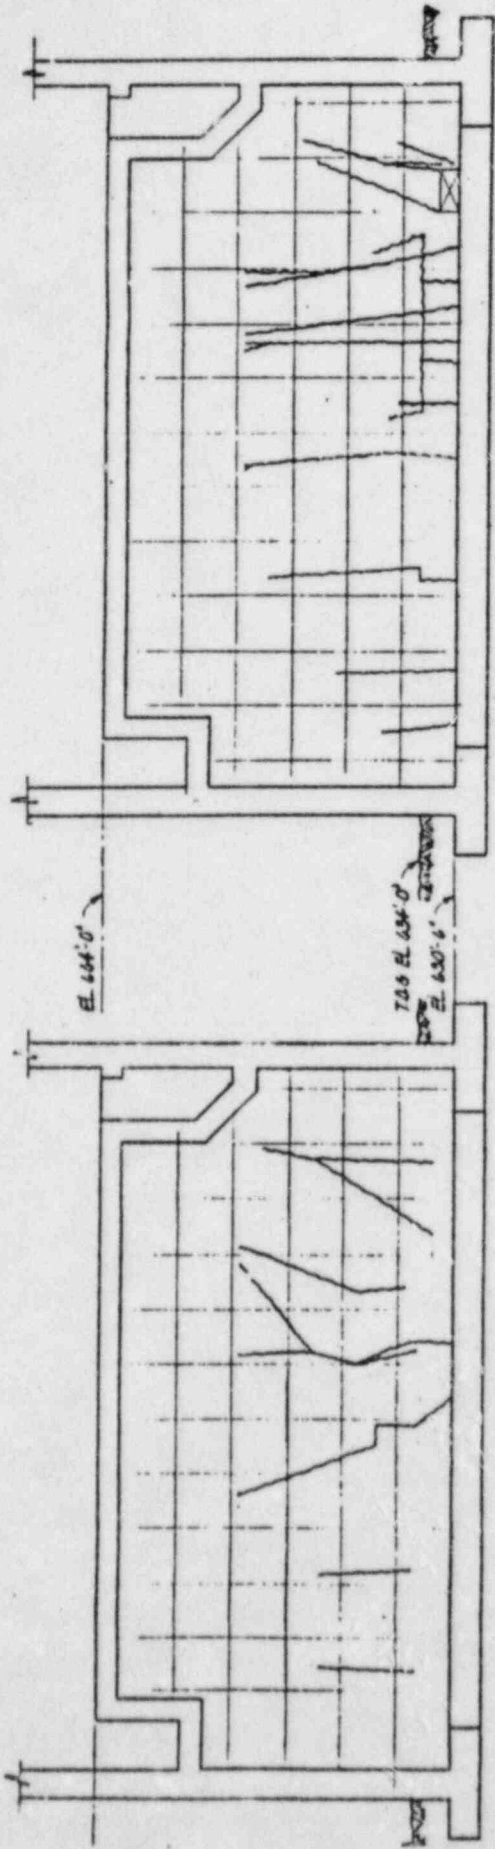
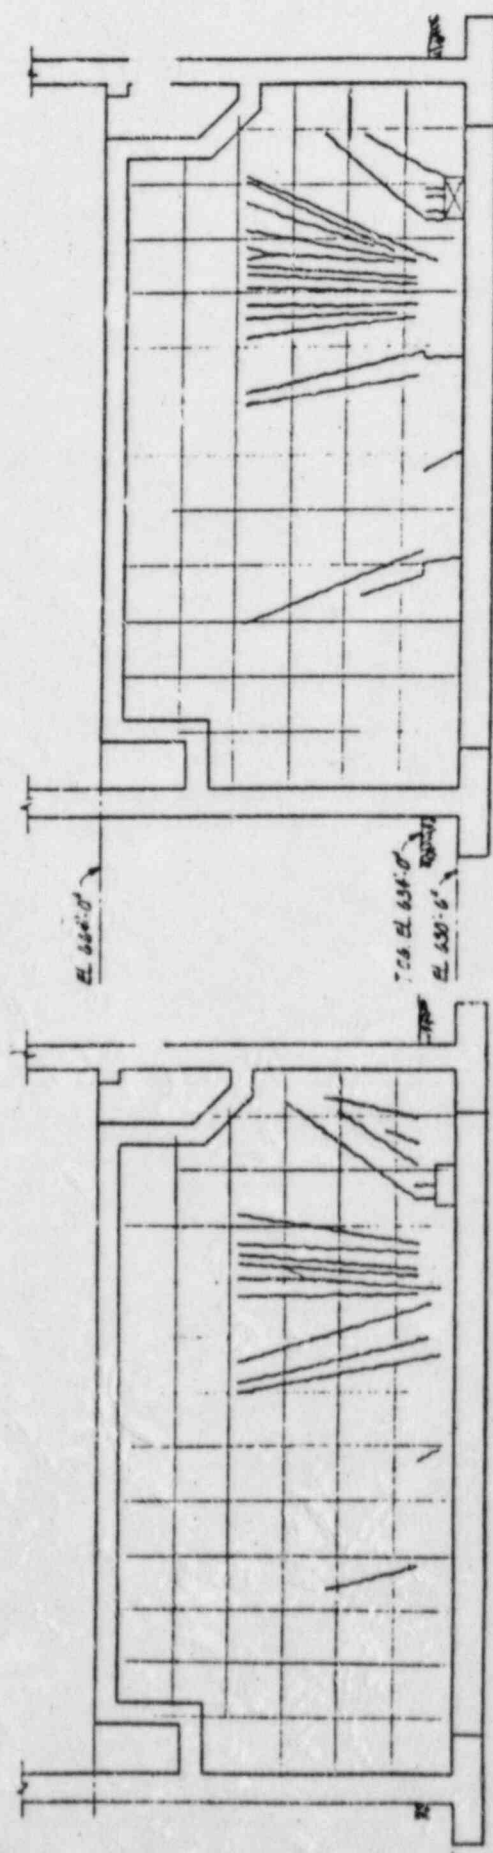
FIGURE 3 - A - 1

1. CRACKS SHOWN WERE MAPPED PRIOR TO PLACING THE PRELOAD. (12-15-78 TO 12-18-78).
2. NORTH & SOUTH WERE NOT MAPPED SINCE NO SIGNIFICANT CRACKS WERE OBSERVED.
3. IN GENERAL, ALL CRACKS WERE MAP LINED WITH SOME CRACKS WITH A THICKNESS OF 28 MILS AS OF 2-2-79.

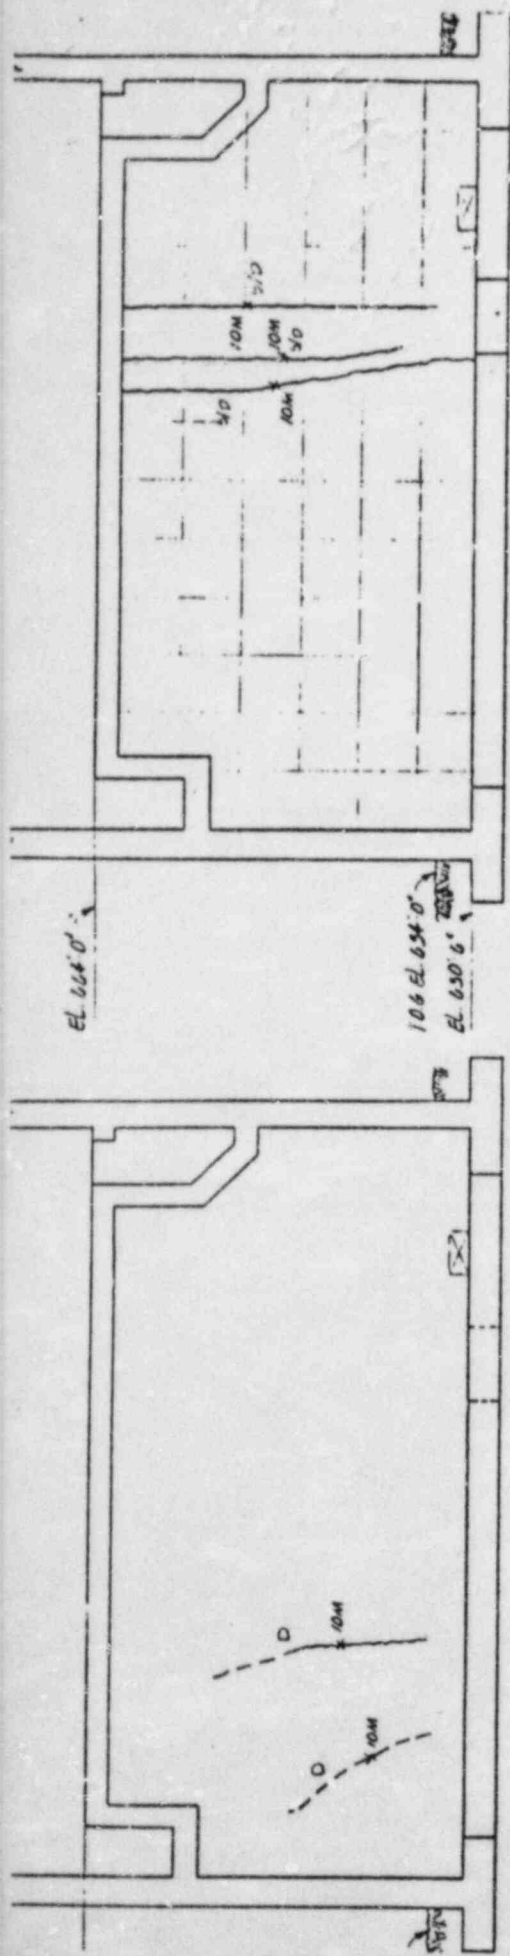
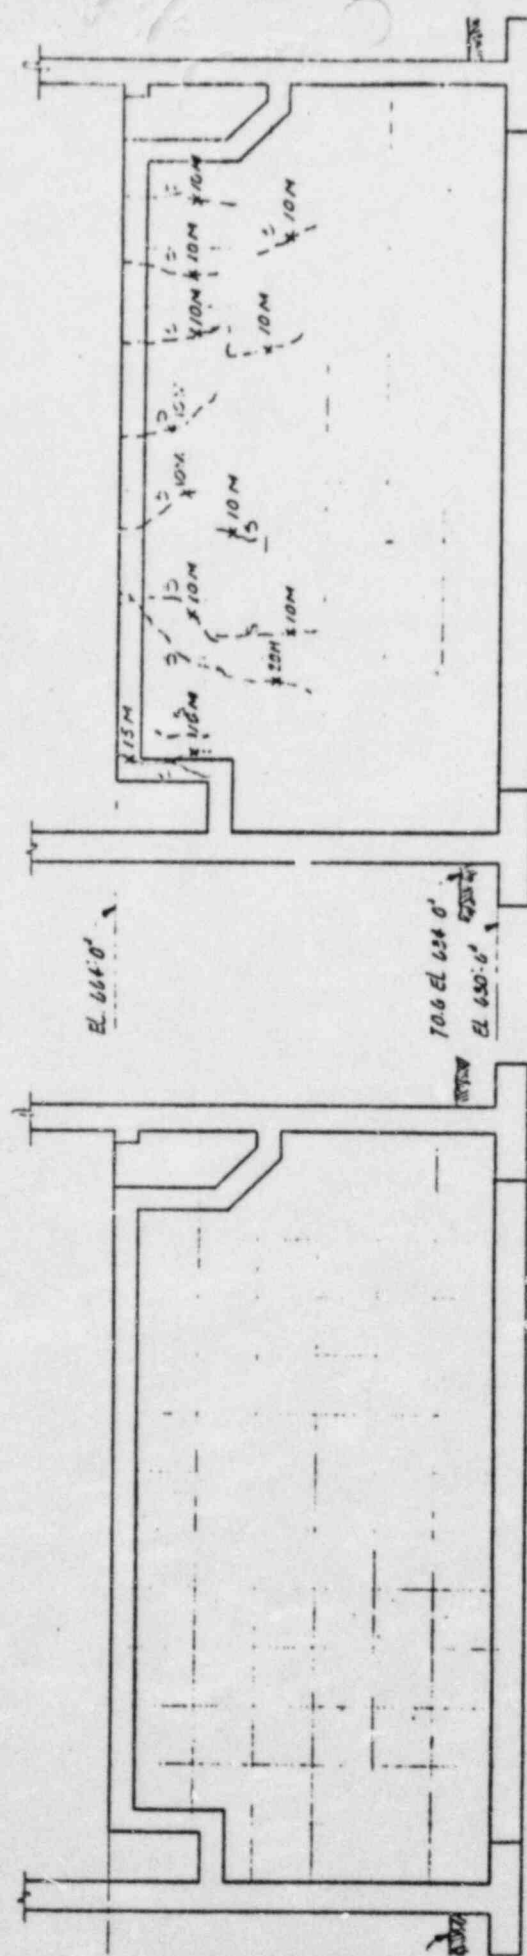
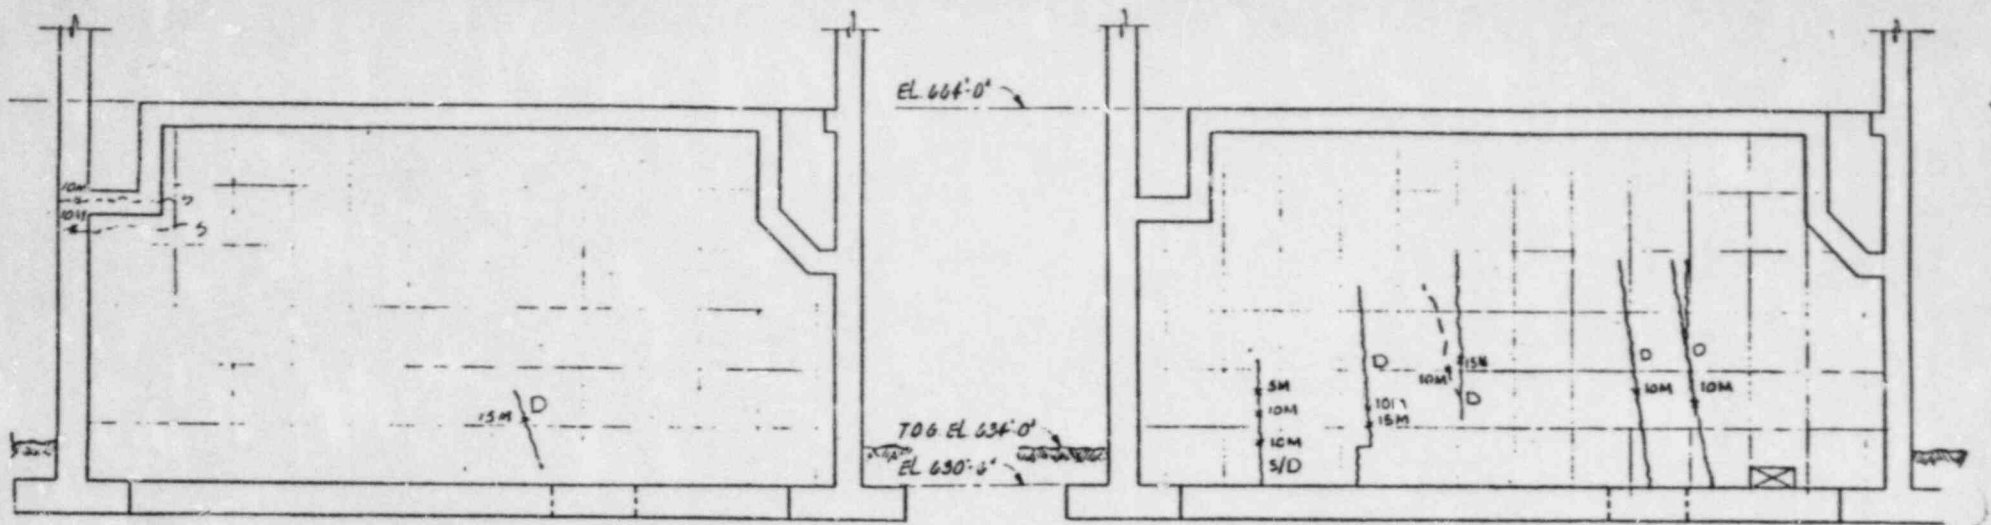
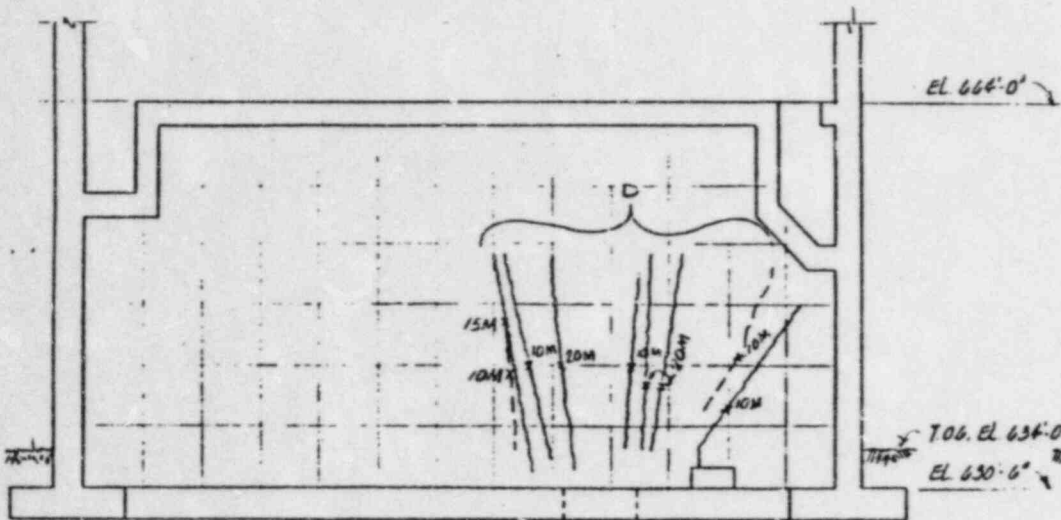
FIGURE 3 B - 1

1. IN GENERAL ALL CRACKS MAPPED IN DEC 1978 WERE HAIRLINE. SOME CRACKS HAD A THICKNESS OF 28 MILS AS OF 2-2-79.
2. FOR CRACK MAPPING OF WALLS FROM EL. 664'-0" TO EL. 631'-6" SEE FIS. 28-3
3. CRACKS LESS THAN 10 MILS IN SIZE ARE NOT SHOWN.

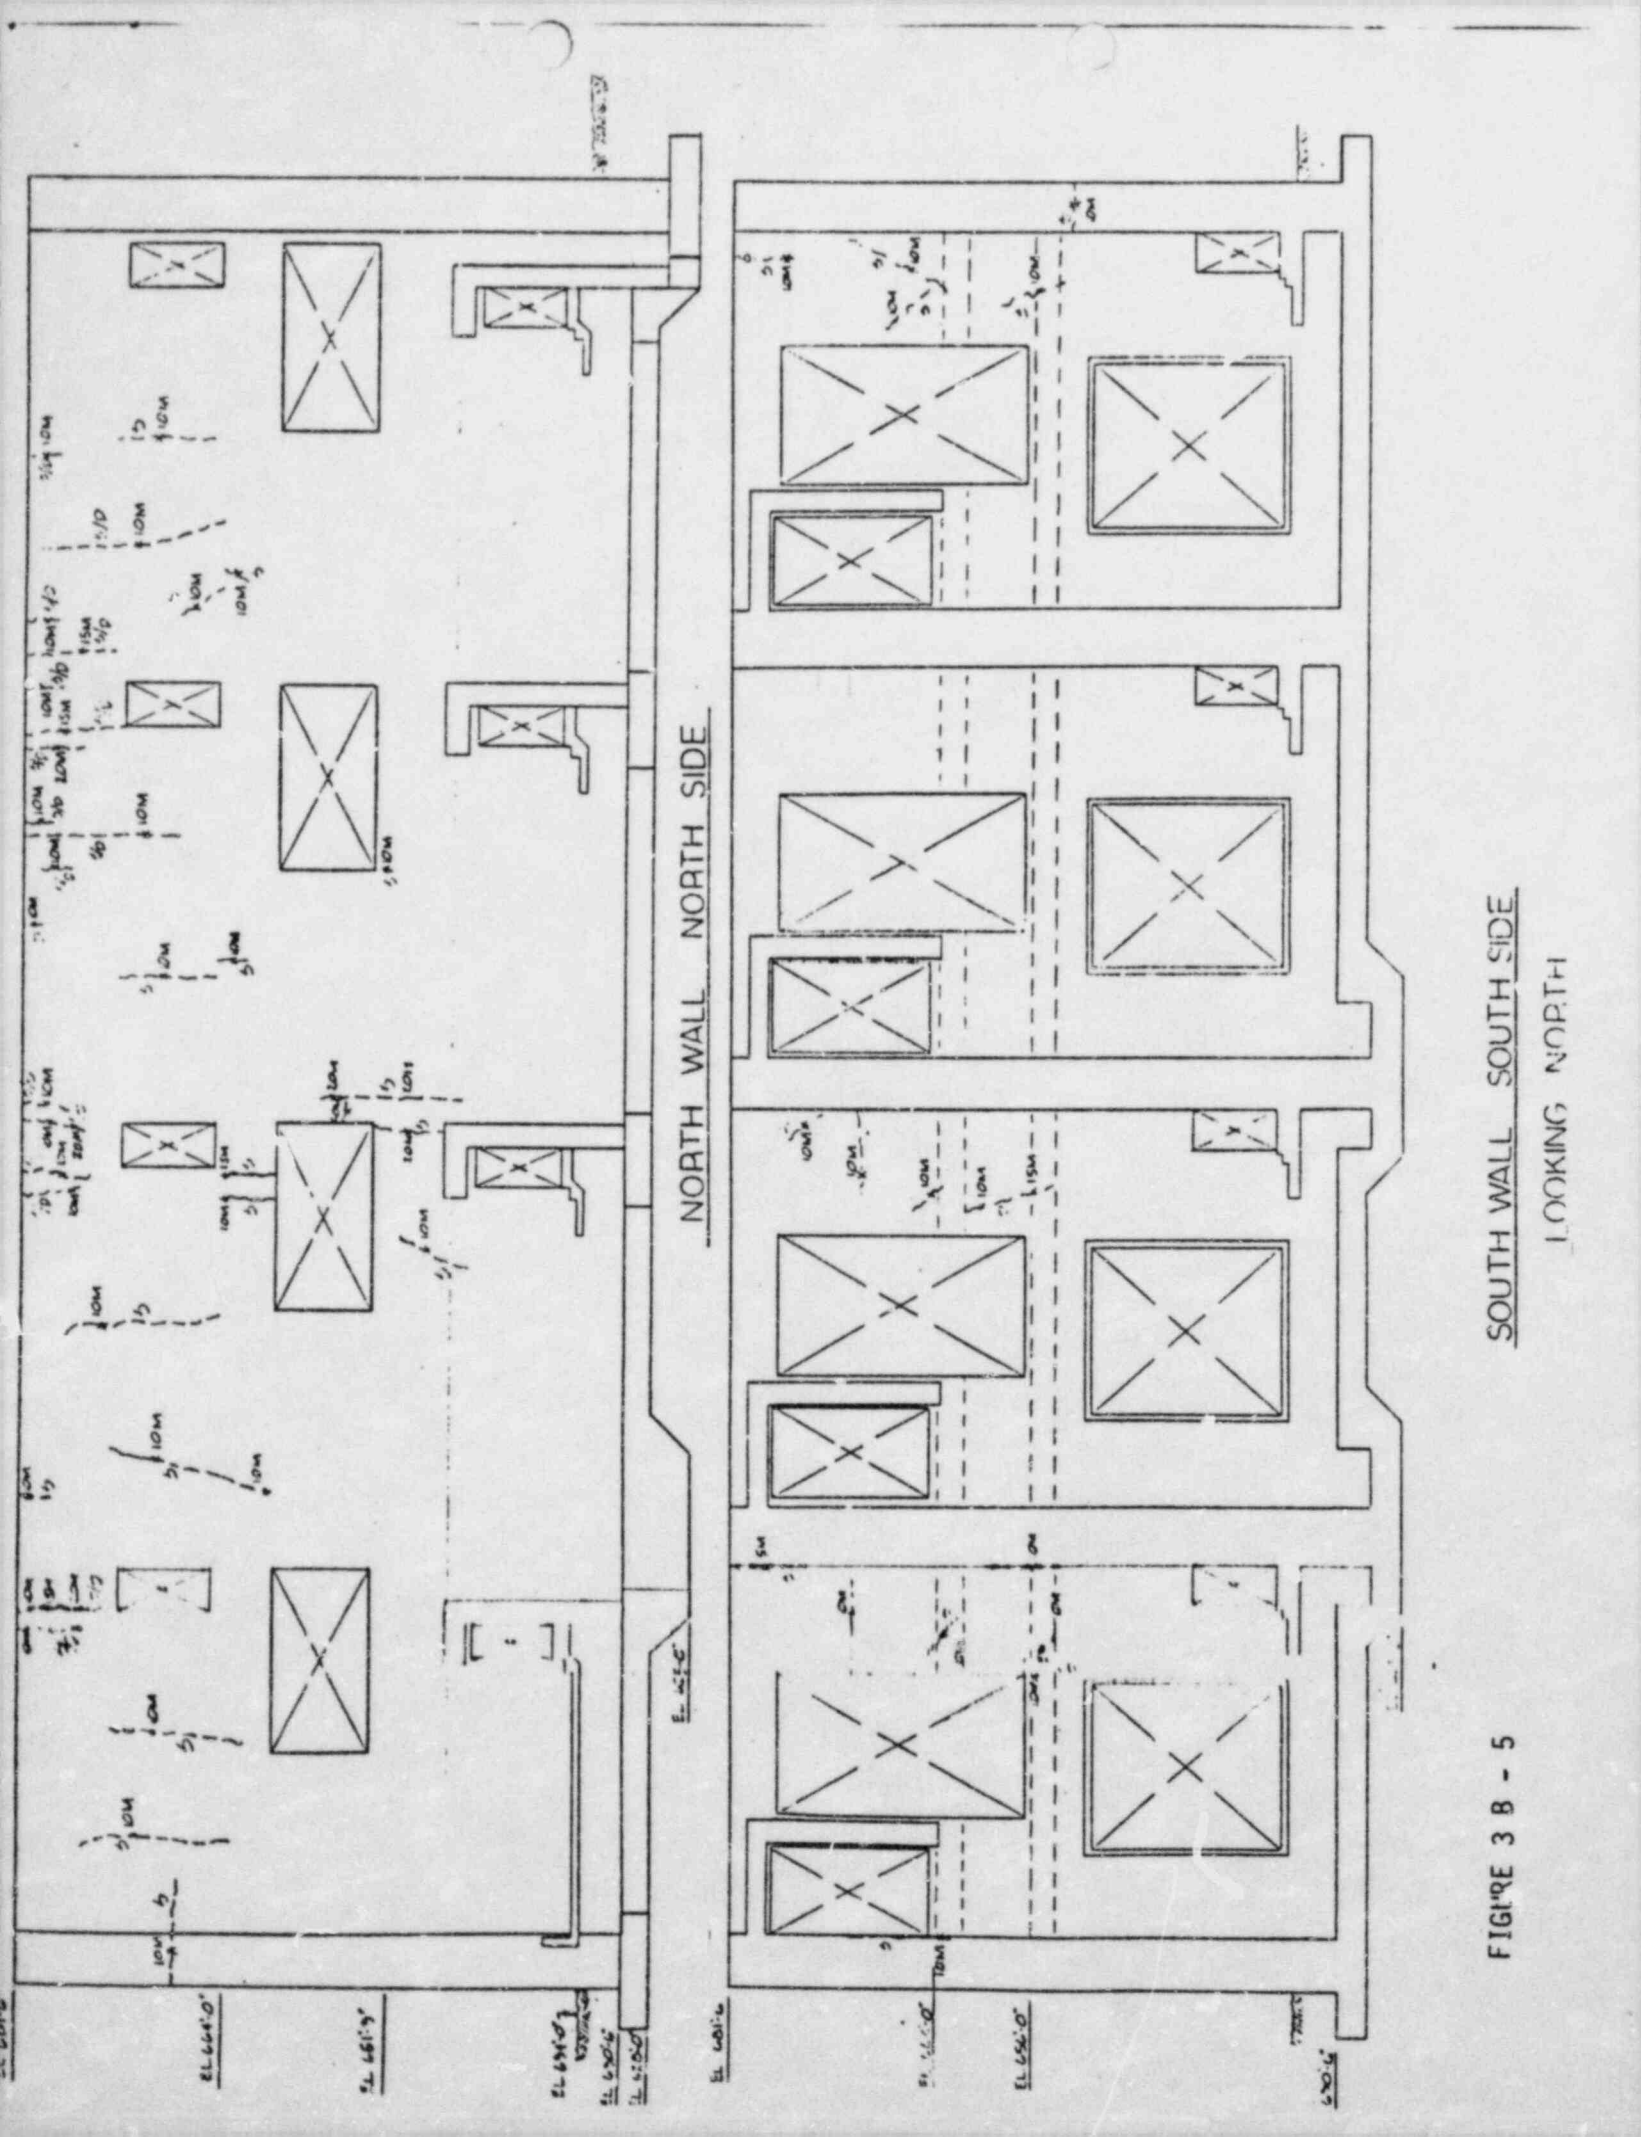
FIGURE 3 B - 5

SOUTH WALL SOUTH SIDE
LOOKING NORTH
