Subject: Duane Arnold Energy Center
Docket No: 50-331
Op. License No: DPR-49
Licensee Event Report #95-008.
File: A-118a

LICENSEE EVENT REPORT (LER)

TITLE (4) Potential Loss of Both Trains of Standby Gas Treatment Due to Leaking Valves

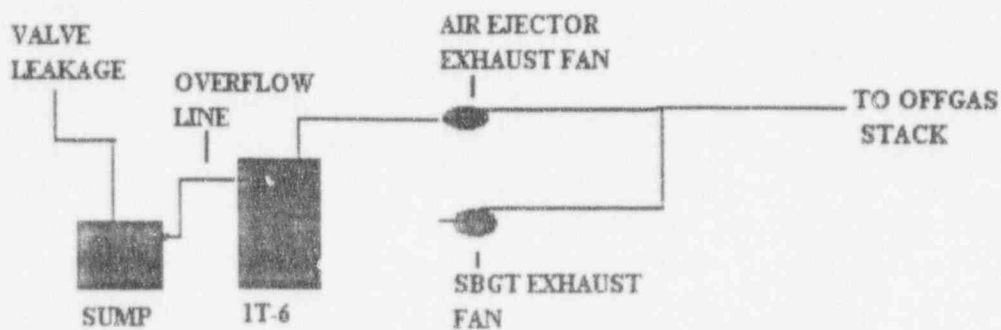
The cause of the 'B' SBGT exhaust fan trip was water in the fan housing resulting from leakage past various Turbine Building high energy steam valves. Leakage past these high energy steam valves is directed to the turbine building equipment drain sump (see diagram). This leakage led to elevated temperatures in the sump. The Turbine Building equipment drain sump is connected to the condensate demineralizer backwash receiving tank (1T-6) via the latter tank's overflow line. The elevated temperatures in the sump were transmitted to 1T-6, which led to an increase in 1T-6 humidity. 1T-6 is vented to the suction ducting of the air ejector exhaust fan. The air ejector exhaust fan discharges to a duct common with SBGT exhaust ducting. The increased humidity from 1T-6 condensed in this line and drained back to the SBGT exhaust fan housings.

Once it was determined that the source of the condensation was the high humidity air in the condensate demineralizer backwash receiving tank, the air from the tank was redirected to the turbine building exhaust ducts. Since this action, there has been no buildup of moisture in the SBTG fan housings.

A plan will be developed to isolate the leaks into the turbine building equipment drain sump and repair the leaking valves. As part of this effort, the maintenance history of those valves will be reviewed and long term actions initiated as appropriate. These actions will be completed by September 29, 1995.

Additionally, the connections between IT6 and the Turbine Building equipment drain sump are being reviewed for design adequacy. Corrective actions will be taken as appropriate.
